August 8, 2001

## INCIDENT REPORTING SYSTEM

NRC INFORMATION NOTICE 2001-05: THROUGH-WALL CIRCUMFERENTIAL CRACKING  
OF REACTOR PRESSURE VESSEL HEAD  
CONTROL ROD DRIVE MECHANISM  
PENETRATION NOZZLES AT OCONEE NUCLEAR  
STATION, UNIT 3

NRC INFORMATION NOTICE 2001-06: CENTRIFUGAL CHARGING PUMP THRUST BEARING DAMAGE NOT DETECTED DUE TO INADEQUATE ASSESSMENT OF OIL ANALYSIS RESULTS AND SELECTION OF PUMP SURVEILLANCE POINTS

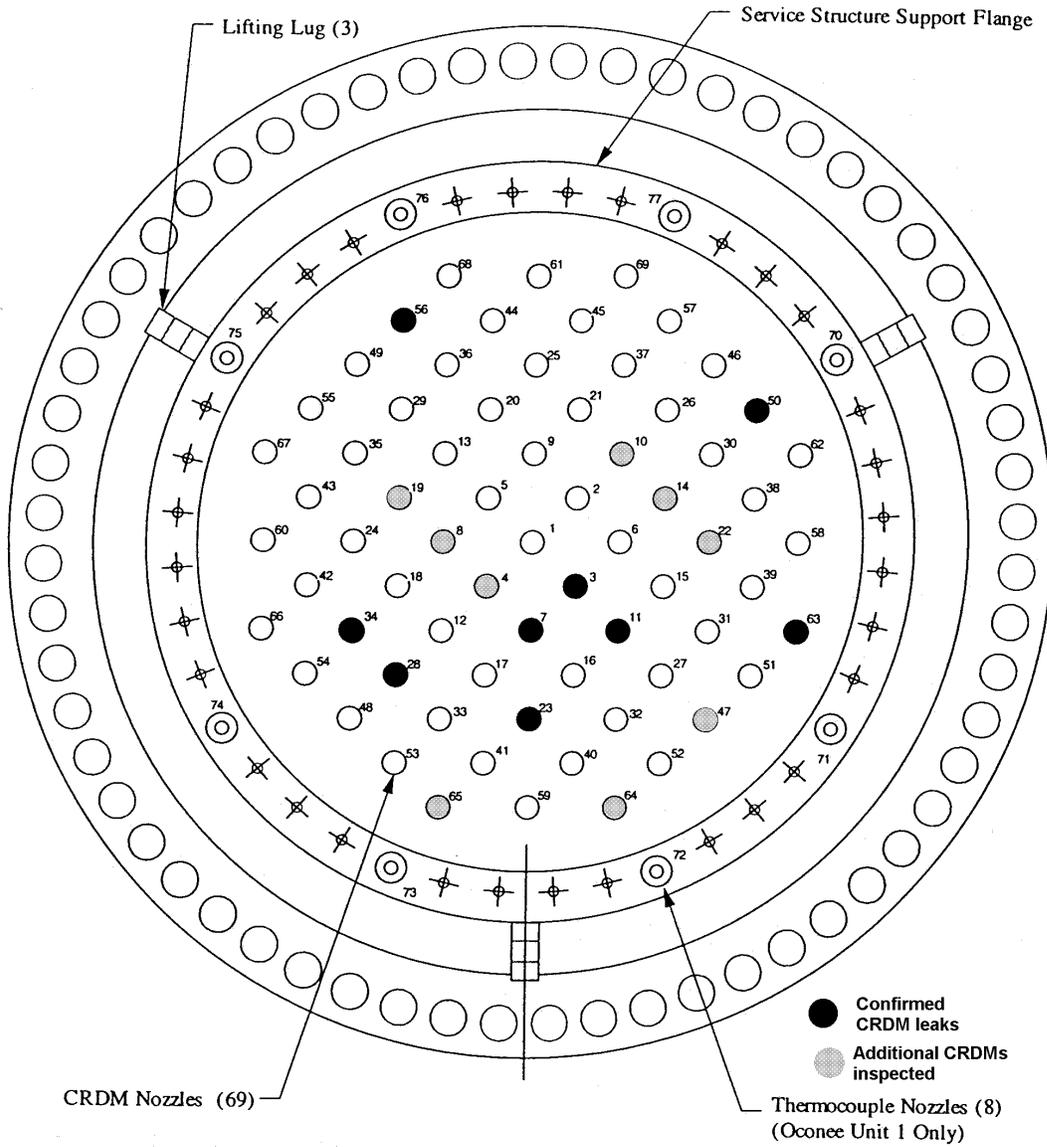
Figure 1: Oconee Reactor Pressure Vessel Head Map

Subsequent dye-penetrant testing (PT) revealed additional indications in two of the nine degraded penetration nozzles. While affecting further repairs of these indications, the licensee identified that each nozzle had significant circumferential cracks in the nozzle above the weld. Further investigations and metallurgical examinations revealed that these cracks had initiated from the outside diameter (OD) of the CRDM penetration nozzles. The circumferential crack in the #56 CRDM nozzle was through-wall, and the #50 nozzle had pin hole through-wall indications. These cracks followed the weld profile contour, and were nearly 165° in length.

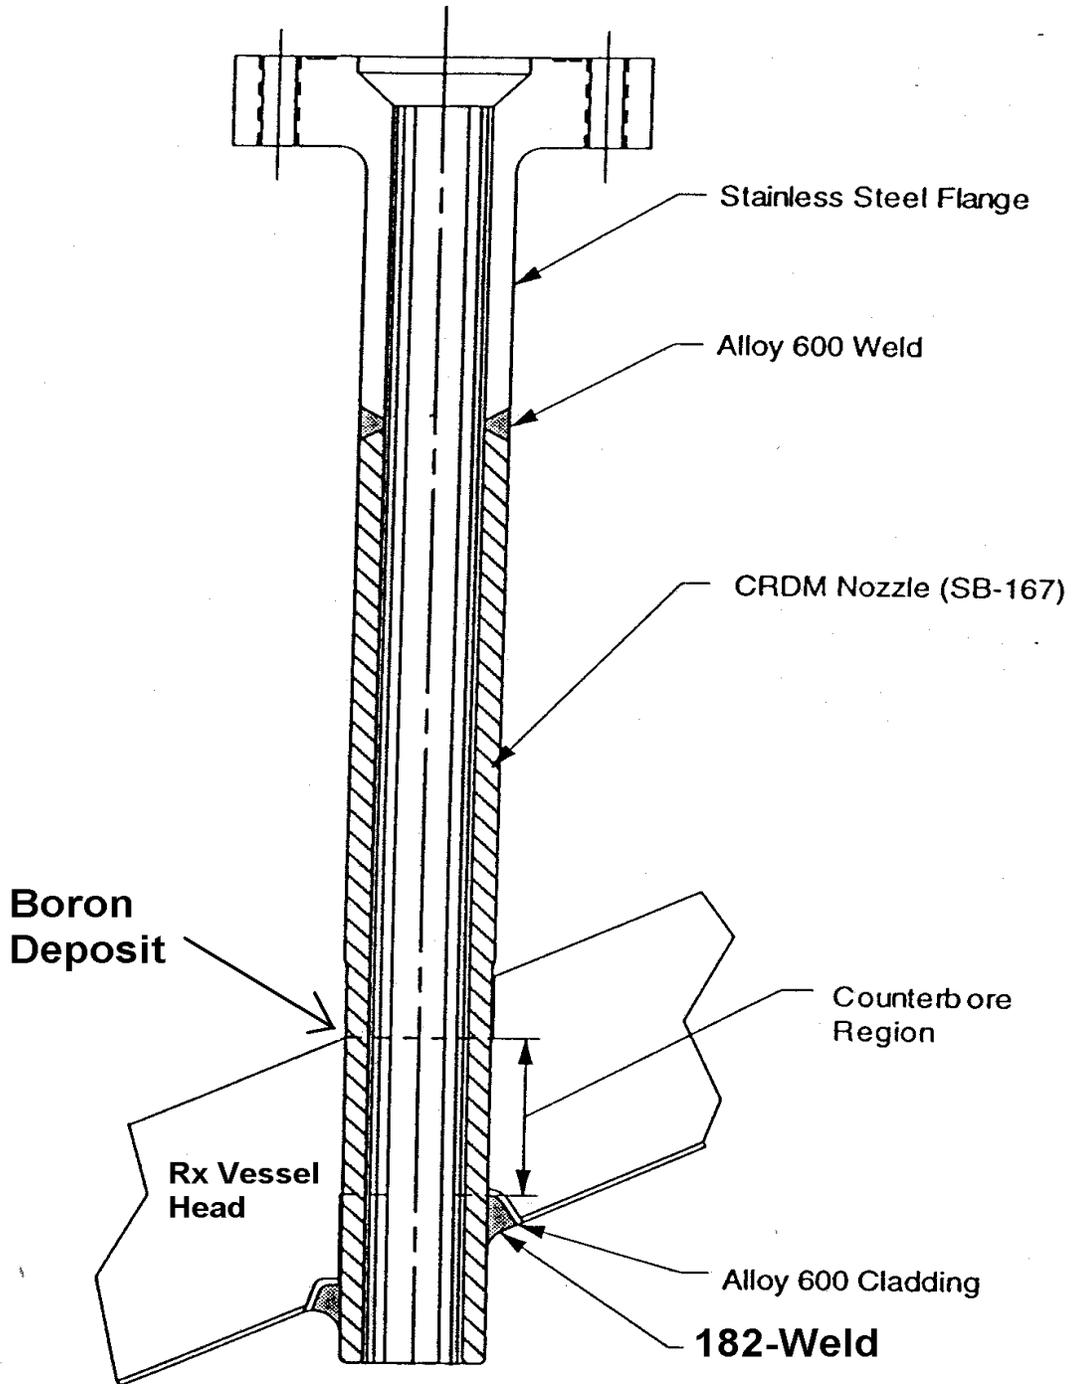
Figure 2: Oconee CRDM Nozzle Penetration (Typical)

The 69 CRDM nozzles at ONS3 are approximately 5 feet long and are J-groove welded to the inner radius of the RPV head, with the lower end of each nozzle extending about 6 inches below the inside of the RPV head (see Figure 2). The nozzles are constructed from 4-inch OD Alloy 600 Inconel procured in accordance with the requirements of Specification SB-167, Section II to the 1965 Edition (including Addenda through Summer 1967) of the American Society of Mechanical Engineers (ASME) Boiler and Pressure Vessel Code. During initial construction, each nozzle was machined to final dimensions to assure a match between the RPV head bore and the OD of the nozzle. The nozzles were shrink-fit by cooling to at least minus 140 degrees F, inserted into the closure head penetration, and then allowed to warm to room temperature (70 degrees F minimum). The CRDM nozzles were tack-welded and then permanently welded to the closure head using 182-weld metal (see Figure 2). The shielded manual metal arc welding process was used for both the tack weld and the J-groove weld. During weld buildup, the weld was ground and PT inspected at each 9/32 inch of the weld. The final weld surface was ground and PT inspected. The weld prep for installation of each nozzle in the RPV head was accomplished by machining and buttering the J-groove with 182-weld metal.
