South Texas Project
Unit 2
Docket No. STN 50-499
2RE08 Steam Generator Condition Monitoring Report

Attachment: Westinghouse Report SG-01-07-002, "South Texas Project Unit 2 2RE08 Refueling Outage Condition Monitoring"

South Texas Project 2RE08 Condition Monitoring Assessment

This report documents the condition monitoring assessment of the NDE results from the South Texas Project 2RE08 refueling outage and inspection, performed in March 2001.

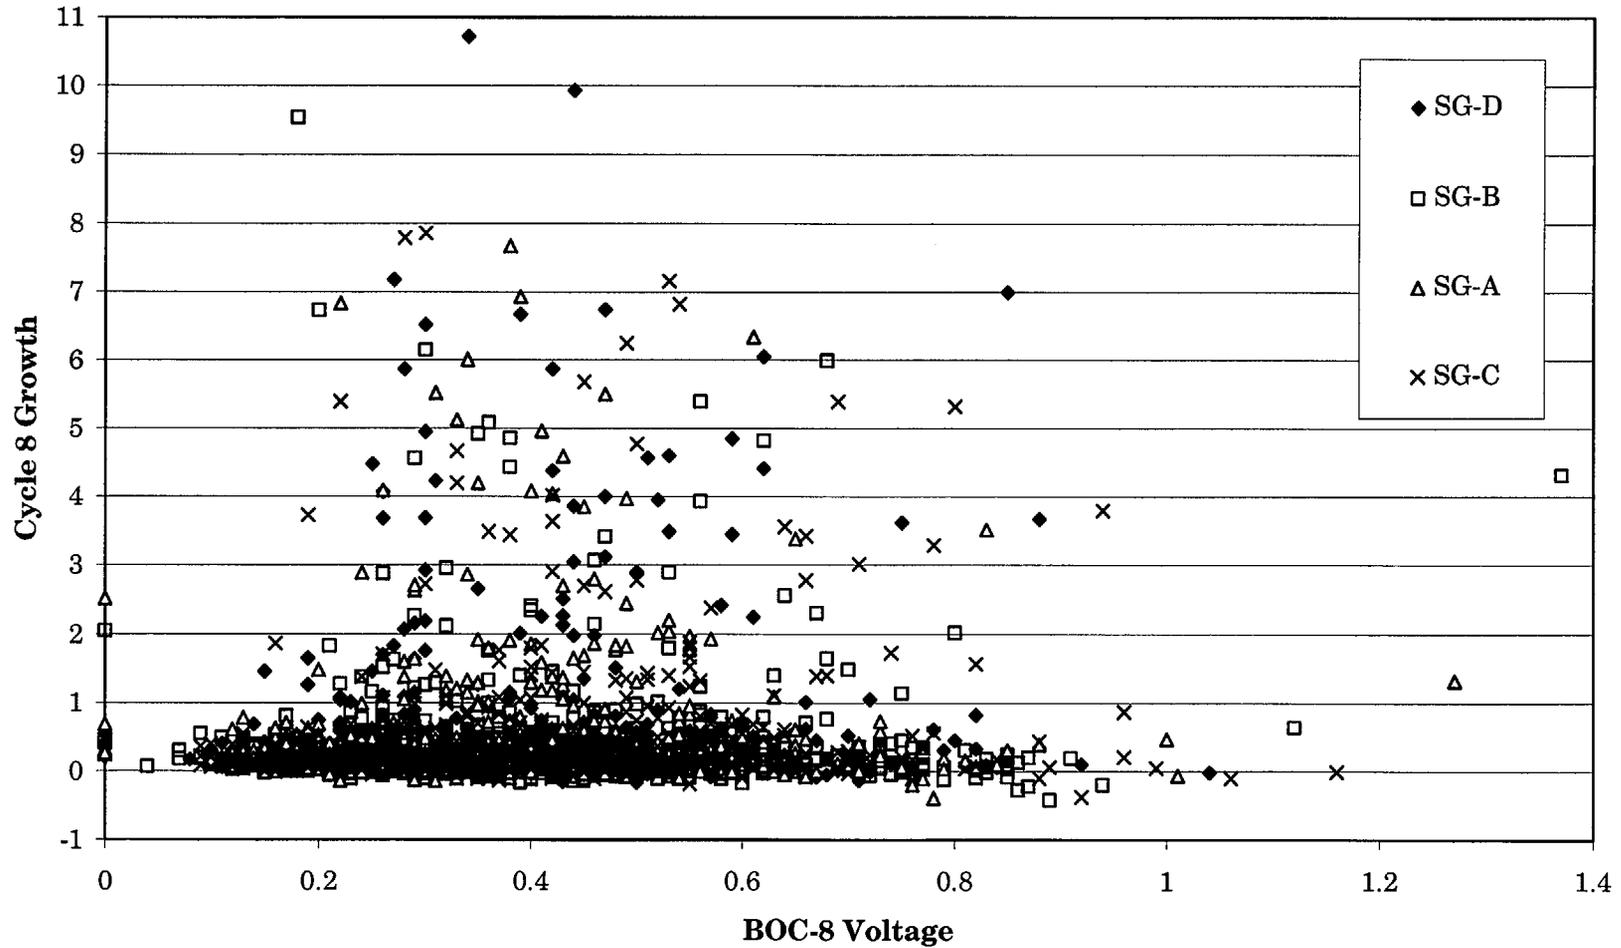
Figure 6-2
South Texas Unit-2
Growth During Cycle 8 as a Function of BOC Voltage
