South Texas Project Electric Generating Station P.O. Box 289 Wadsworth, Texas 77483

South Texas Project
Unit 2
Docket No. STN 50-499
2RE08 Steam Generator Condition Monitoring Report

Attachment: Westinghouse Report SG-01-07-002, "South Texas Project Unit 2 2RE08 Refueling Outage Condition Monitoring"

South Texas Project 2RE08 Condition Monitoring Assessment

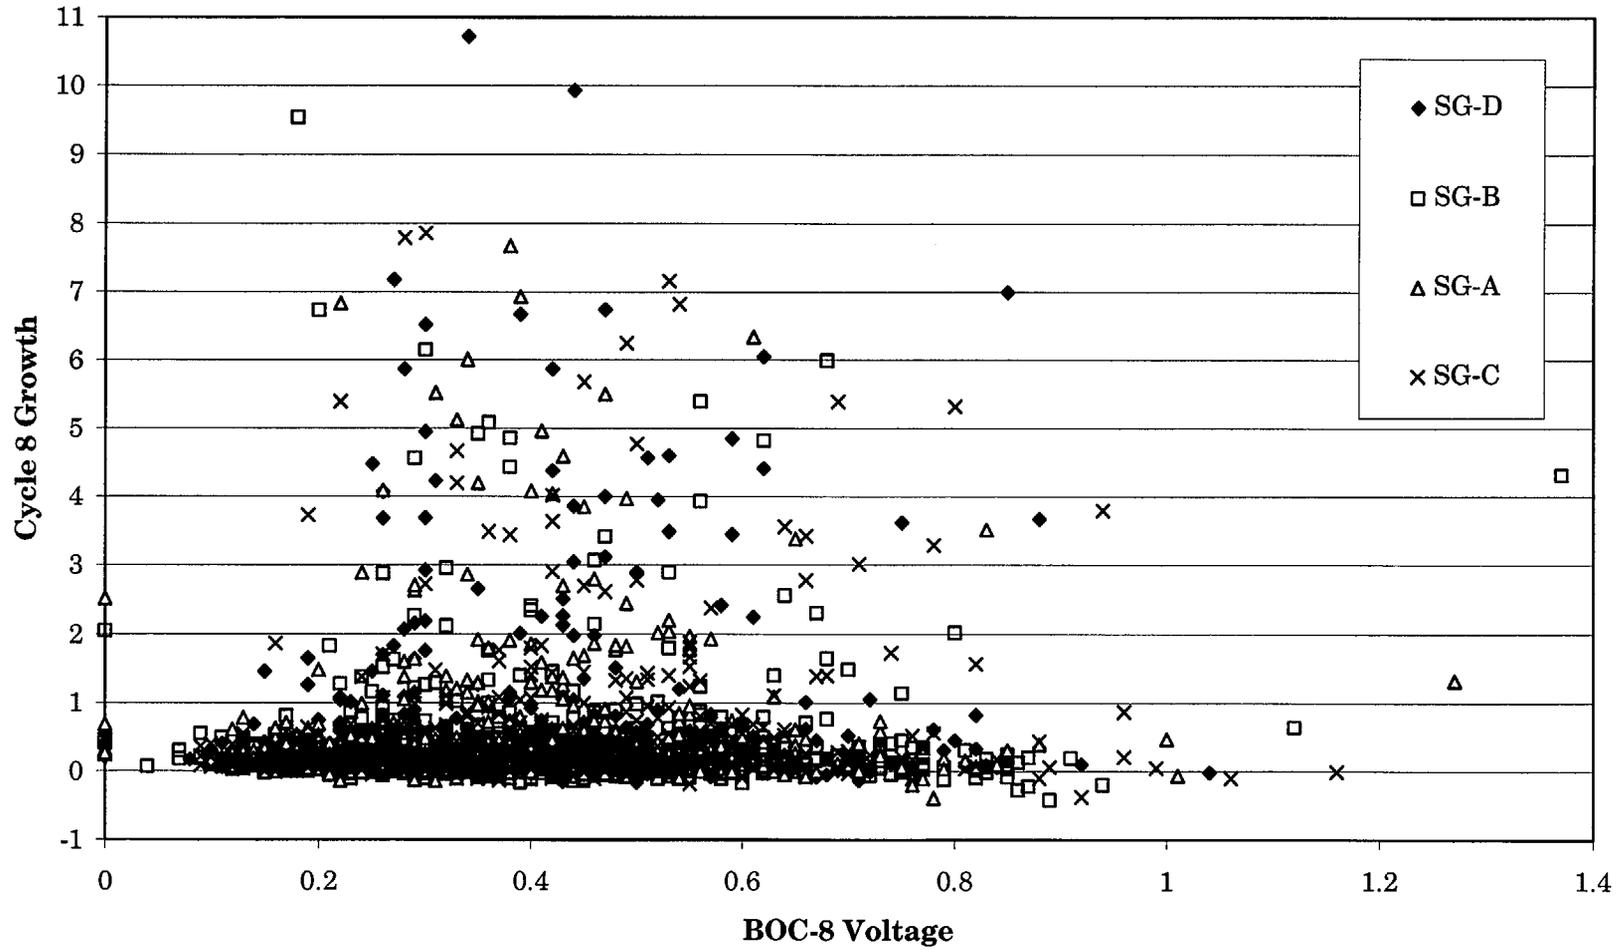
Figure 6-2
South Texas Unit-2
Growth During Cycle 8 as a Function of BOC Voltage

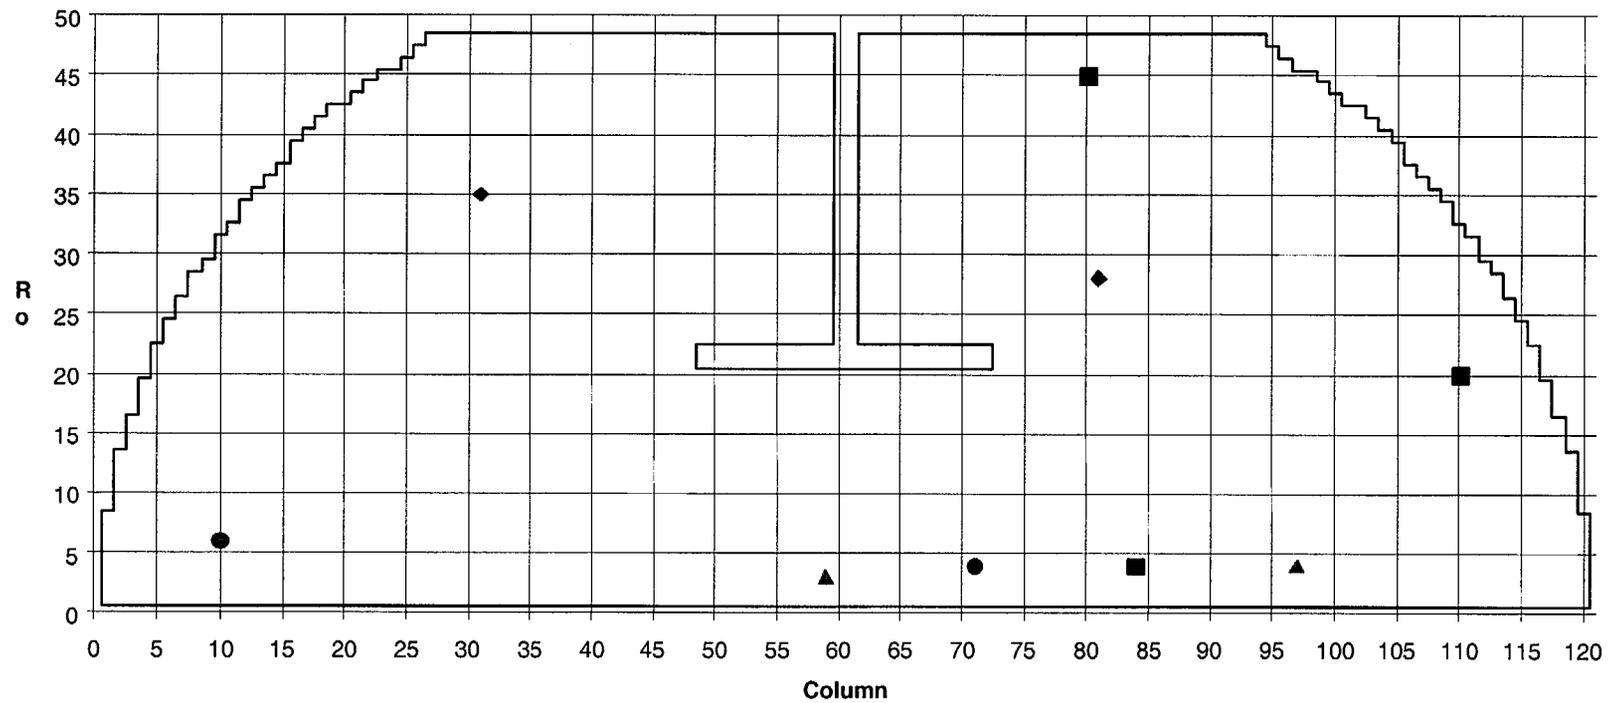
Figure 6.2-1: Location of Circumferential Indications

The purpose of this section of the report is to deal with the structural integrity of the circumferential indications found during the inspection. A total of ten (10) circumferential indications were detected, with nine (9) of those being at the top of the hot-leg tubesheet and one (1) at a paired-ding feature located about 3.5" above the 16C tube support plate. All of these indications were plugged. A summary table extracted from the plugging list is provided in Table 6.2-1. Examination of the table data indicate that most of the indications are too small to reliably size, hence the subsequent reported depths and areas should not be considered to be very accurate. This is not a shortcoming because the indications are small. The locations of the cracking relative to the row and column numbers in the SGs are illustrated on Figure 6.2-1.
