SUBJECT: SITE VISIT TO THE QUIVIRA URANIUM MILL, AMBROSIA LAKE,
NEW MEXICO

SITE VISIT TO THE QUIVIRA URANIUM MILL
AMBROSIA LAKE, NEW MEXICO
JULY 24, 2001

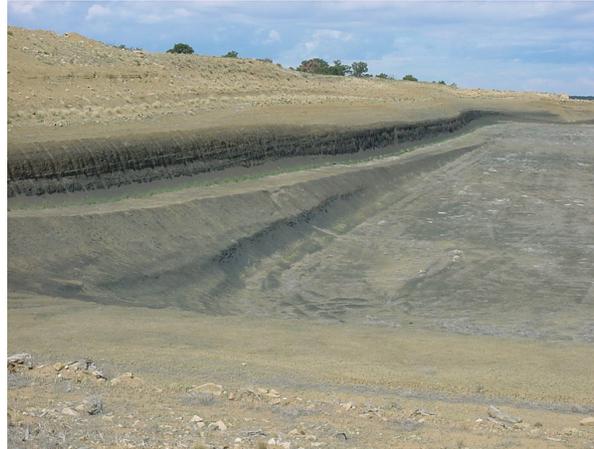
Photo 1: Tres Hermanos
Sandstone

that were exposed in a borrow pit excavation (Photo 1). These units are part of the bedrock ground-water system beneath the site, and are included in the ACL application for the bedrock system. The exposures exhibited the very fine-grained nature of the Tres Hermanos sandstones. The site visit continued with several stops illustrating the diversions that Quivira made to the Arroyo Puerto surface drainage and exposures of the alluvial materials north east of the mill site. Photo 2 shows the fine-grained nature of the alluvial material where surficial soils have been removed near a mine vent. The alluvium is addressed in the second ACL application submitted by the licensee. The interceptor trenches, situated on the east side of the main tailings impoundments were also examined. Mr. Luthiger explained that water from the underground mine workings in section 30, to the north of the mill, is pumped to the surface, processed through the ion exchange units at the mill to remove uranium, then discharged into the Arroyo Puerto. The discharged water infiltrates into the alluvium and maintains a hydraulic head that flushes contaminated ground water into the interceptor trench situated west of the arroyo. The water captured in the interceptor trench is then pumped into existing evaporation impoundment number 9, located near the interceptor trench. Photos 3 and 4 show the interceptor trench. Photo 4 also shows the fine-grained nature of the alluvium exposed in the trench wall.
