EOC18 Refueling Outage Report Oconee Unit 2 Section 9

Oconee Nuclear Station Units 2

Third 10-YEAR INTERVAL REQUEST FOR RELIEF NO. 01-011

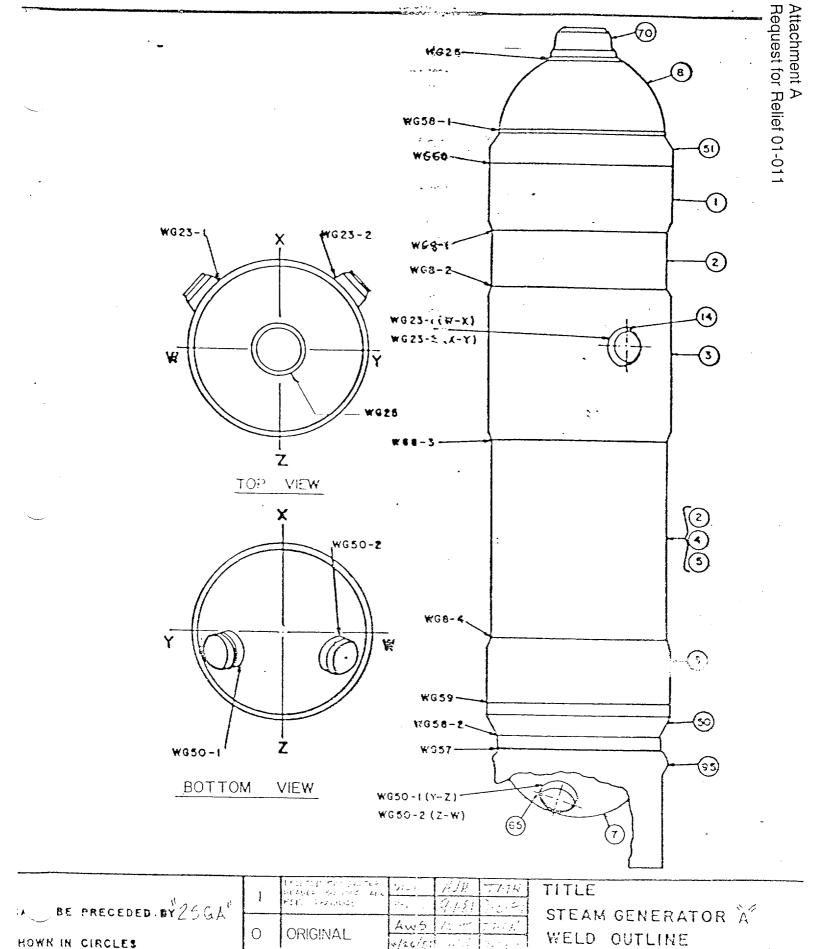
A. Steam Generator 2A Nozzle-to-Vessel Weld 2-SGA-WG25 (Item B03.130.005) was examined to the maximum extent practical using ultrasonic techniques in accordance with the requirements of ASME Section XI, Appendix VIII, Supplements 4 and 6 of the 1995 Edition with the 1996 Addenda as administered by the Performance Demonstration Initiative (PDI). The qualifications were conducted on samples with access to both sides of the weld. Therefore, Duke Energy Corporation does not claim credit for a single sided examination. Reference Attachment A for a drawing of the Generator.

This weld is limited to 57.98% coverage of the required volume because of the nozzle configuration. In order to achieve more coverage, the nozzle would have to be re-designed to allow scanning from both sides of the weld.

B. Steam Generator 2A Nozzle-to-Vessel Inside Radius Section for welds 2-SGA-WG25 (Item B03.140.005) was examined to the maximum extent practical using ultrasonic techniques in accordance with the requirements of ASME Section XI, Appendix I of the 1989 Edition. Reference Attachment A for a drawing of the Generator.

This weld is limited to 70.21% coverage of the required volume. Limitations were caused by the ratio of the nozzle OD to the vessel thickness. When the nozzle OD is large in relation to the vessel thickness, less coverage can be obtained when scanning from the vessel side.

C. Unit 2 Steam Generator A Shell to Shell Weld 2-SGA-WG8-1 (Item C01.010.001) was examined to the maximum extent practical using ultrasonic techniques in accordance with the requirements of ASME Section XI, Appendix VIII Supplements 4 and 6 of the 1995 Edition with the 1996 Addenda as administered by the PDI. Reference Attachment A for a drawing of the Steam Generator 2A.

This weld is limited to 50.89% coverage of the required volume because of the taper configuration. In order to achieve more coverage, the weld would have to be re-designed to allow scanning from both sides.

D. Unit 2 Steam Generator A Upper Tubesheet to Shell Weld 2-SGA-WG60 (Item C01.030.001) was examined to the maximum extent practical using ultrasonic techniques in accordance with the requirements of ASME Section XI, Appendix VIII Supplements 4 and 6 of the 1995 Edition with the 1996 Addenda as administered by the PDI. Reference Attachment A for a drawing of the Steam Generator 2A.

This weld is limited to 42.15% coverage of the required volume because of the configuration, and a support hanger and support pad interfering with UT scans. In order to achieve more coverage, the weld would have to be re-designed to allow scanning from both sides.

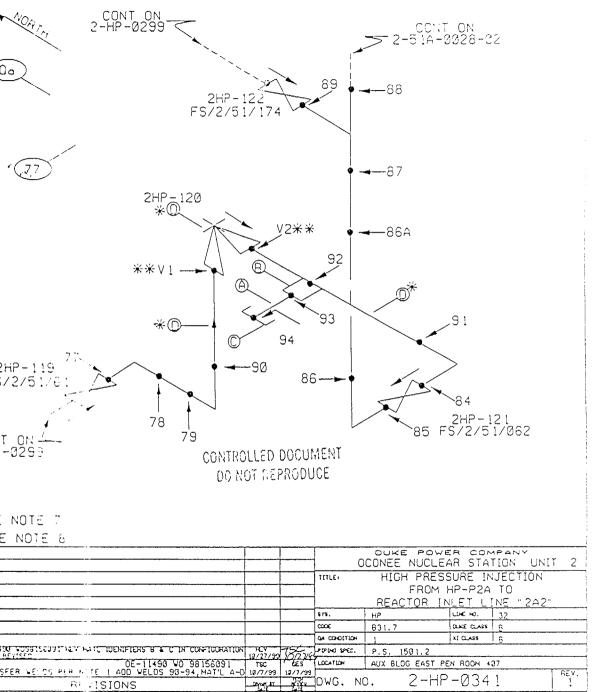
E. Valve 2HP-120 to Pipe Weld 2HP-341-V1 (Item C05.021.044) is limited to 61.34% coverage of the required volume because of the single sided access due to the valve configuration. In order to achieve more coverage, the valve configuration would have to be re-designed to allow scanning from both sides of the weld. Reference Attachment B for a drawing of the valve to pipe weld.

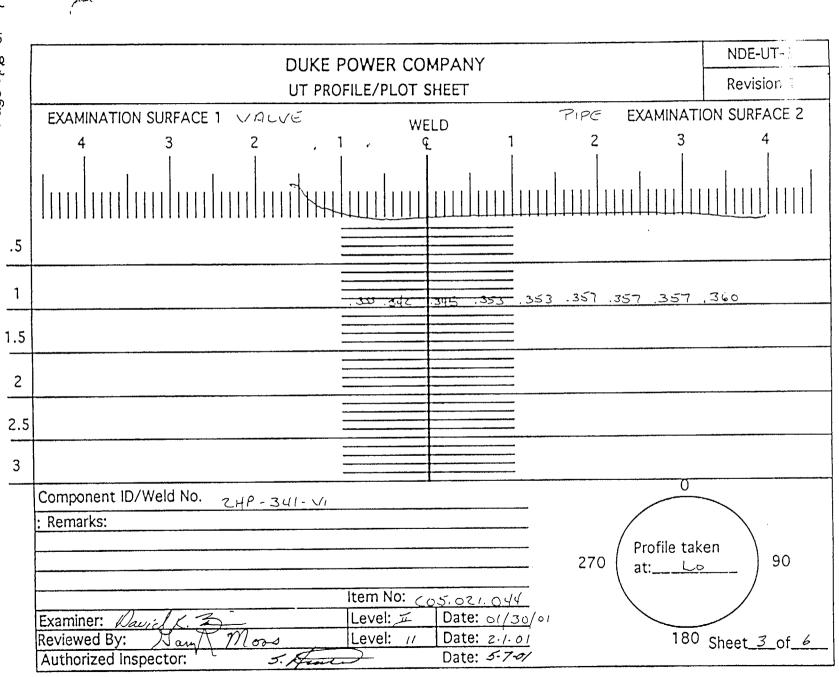
DUKE POWER (COMPANY		FORM NDE-UT-4			
	ISI LIMITATION REPORT						
Component/Weld ID: 2HP-341-V1	lt	em No: C05.021.044	Remarks:				
🖾 NO SCAN	SURFACE	BEAM DIRECTION	DUE TO VALVE	CONFIGURATIION			
LIMITED SCAN		□ 1 ⊡ 2 □ cw □ ccw					
FROM L to LN/A							
ANGLE: 0 0 45 0 60 Other		FROM _ 0 _ DEG to _ 360 _ DEG					
		BEAM DIRECTION		· · · · · · · · · · · · · · · · · · ·			
LIMITED SCAN	□ 1 □ 2	□ 1 □ 2 □ cw □ ccw					
FROM L to L	INCHES FROM	1 WO to					
ANGLE: 0 0 45 0 60 0 Other							
	SURFACE	BEAM DIRECTION		·····			
LIMITED SCAN	□ 1 □ 2	□ 1 □ 2 □ cw □ ccw					
FROM L to L	INCHES FROM	1 WO to					
ANGLE: 0 0 45 0 60 0 Other							
	SURFACE	BEAM DIRECTION					
LIMITED SCAN	□ 1 □ 2	□ 1 □ 2 □ cw □ ccw					
FROM L to L	INCHES FROM	to to					
ANGLE: 0 0 45 0 60 0ther							
Prepared By: David K. Zimmerman	12 Level: II Da	ate 1/30/01 Sketch(s) attached 🗵	yes 🗆 no	Sheet 4 of 6			
Reviewed By: Jary Moss	Date: 2-1-01	Authorized Inspector: 5. Authorized		Date: 5-7-0/
