**DOCKET 50-255 - LICENSE DPR-20 - PALISADES PLANT**  
**LICENSEE EVENT REPORT - 01-004, CONTROL ROD DRIVE MECHANISM UPPER HOUSING ASSEMBLY CRACK INDICATIONS**

<b>FACILITY NAME (1)</b> NUCLEAR MANAGEMENT COMPANY PALISADES NUCLEAR PLANT		<b>DOCKET NUMBER (2)</b> 05000255	<b>PAGE (3)</b> 1 OF 5
<b>TITLE (4)</b> CONTROL ROD DRIVE MECHANISM UPPER HOUSING ASSEMBLY CRACK INDICATIONS			
<b>EVENT DATE (5)</b>			<b>OTHER FACILITIES INVOLVED (8)</b>
MO	DAY	YEAR	FACILITY NAME
06	21	2001	DOCKET NUMBER
<b>LER NUMBER (6)</b>		<b>REPORT DATE (7)</b>	DOCKET NUMBER 05000
YEAR	SEQUENTIAL NUMBER	REV NO	MO
2001	004	00	08
		YEAR	2001
<b>OPERATING MODE (9)</b>		<b>THIS REPORT IS SUBMITTED PURSUANT TO THE REQUIREMENTS OF 10 CFR §: (Check all that apply) (11)</b>	
3	20.2201(b)		20.2203(a)(3)(ii)
<b>POWER LEVEL (10)</b>		50.73(a)(2)(ii)(B)	
0	20.2201(d)		50.73(a)(2)(ix)(A)

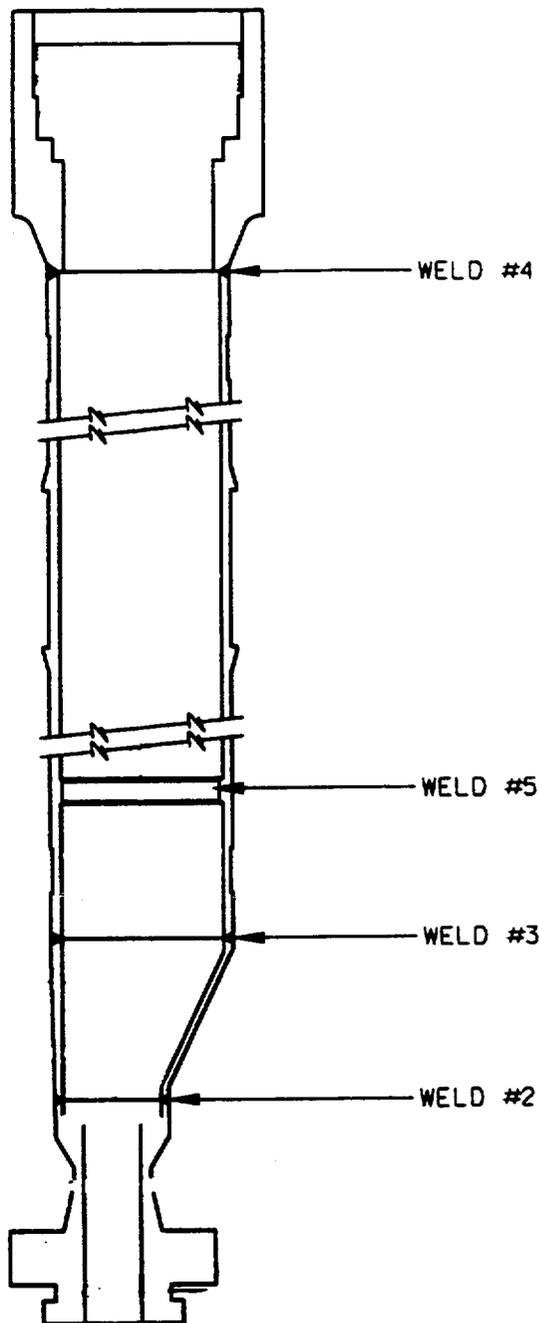
**FIGURE 1  
PALISADES PLANT  
CRDM UPPER HOUSING ASSEMBLY DRAWING**

On June 20, 2001, the plant was shut down from full power operation in accordance with plans to confirm the source of the leak and make repairs. Unidentified leakage had trended from approximately 0.1 gpm to 0.3 gpm. On June 21, 2001, with the plant in Mode 3, entry into containment confirmed slightly increased leakage at the suspected fitting. However, by observation, it was determined that the fitting leakage did not completely account for the change in unidentified leakage. Subsequently, during further walkdown of the PCS, a pressure boundary leak was identified in the control rod drive mechanism (CRDM) number 21 [DRIV] upper housing assembly. Specifically, the leak was observed near the weld (weld #3) of the upper housing assembly pipe to the eccentric reducer. Upon identification, the plant was placed in Mode 5 to effect repairs. Figure 1 (page 4) depicts a drawing of a CRDM upper housing assembly and identifies the weld #3 location.

Non-destructive examination of the CRDM-21 upper housing assembly revealed a through-wall axially oriented crack through the weld. The CRDM-21 upper housing assembly was removed for destructive examination and will be replaced. A detailed metallographic examination of the #3 weld area identified axial, as well as circumferential indications.

The CRDM-21 housing is one of 45 assemblies that include a nominal eight-inch diameter austenitic stainless steel pipe. Each of the 45 CRDMs consists of a reactor vessel head penetration, upper housing assembly and seal housing that are primary pressure boundary components. Each stainless steel (type 347) CRDM upper housing assembly is mounted on a nozzle flange and extends approximately 15 feet to the seal housing and drive package. There are four welds (numbers 2 through 5) on the upper housing assembly, as shown in Figure 1. The #1 weld is located between the control rod mechanism housing flange and the reactor vessel penetration. All five welds on a number of housings were initially examined using various non-destructive examination techniques. The only additional indications identified were near the same weld location as that discovered on CRDM-21 (weld #3). The weld #3 region then became the focal point of further inspections. To date, examinations of the CRDM upper housings using various non-destructive examination techniques (ultrasonic, radiographic and/or visual) have identified ASME Section XI reportable indications in the weld #3 location for 29 CRDM upper housing assemblies. Figure 2 (page 5) shows the CRDM configuration on the reactor head, and identifies which CRDMs have been found with ASME Section XI reportable indications near the #3 weld area. Only the original indication on CRDM-21 has been determined to be through-wall.

The cause of the through-wall crack in the CRDM-21 upper housing assembly has been identified to be chloride induced transgranular stress corrosion cracking. This is also the likely cause of the indications in the other CRDM upper housing assemblies. However, a final root cause determination has not yet been completed. The cause of the event will be updated in the supplemental LER.

**Weld #1 is not shown on this diagram, but is located between the control rod mechanism housing flange and the reactor vessel penetration**

The CRDM-21 upper housing assembly will be replaced prior to start-up from the current plant outage. Where such action is determined to be appropriate, other CRDM upper housing assemblies will be replaced or repaired prior to start-up. Other corrective actions may be identified as the root cause determination is completed. Corrective actions will be updated in the supplemental LER.
