Subject: Borg-Warner 3" and 4" Swing Check Valves

10 CFR PART 21 NOTIFICATION

(Reference No. CFRN-9301)

Texas Utilities, Comanche Peak Steam Electric Station.  
Basic Component: 4-inch 150# Bolted Bonnet Swing Check Valve  
BW/IP Part No. 75580  
TU Tag Nos. 2CC-0697 & 2CC-0693

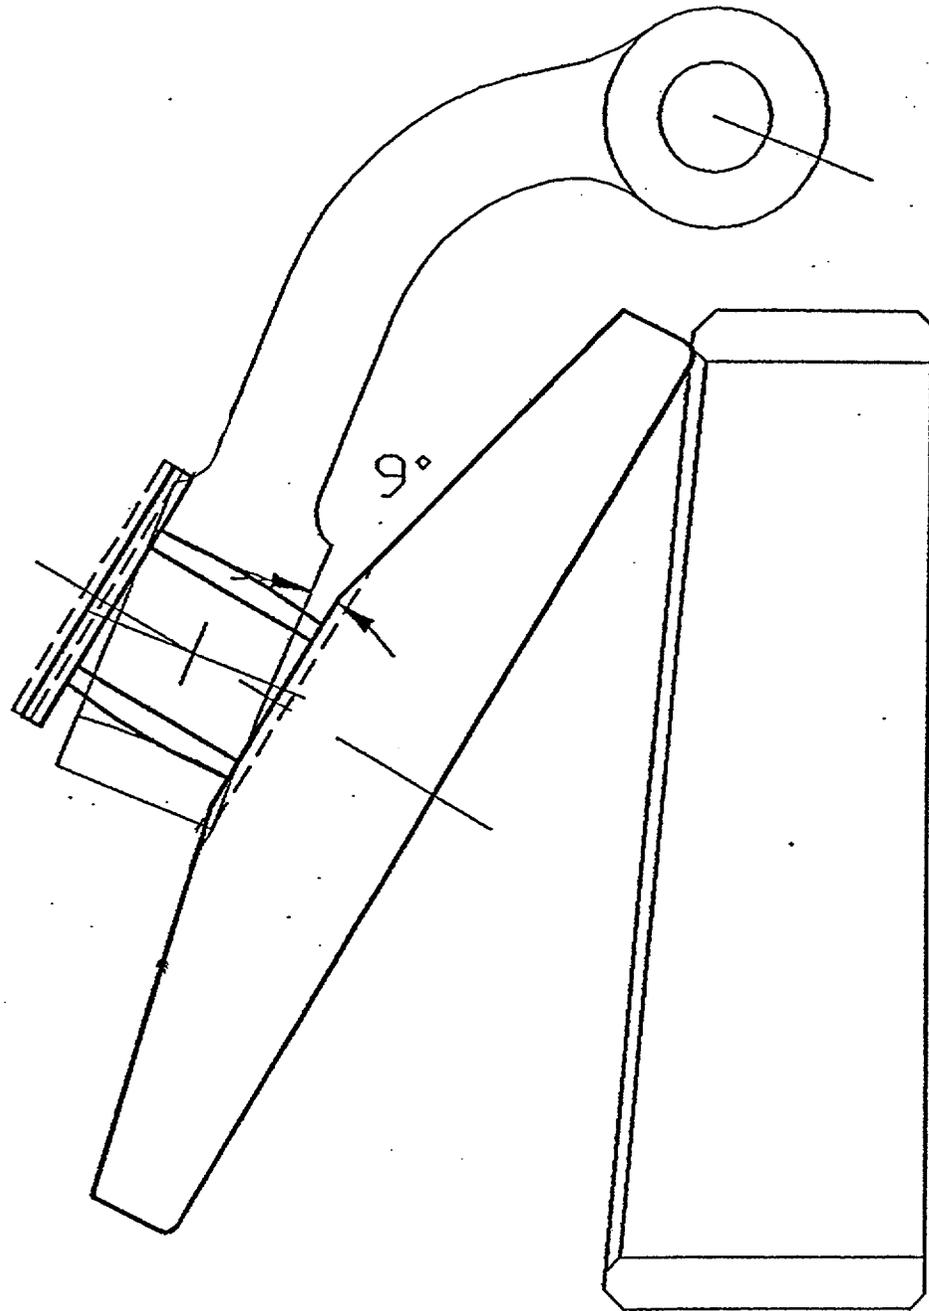
Required Angle of Disc Rotation and Axial Gap for Interference

Valve 2CC-0697 did not fully close during pre-operational testing. Radiographs taken at the time of failure show the disk positioned at approximately 21° from the full closed position. The valve was disassembled. The top of the disk was found to be lodged under the seat lip preventing full closure. Valve 2CC-0693 subsequently failed testing in a similar manner. Both valves are located in the Component Cooling Water return lines from the Reactor Coolant Pump Motor Coolers and do not serve an active safety function. However the failure mechanism could apply to other valves that do provide a safety function.

Evaluation of the basic component by BW/IP indicates the root cause of the failure to close is due to the configuration of the attachment weld between the disk to the stud. Prior to 1977, this weld was placed on the back surface of the stud and extended into the bushing bore. In disks manufactured after 1977, the weld was recessed into the back surface of the disk and a final machine cut made to assure a flush surface.

On May 31, 2001, Arizona Public Service Co. advised Flowserve that they recently encountered the same problem on a 4"-1500# pressure seal swing check valve. Because of this, Flowserve decided it would be prudent to notify or re-notify all customers who purchased 3" or 4" swing check valves or disc assemblies in 1977 or earlier of the potential problem. We recommend the valves be inspected at the earliest convenient time and if evidence of interference is found, replace the disc assembly. The enclosed sketch depicts the potential problem if there is excessive disc angular movement.

Corrective action is complete with the disk design modification identified above.

Licensees with valve installations effected by this notice should install a new disk component or refurbish the existing disk.
