CONNECTICUT YANKEE ATOMIC POWER COMPANY

HADDAM NECK PLANT

Haddam Neck Plant  
Historical Site Assessment Supplement in Support of the License Termination Plan  
(TAC NO. MA9791)

**Subject: Historical Site Assessment Supplement**

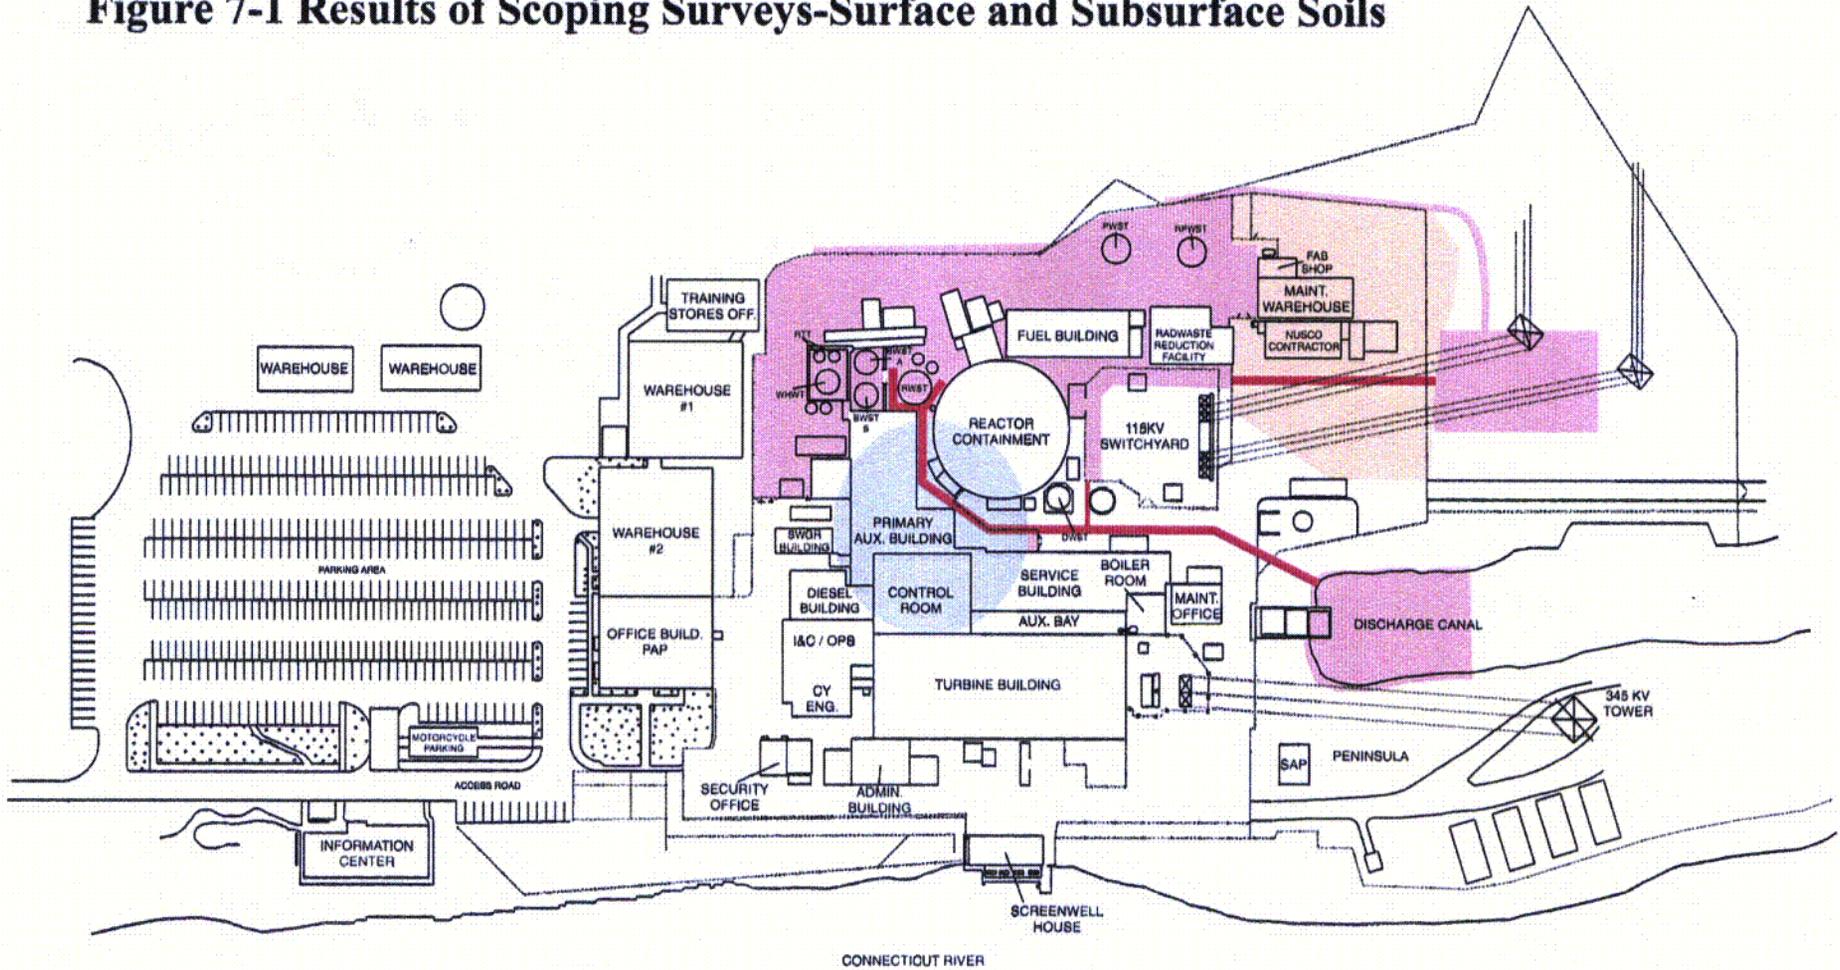
**Figure 7-1 Results of Scoping Surveys-Surface and Subsurface Soils**

- General area of site affected by radiological events
- Yard drains affected by documented radiological events
- Area of potential migration of residual radioactivity
- Potential residual radioactivity in the expanded protected area. (orig grade)
- Area of potential residual radioactivity from operations

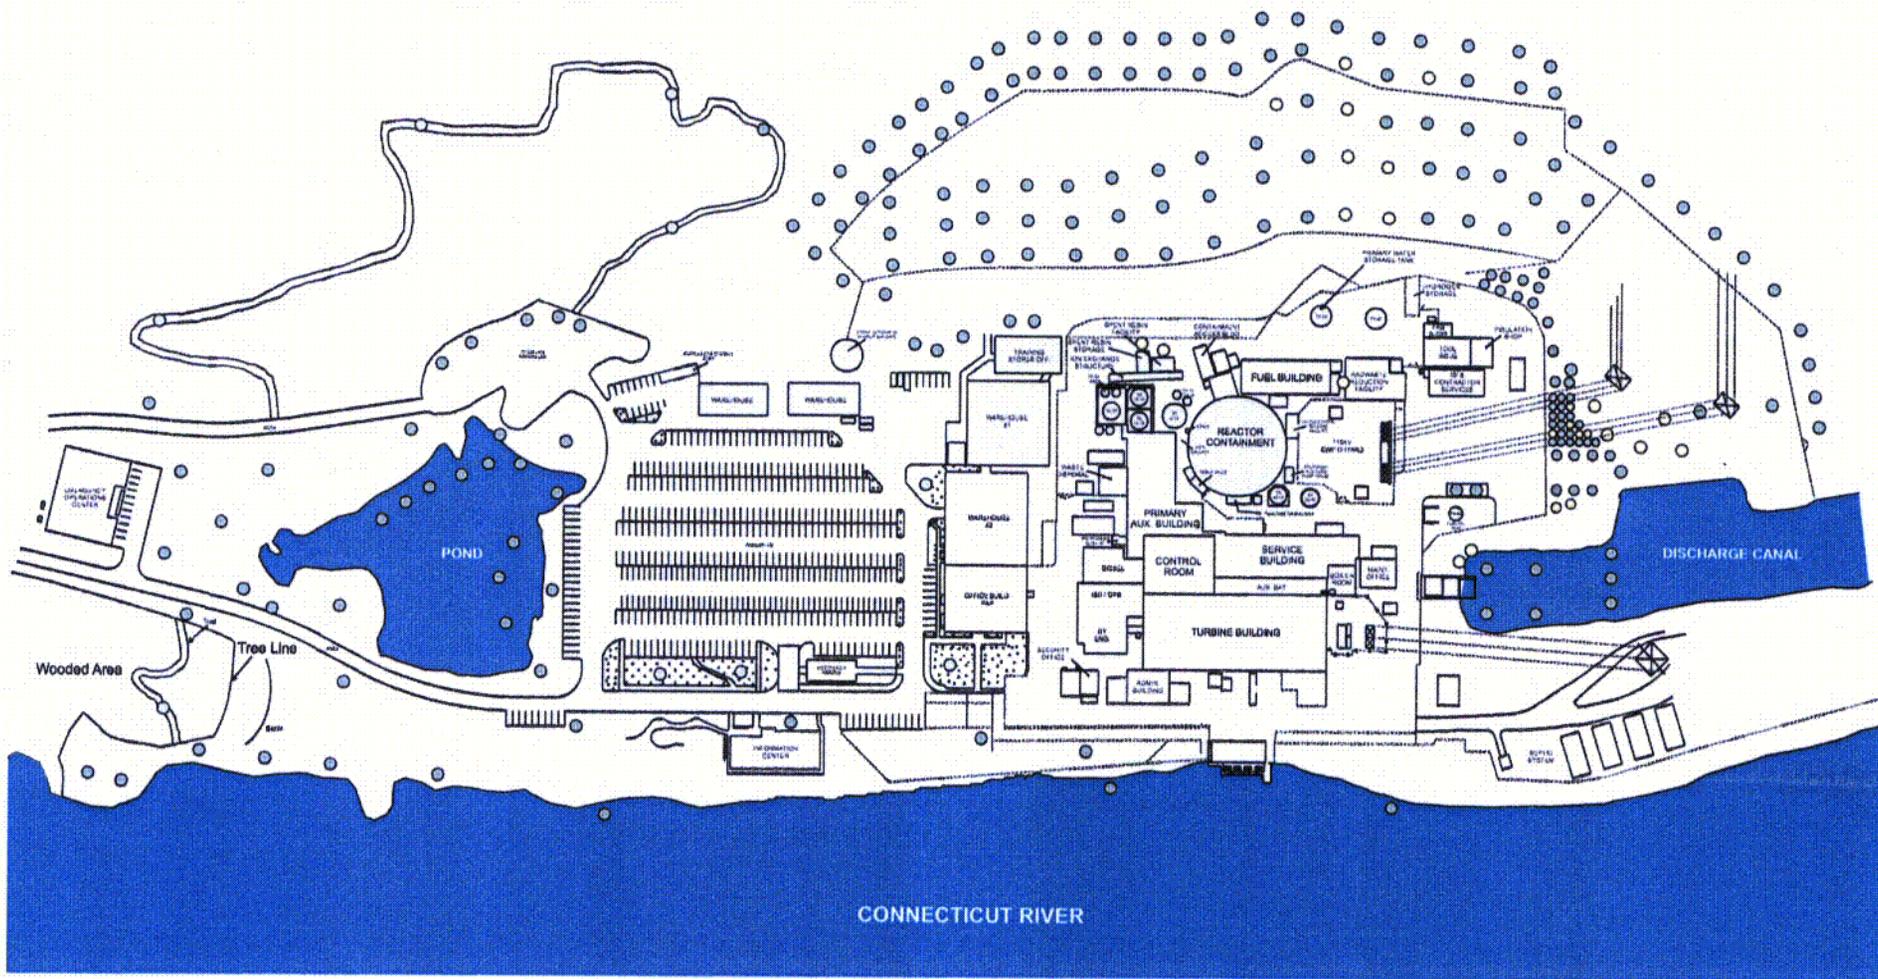
**Figure 7-2 Soil Sampling Summary (Reference 7-2)**

INDICATES AREAS OF THE SITE THAT SOIL HAS BEEN SURVEYED / SAMPLED FOR RADIOACTIVE MATERIALS - NO DETECTABLE ACTIVITY

INDICATES AREAS OF THE SITE THAT SOIL HAS BEEN SURVEYED / SAMPLED FOR RADIOACTIVE MATERIALS - DETECTABLE ACTIVITY
