Subject: Borg-Warner 3" and 4" Swing Check Valves

10 CFR PART 21 NOTIFICATION

(Reference No. CFRN-9301)

Texas Utilities, Comanche Peak Steam Electric Station.
Basic Component: 4-inch 150# Bolted Bonnet Swing Check Valve
BW/IP Part No. 75580
TU Tag Nos. 2CC-0697 & 2CC-0693

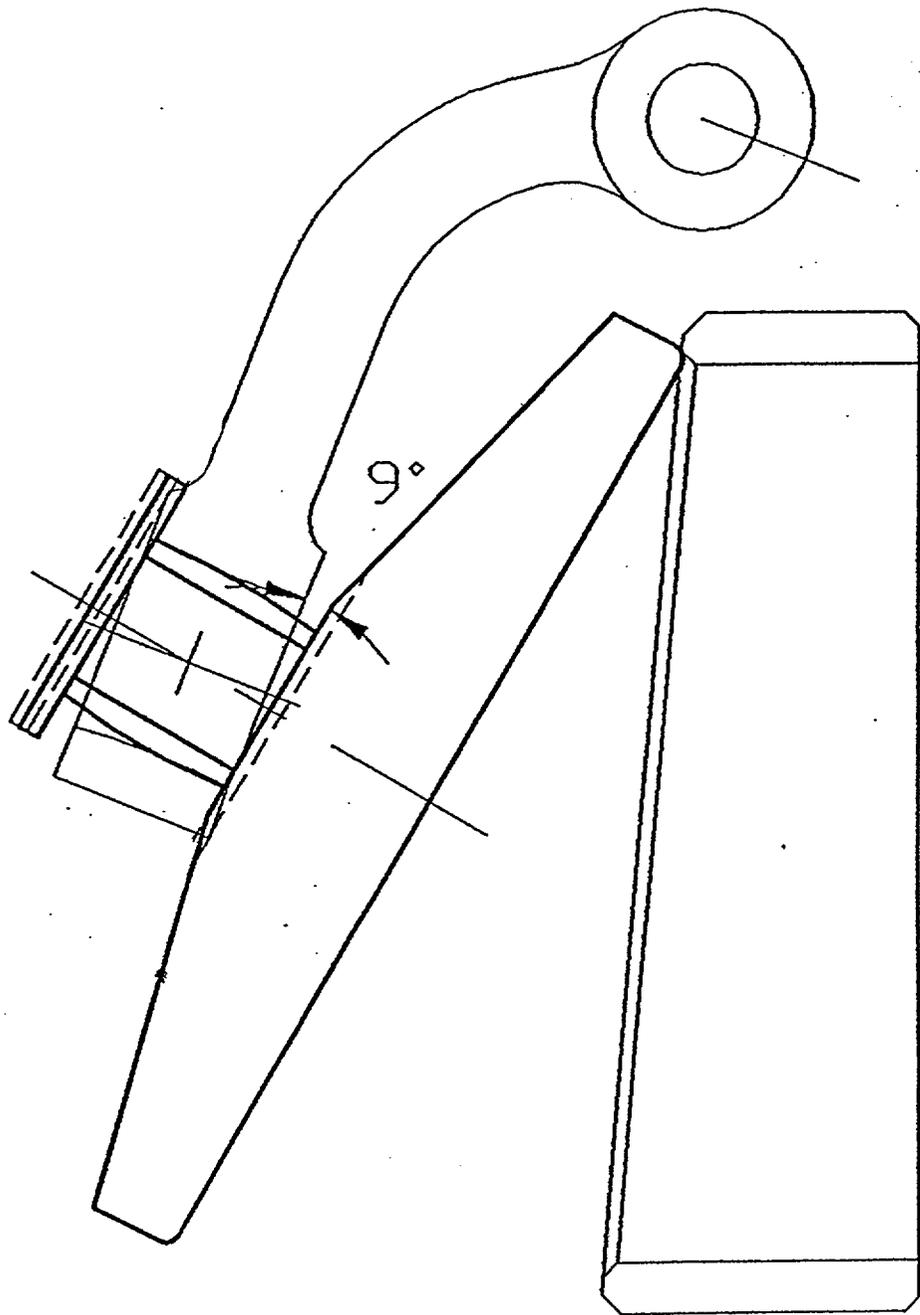
Required Angle of Disc Rotation and Axial Gap for Interference

Valve 2CC-0697 did not fully close during pre-operational testing. Radiographs taken at the time of failure show the disk positioned at approximately 21° from the full closed position. The valve was disassembled. The top of the disk was found to be lodged under the seat lip preventing full closure. Valve 2CC-0693 subsequently failed testing in a similar manner. Both valves are located in the Component Cooling Water return lines from the Reactor Coolant Pump Motor Coolers and do not serve an active safety function. However the failure mechanism could apply to other valves that do provide a safety function.

Evaluation of the basic component by BW/IP indicates the root cause of the failure to close is due to the configuration of the attachment weld between the disk to the stud. Prior to 1977, this weld was placed on the back surface of the stud and extended into the bushing bore. In disks manufactured after 1977, the weld was recessed into the back surface of the disk and a final machine cut made to assure a flush surface.

This notice applies to all BW/IP 4-inch, 150#, bolted bonnet swing check valves which have a raised disk-stud retention weld on the back surface of the disk.

On May 31, 2001, Arizona Public Service Co. advised Flowserve that they recently encountered the same problem on a 4"-1500# pressure seal swing check valve. Because of this, Flowserve decided it would be prudent to notify or re-notify all customers who purchased 3" or 4" swing check valves or disc assemblies in 1977 or earlier of the potential problem. We recommend the valves be inspected at the earliest convenient time and if evidence of interference is found, replace the disc assembly. The enclosed sketch depicts the potential problem if there is excessive disc angular movement.

Corrective action is complete with the disk design modification identified above.

Licensees with valve installations effected by this notice should install a new disk component or refurbish the existing disk.
