Perry Nuclear Power Plant  
Docket No. 50-440  
Feedwater Penetration Condition Report Investigation Summary

## FEEDWATER PENETRATIONS - EXECUTIVE SUMMARY OF THE FINAL INVESTIGATION

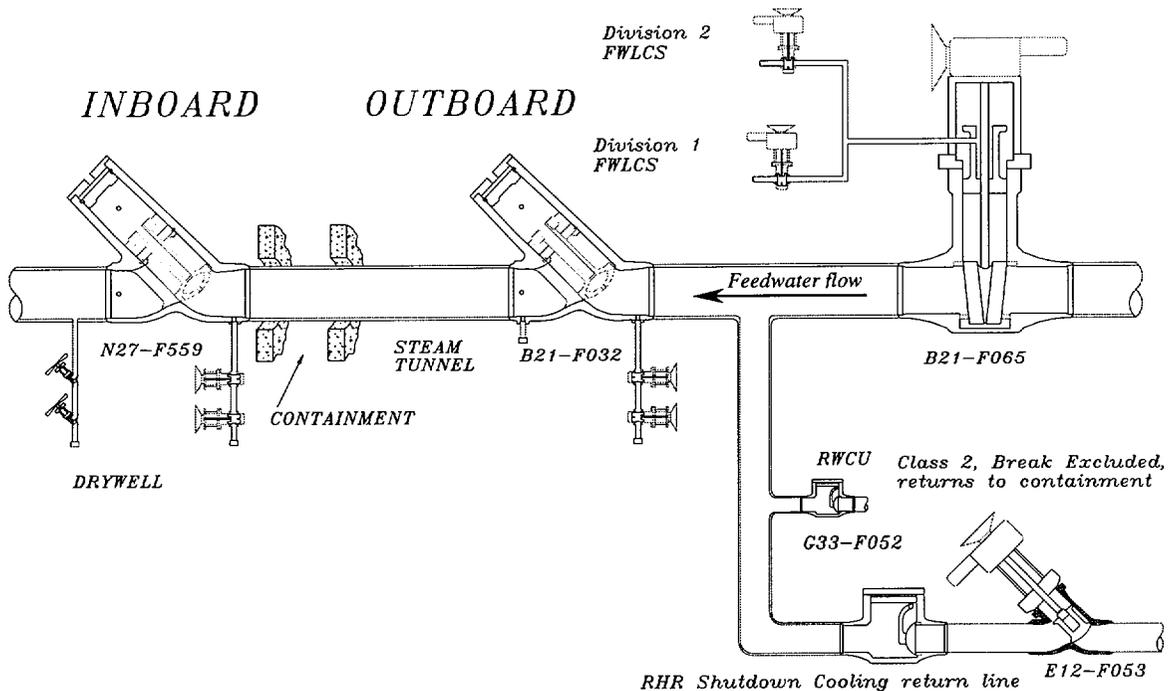
Both the amendment and the DCP concern hardware modifications as well as changes to the inservice testing of the Feedwater penetrations P121 (A Side) and P414 (B side). The major hardware involved in the scope of this CR includes: the ASME Class 1, 20 inch controlled closure Feedwater check valves, 1N27-F0559A/B (inboard check valves) and 1B21-F0032A/B (outboard check valves), the ASME Class 2 motor-operated gate valves, 1B21-F0065A/B, a 12 inch Residual Heat Removal (RHR) branch line off of each train of the ASME Class 2 Feedwater piping (between 1B21-F0065A/B and 1B21-F0032A/B) and corresponding isolation valves consisting of check valves 1E12-F0050A/B and globe valves 1E12-F0053A/B. Lastly, an ASME Class 2, 6 inch Reactor Water Cleanup line, connects to each train of the RHR line between each Feedwater train and the first isolation valve of the RHR line.

The DCP reconfigured the Feedwater Leakage Control System (FWLCS) from filling the Feedwater piping volume between the 1B21-F0065A/B and the check valves, to directly injecting into the bonnets and between the gate valve discs of 1B21-F0065A/B.
