Perry Nuclear Power Plant
Docket No. 50-440
Feedwater Penetration Condition Report Investigation Summary

FEEDWATER PENETRATIONS - EXECUTIVE SUMMARY OF THE FINAL INVESTIGATION

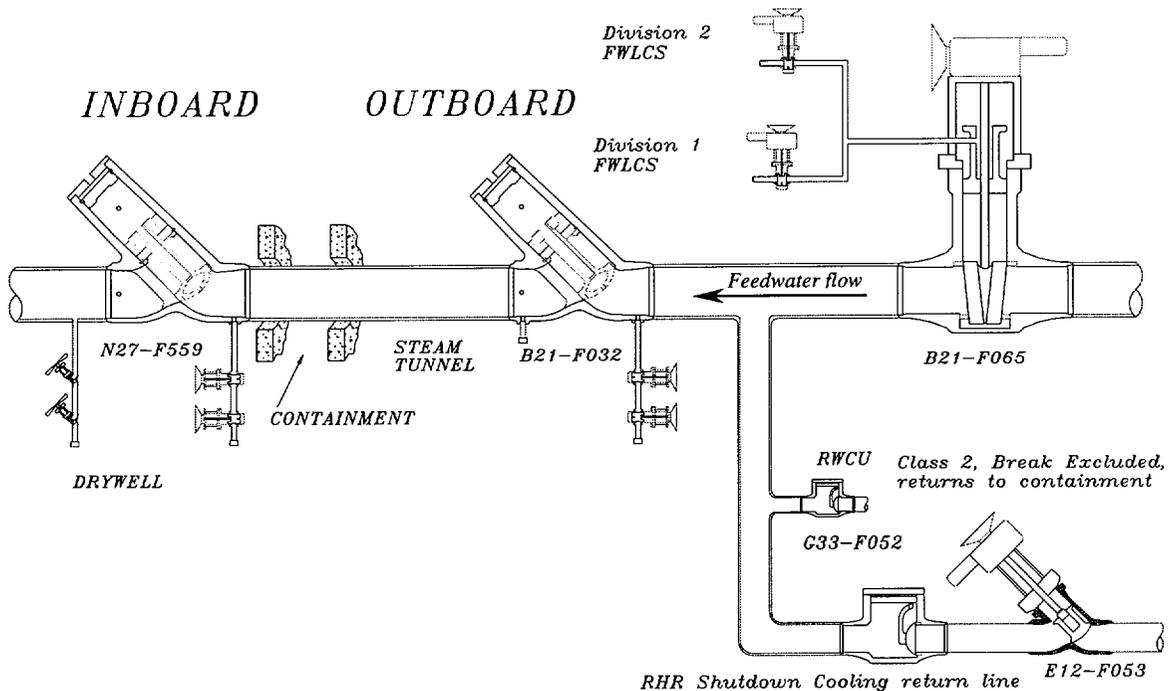
Both the amendment and the DCP concern hardware modifications as well as changes to the inservice testing of the Feedwater penetrations P121 (A Side) and P414 (B side). The major hardware involved in the scope of this CR includes: the ASME Class 1, 20 inch controlled closure Feedwater check valves, 1N27-F0559A/B (inboard check valves) and 1B21-F0032A/B (outboard check valves), the ASME Class 2 motor-operated gate valves, 1B21-F0065A/B, a 12 inch Residual Heat Removal (RHR) branch line off of each train of the ASME Class 2 Feedwater piping (between 1B21-F0065A/B and 1B21-F0032A/B) and corresponding isolation valves consisting of check valves 1E12-F0050A/B and globe valves 1E12-F0053A/B. Lastly, an ASME Class 2, 6 inch Reactor Water Cleanup line, connects to each train of the RHR line between each Feedwater train and the first isolation valve of the RHR line.

The DCP reconfigured the Feedwater Leakage Control System (FWLCS) from filling the Feedwater piping volume between the 1B21-F0065A/B and the check valves, to directly injecting into the bonnets and between the gate valve discs of 1B21-F0065A/B.
