ROCHESTER GAS AND ELECTRIC CORPORATION • 89 EAST AVENUE, ROCHESTER, N.Y. 14649-0001 • 716 546-2700

Subject: Response to NRC Bulletin 2001-01, Subject: CIRCUMFERENTIAL
CRACKING OF REACTOR PRESSURE VESSEL HEAD PENETRATION
NOZZLES
R. E. Ginna Nuclear Power Plant
Docket No. 50-244

ENCLOSURE 1
NRC BULLETIN 2001-01 REQUESTED INFORMATION

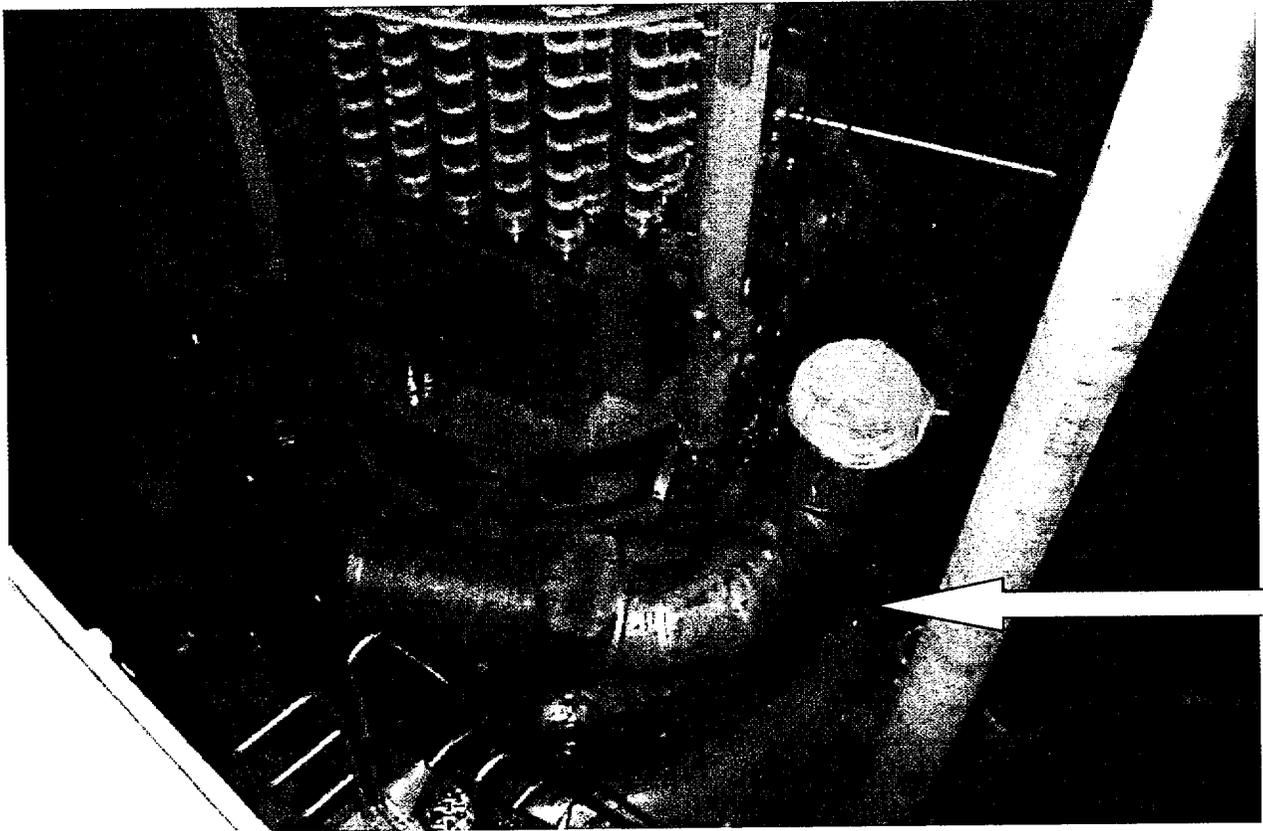
Enclosure 3A

In addition to the inspections noted above, the lower portion of the reactor vessel head between the upper surface of the head flange and the CRDM Cooling Shroud support ring is visible to the refueling crew during each refueling outage. This region, approximately 20-24 inches in arc length, is insulated with reflective type insulation panels which are removed by the refueling crew prior to disassembly of the reactor vessel (see Enclosure 3A, by lower red ring or arrow).

Since the 20-24 inch arc length under discussion is below the outer most row of penetrations, this area could be expected to show telltale signs of boric acid leakage from outer row penetrations, and be obvious to refueling crews during reflective insulation removal. Appropriate corrective action would be taken to determine the source of boric acid leakage if this were observed.

Enclosure 3A, Reactor Vessel Head region in the refuel cavity - Starting in the lower right area of the vessel (see the arrowhead by the red ring near the flange),

the reflective insulation removed each refueling outage as discussed in a previous section can be seen just below the circular HVAC duct with the FME protective cover. Moving upward, the circular HVAC duct is partially shown. In its fully installed state, this duct work encircles approximately 270 degrees the head region.

The HVAC duct work connects to the CRDM Cooling Shroud Lower Chamber (circular section) which can be seen immediately behind the circular HVAC duct work. Above and connected to the CRDM Cooling Shroud Lower Chamber is the CRDM Cooling Shroud Upper Chamber (rectangular section). Note that one instrumentation connection point (Conoseal) can be seen at the flat junction plate area above and to the left of the HVAC duct work connection to the lower CRDM Cooling shroud (light spot).

Behind the rectangular Upper CRDM Cooling Shroud are the control rod motor drive coils with the position indicating system coil stacks above. The large tube steel columns connected to the head are part of the head lift rig assembly. Note that one is located just behind the stud tensioning device lift rig at the top of the picture. The small bore pipe protruding out away from the lift rig column is part of the Reactor Vessel head vent system.

This photograph (best available) is shown with the duct work (vertical riser) and instrumentation ports partially dis-assembled.

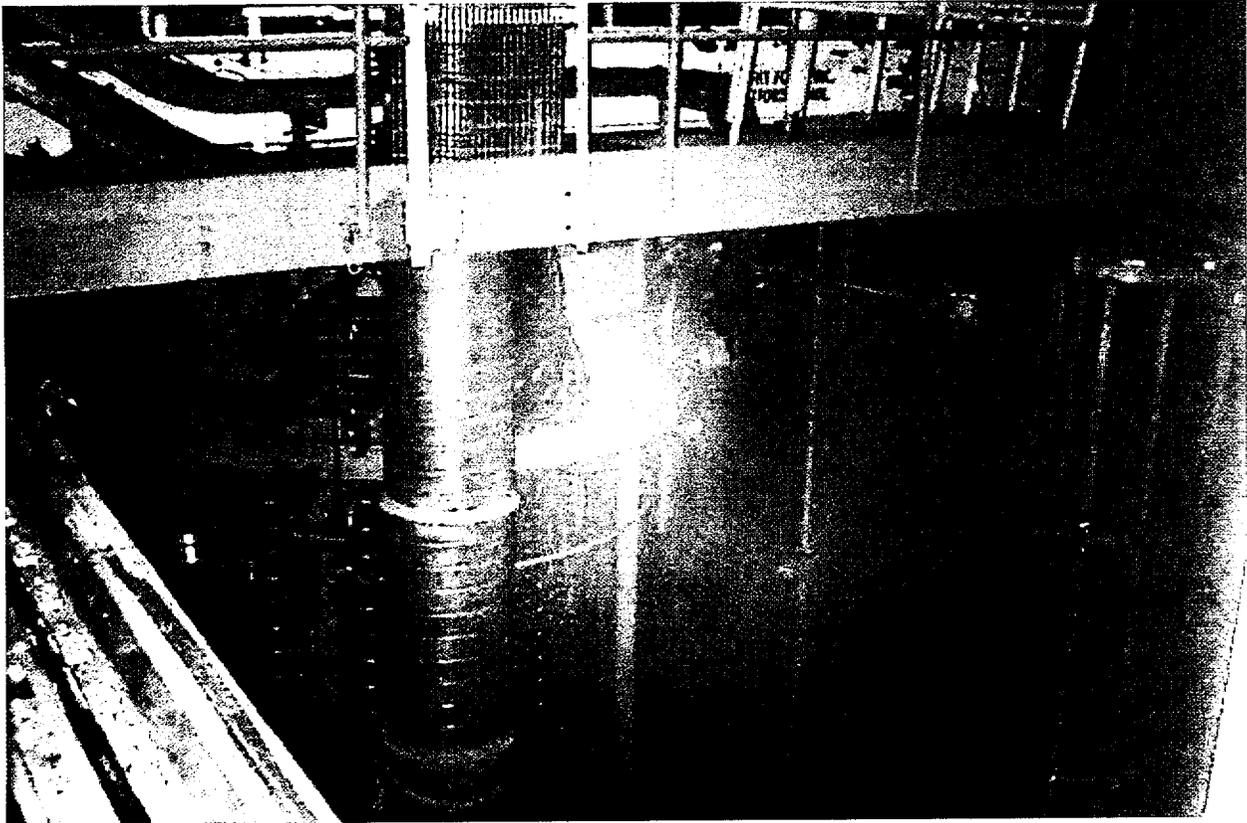
Enclosure 3B

Enclosures 3B and 3C, Missile Shield Area - Note that the majority of the cable runs and connections are located outside the periphery of the CRDM upper housing area. Cables are then bundled together for entry above the CRDM area as shown in Enclosure 3C.
