MEMORANDUM TO: John A. Grobe, Chairman  
Manual Chapter 0350 Panel for D.C. Cook

SUBJECT: RESOLUTION OF DEGRADED CEQ FAN ROOM WALL

Discussion of Containment  
Subcompartment Walls

Restarting D. C. Cook  
June 1, 2000

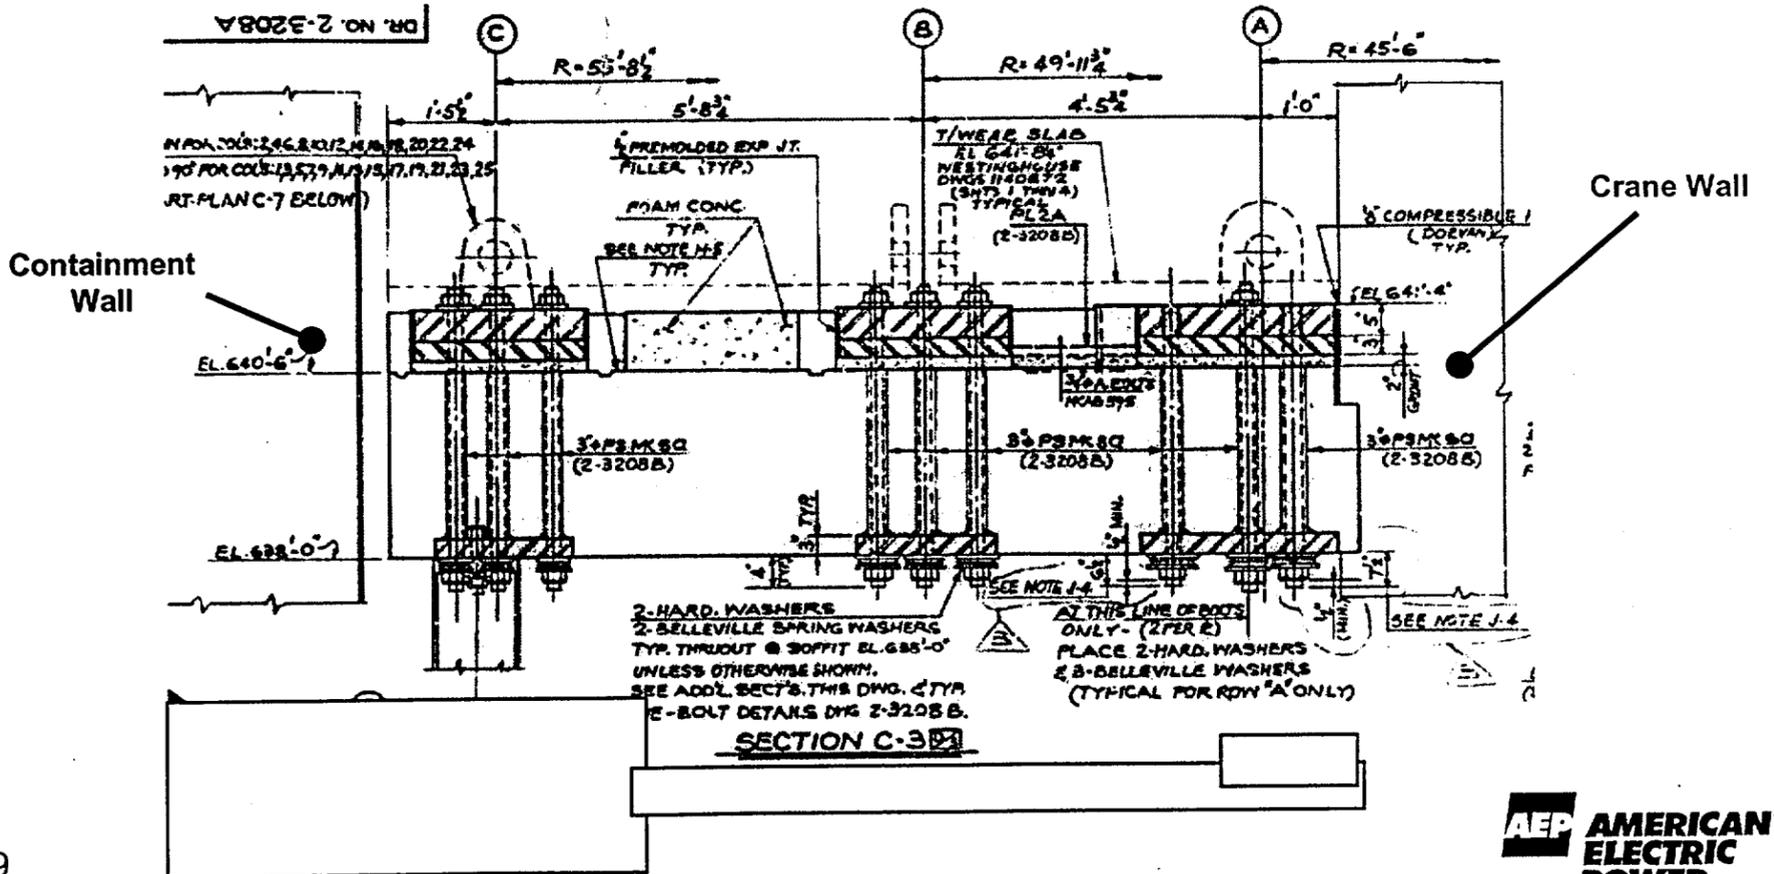
## ■ Typical Slab/Column Connection (Unit 2 Only)

- **Pockets at Top of 126° Wall for Bolting**
- **Design Required Pockets to be Grouted**
- **Pockets Left Open From Original Construction**
