SUBJECT: RESOLUTION OF DEGRADED CEQ FAN ROOM WALL

Discussion of Containment
Subcompartment Walls

Restarting D. C. Cook
June 1, 2000

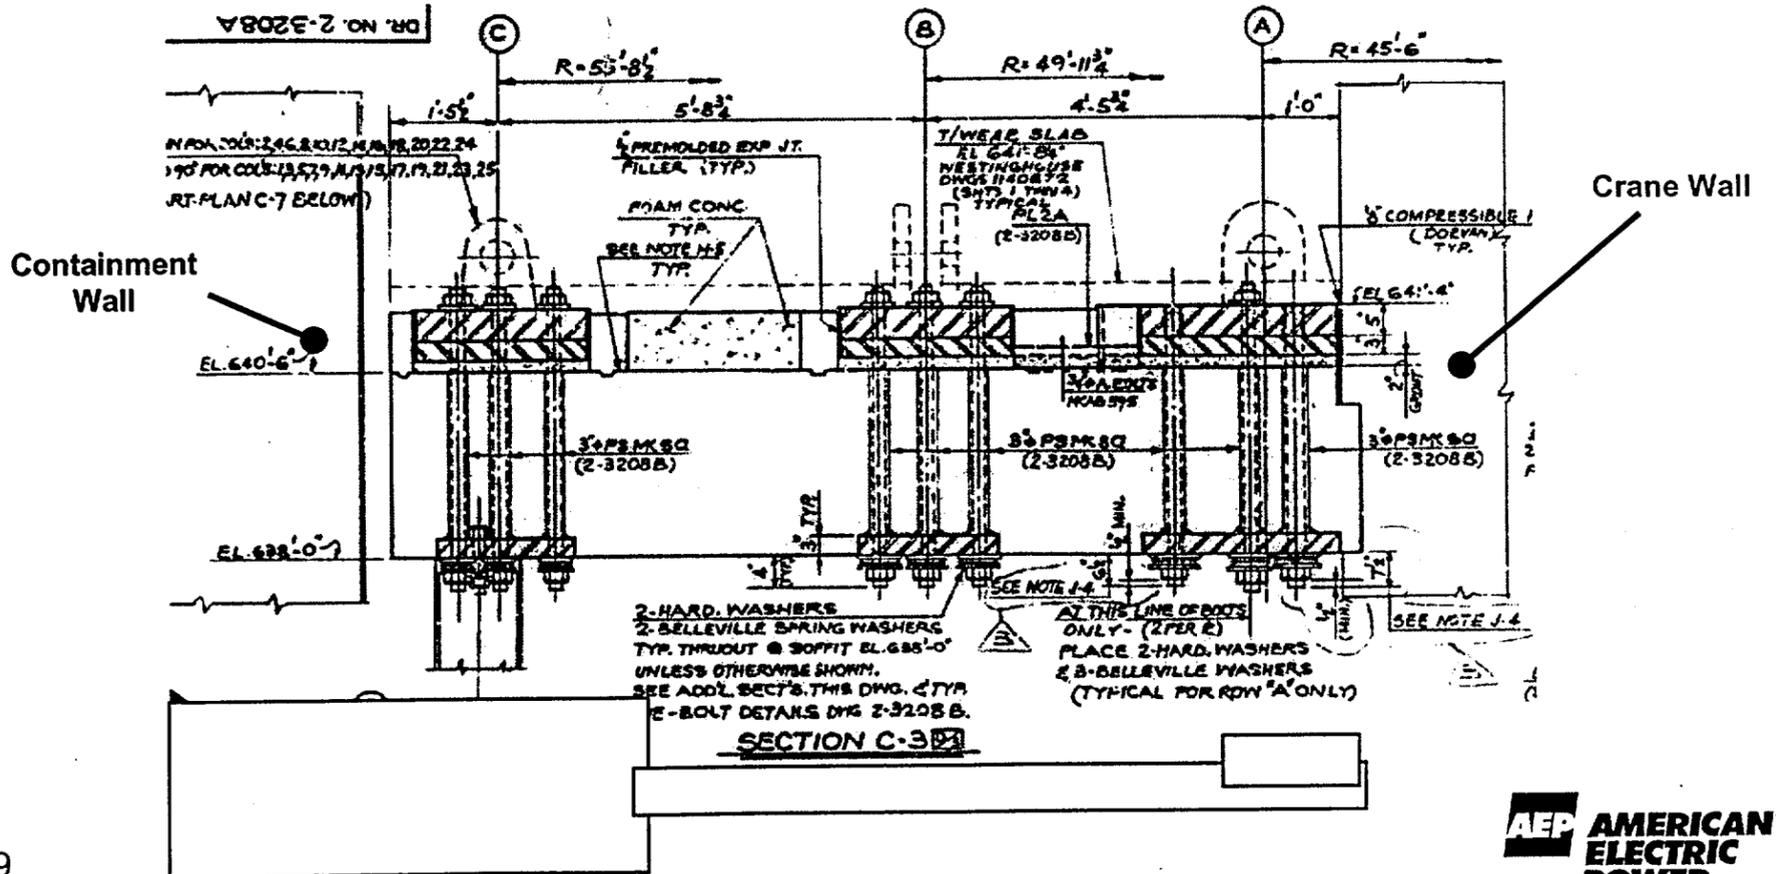
■ Typical Slab/Column Connection (Unit 2 Only)

- **Pockets at Top of 126° Wall for Bolting**
- **Design Required Pockets to be Grouted**
- **Pockets Left Open From Original Construction**

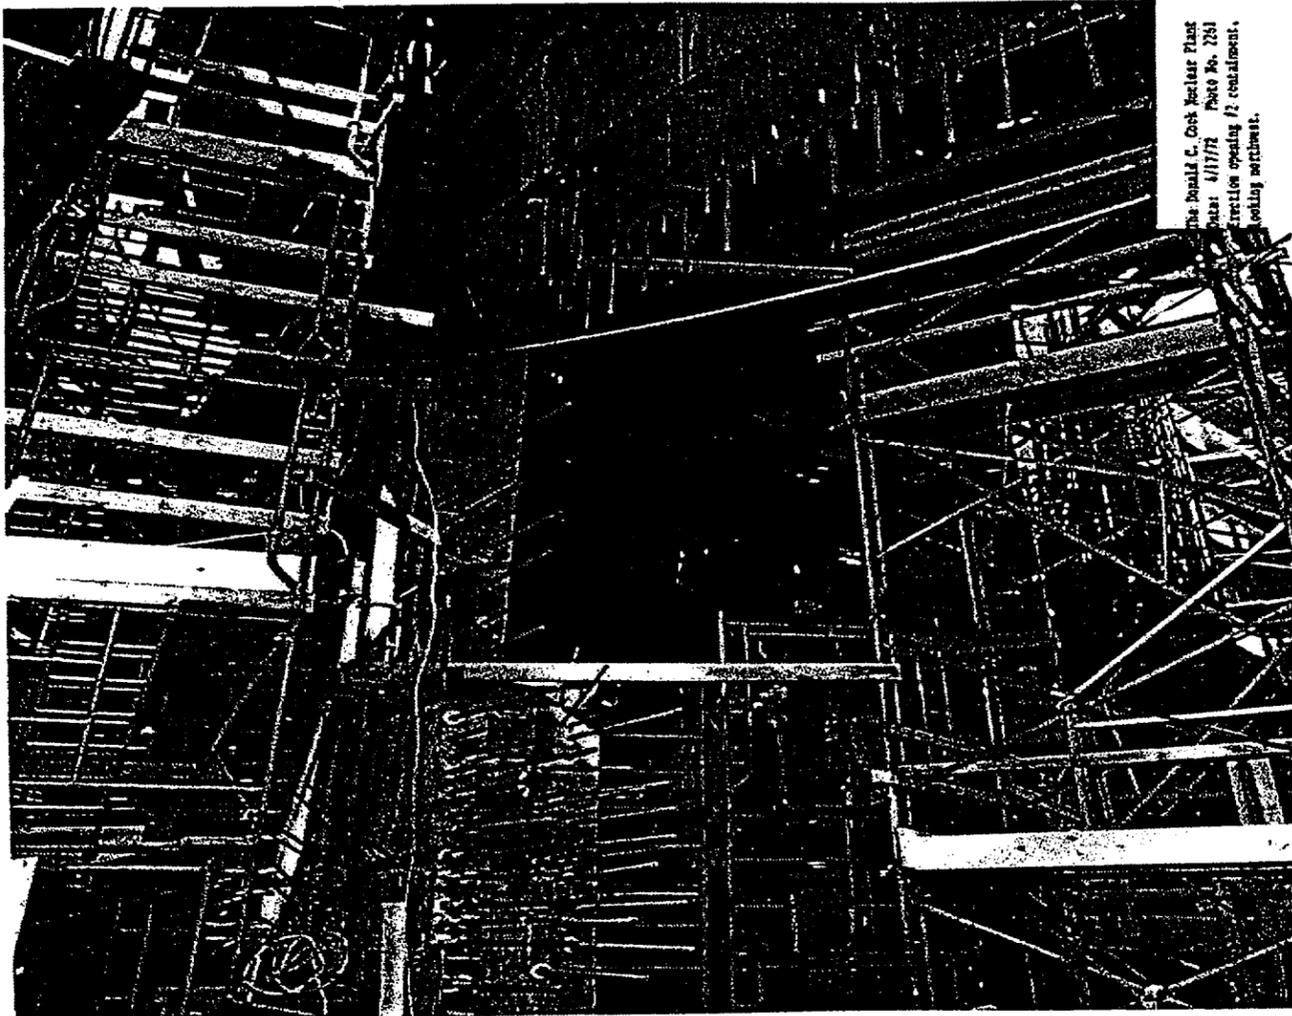
Extent of Condition: Crane Wall Construction Opening

The Donald C. Cook Nuclear Plant
is under construction. Photo No. 7251
shows the extent of condition,
including settlement.
