American Electric Power

Nuclear Regulatory Commission

Discussion of Containment
Subcompartment Walls

Restarting D. C. Cook
June 1, 2000

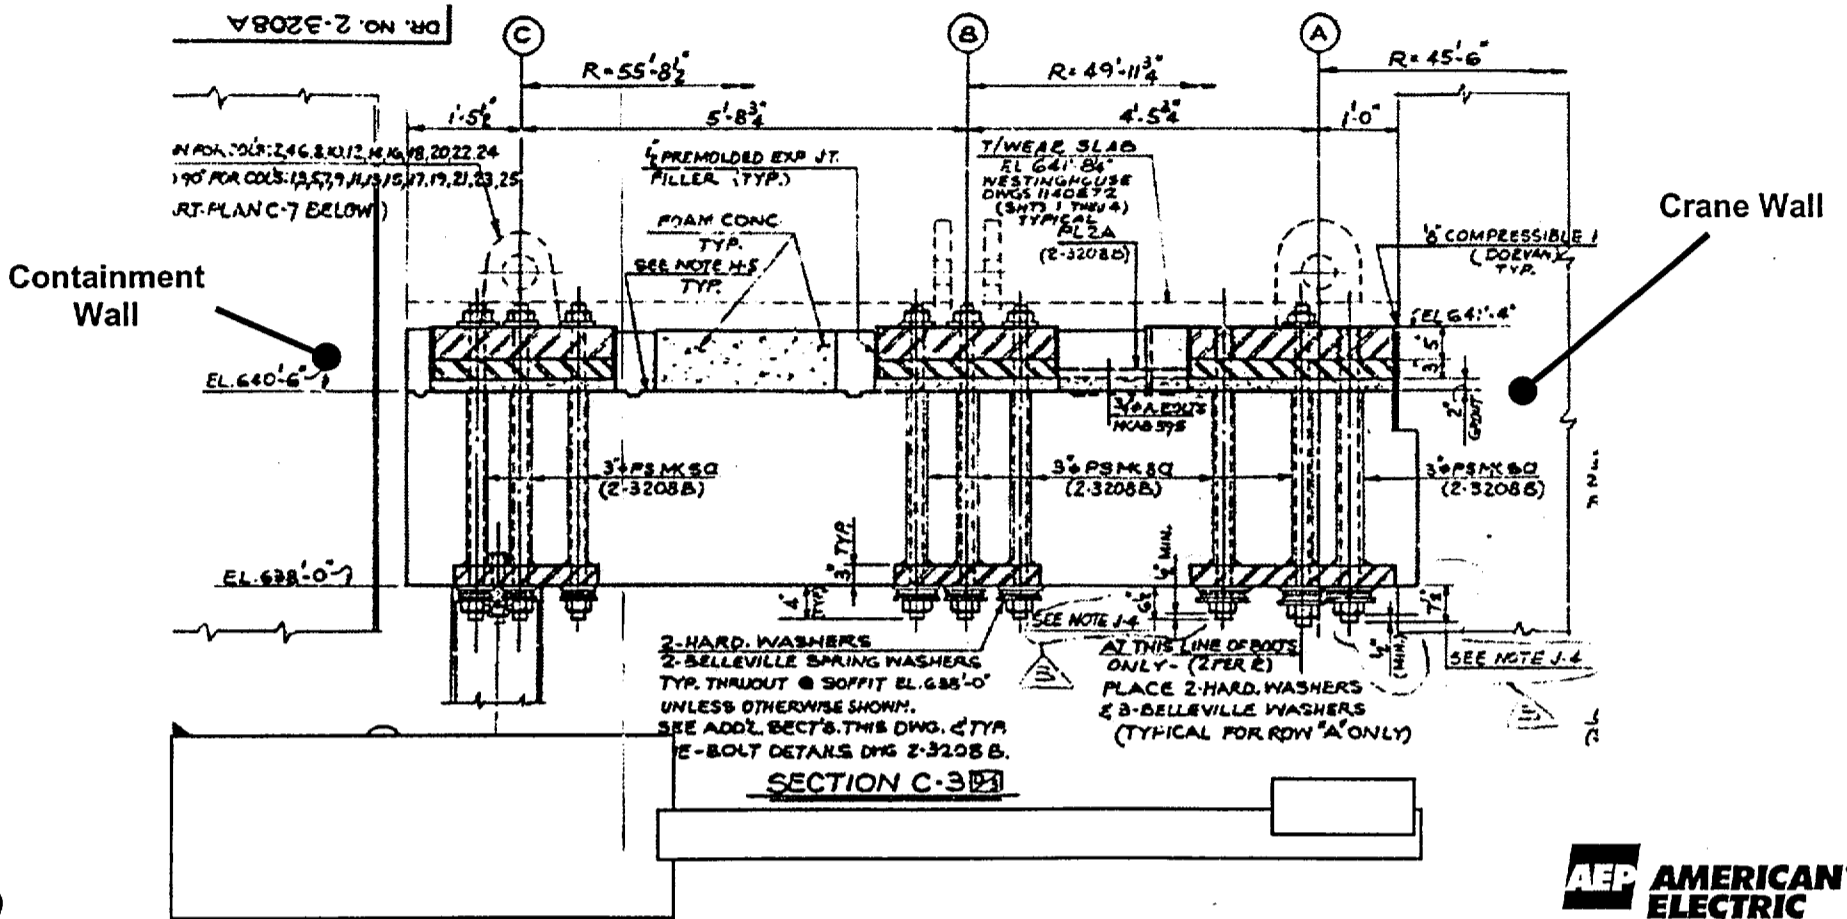
■ Typical Slab/Column Connection (Unit 2 Only)

- Pockets at Top of 126° Wall for Bolting
- Design Required Pockets to be Grouted
- Pockets Left Open From Original Construction

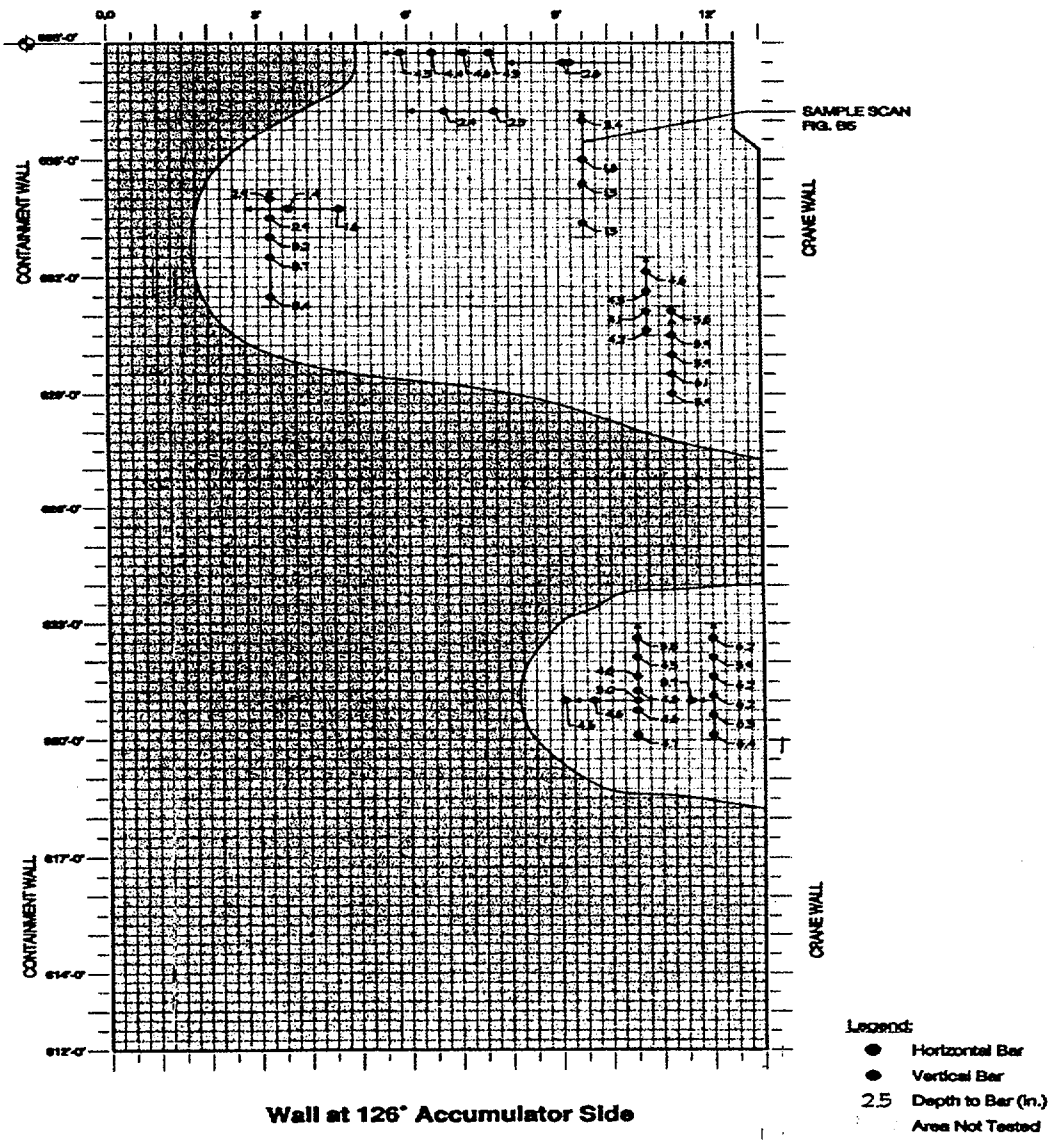
Description of the Issues: Wall Radar Mapping

- Horizontal bars per design
- Vertical bars
 - » Most areas per design
 - » Up to 15 inch spacing in limited areas

- Minimum ACI cover requirements met
- Average maximum depth developed for horizontal bars and vertical bars
