SUBJECT: NRC INSPECTION REPORT 40-8102/01-01

Report No.: 40-8102/01-01

Facility: Exxon Highland Uranium Mill Site

Location: Converse County, Wyoming

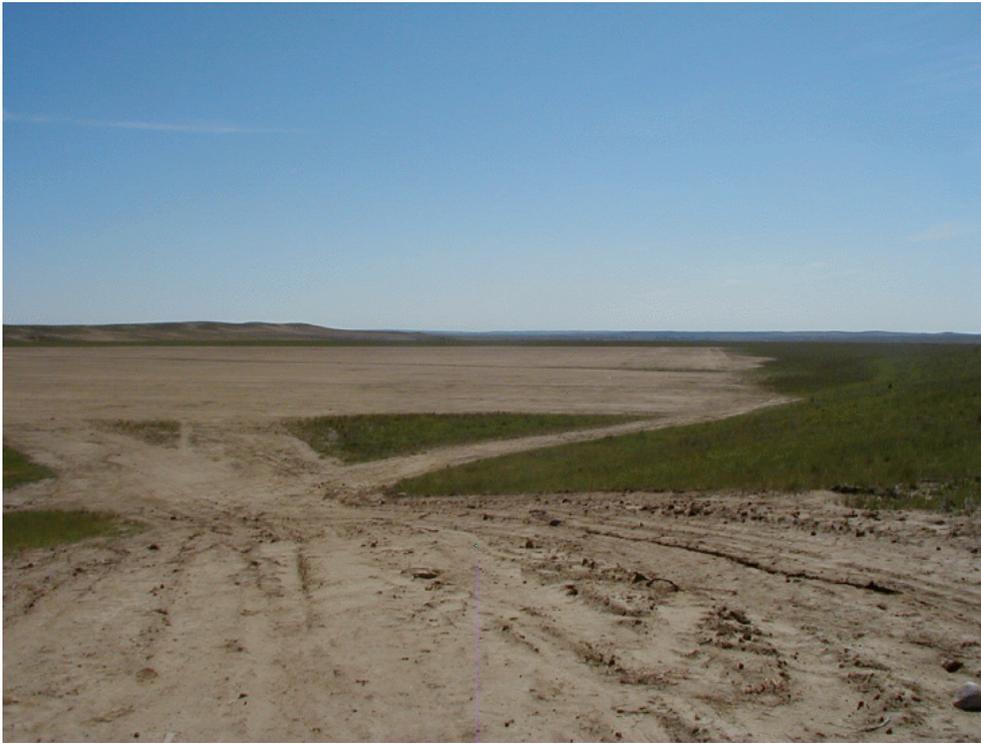
Although no cover cracking or distress was observed, it appeared that settlement may be continuing at portions of the cover. The earthen cover showed only minor undulation to an extent consistent with the fact that the tailings were reclaimed in place. During this inspection, the NRC considered that the sideslopes and diversion ditches were stable.

Exxon Highlands Tailings Impoundment Looking East North East

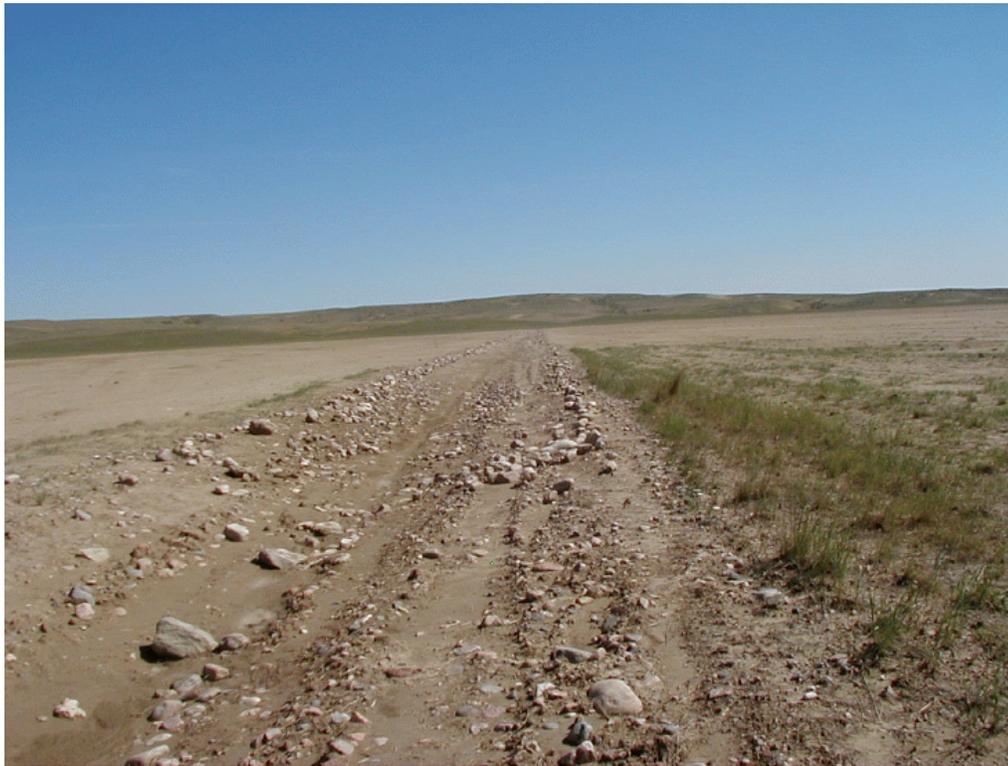
Drainage Ditch Located in Center of Tailings Impoundment Looking North

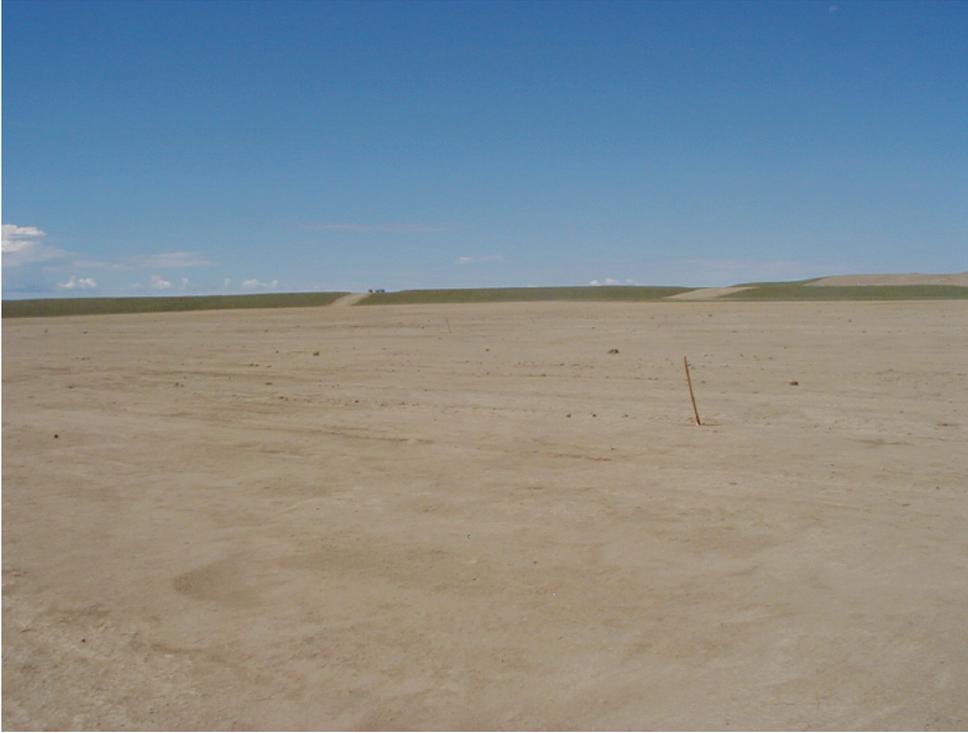
On top of Exxon Highlands Impoundment Looking West at one of the Settlement Monuments

The inspector determined that site reclamation had been accomplished in accordance with the approved reclamation plan. However, continued surveillance of settlement monuments was needed to assure that excessive tailings consolidation does not take place.

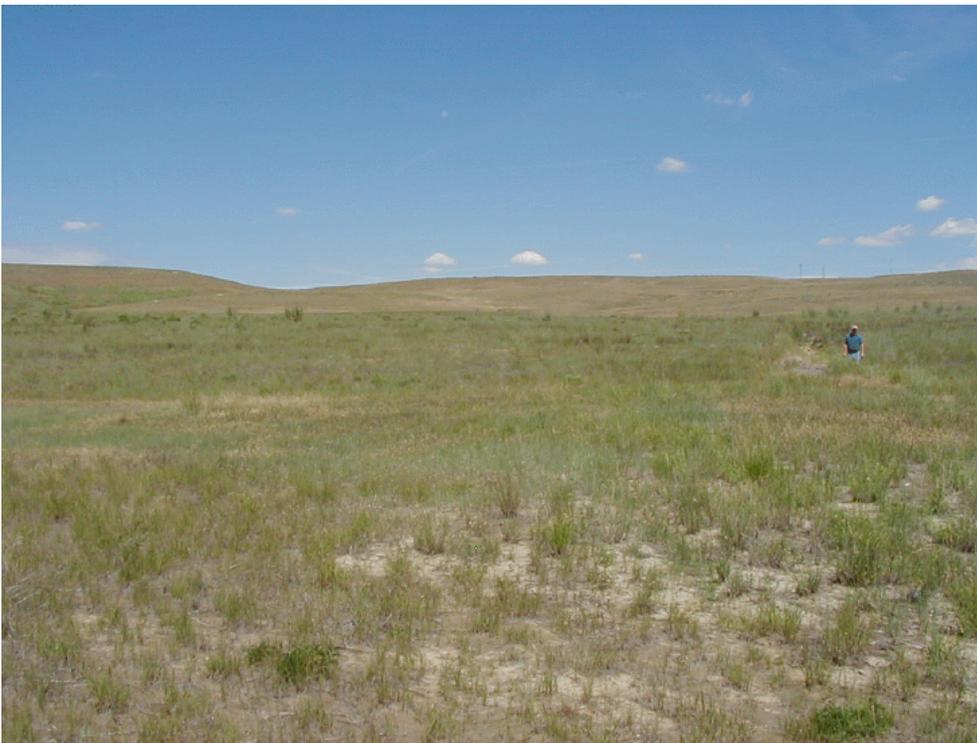
During a walking tour of the site, significant sedimentation was observed in the diversion channel adjacent to the site. The NRC inspectors had concerns regarding the adequacy of the current erosion protection design in light of the decreased capacity of the diversion channel. NRC staff stated that the licensee would be informed by letter concerning further information needed by the NRC on the current erosion protection design.

Look North Showing Gully and Sediment in Main Drainage Chanel

Licensed activities at Exxon's former Highland Uranium Mill site have been accomplished by a contractor. No Exxon personnel were stationed at the site. Exxon's site project manager has visited the site on an as-needed basis. Routine activities at the site included groundwater monitoring, settlement monument monitoring, well maintenance, weed control, and filling in of the settled area on the tailings impoundment. Re-seeding of the reclamation area is planned for completion this fall. Additional work needs to be done to clean up sediment in the main drainage channel.
