SUBJECT: NRC INSPECTION REPORT 40-4492/01-01

Report No.: 40-4492/00-01

Facility: Former Gas Hills Project

Inspection Date: July 11, 2001

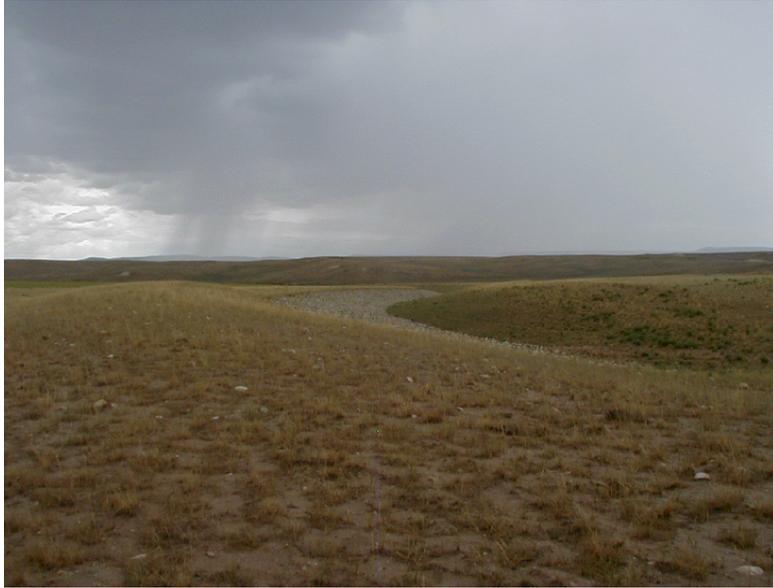
Tailings Pond #2 Main Drainage Channel Looking West

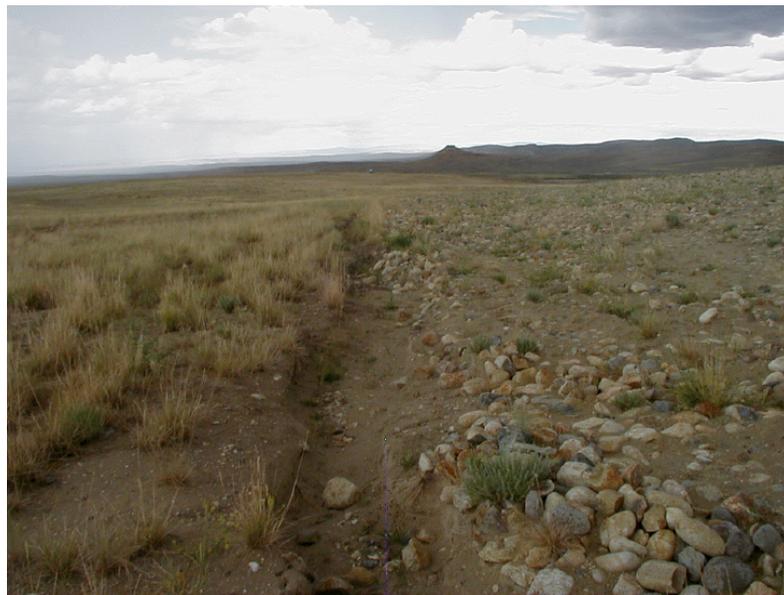
Gullying at Edge of Tailings Pond #2 Rock Cover Looking East

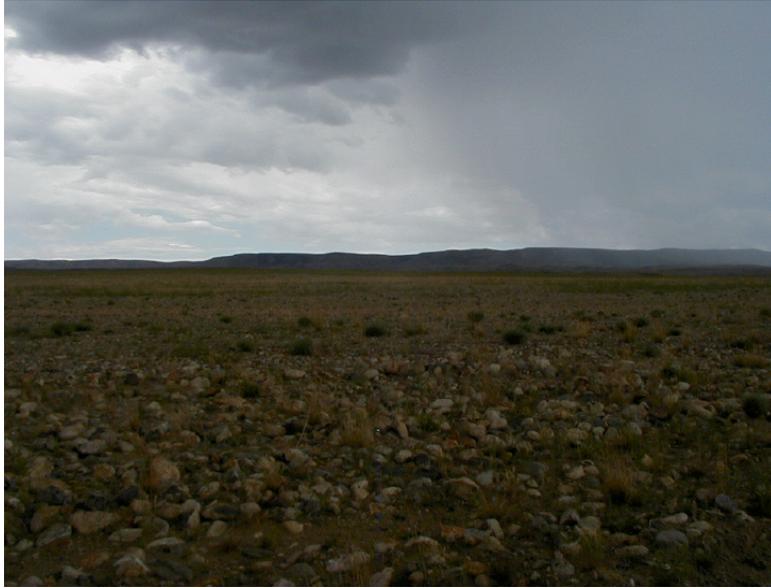
Top of Tailings Pond #2 Looking North West

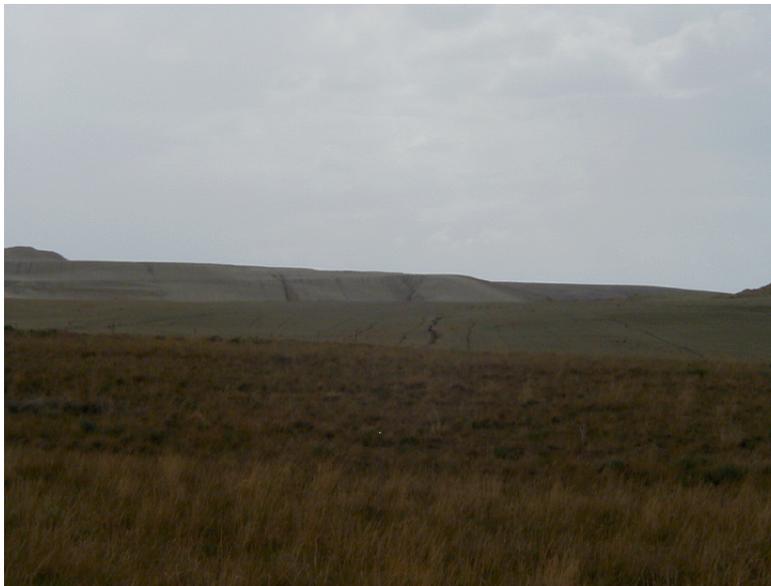
Gullying in side of Tailings Pond #1 Looking North
