## Appendix 10 - Analysis of Zaporizhzhya, Unit 1 Fire on January 27, 1984

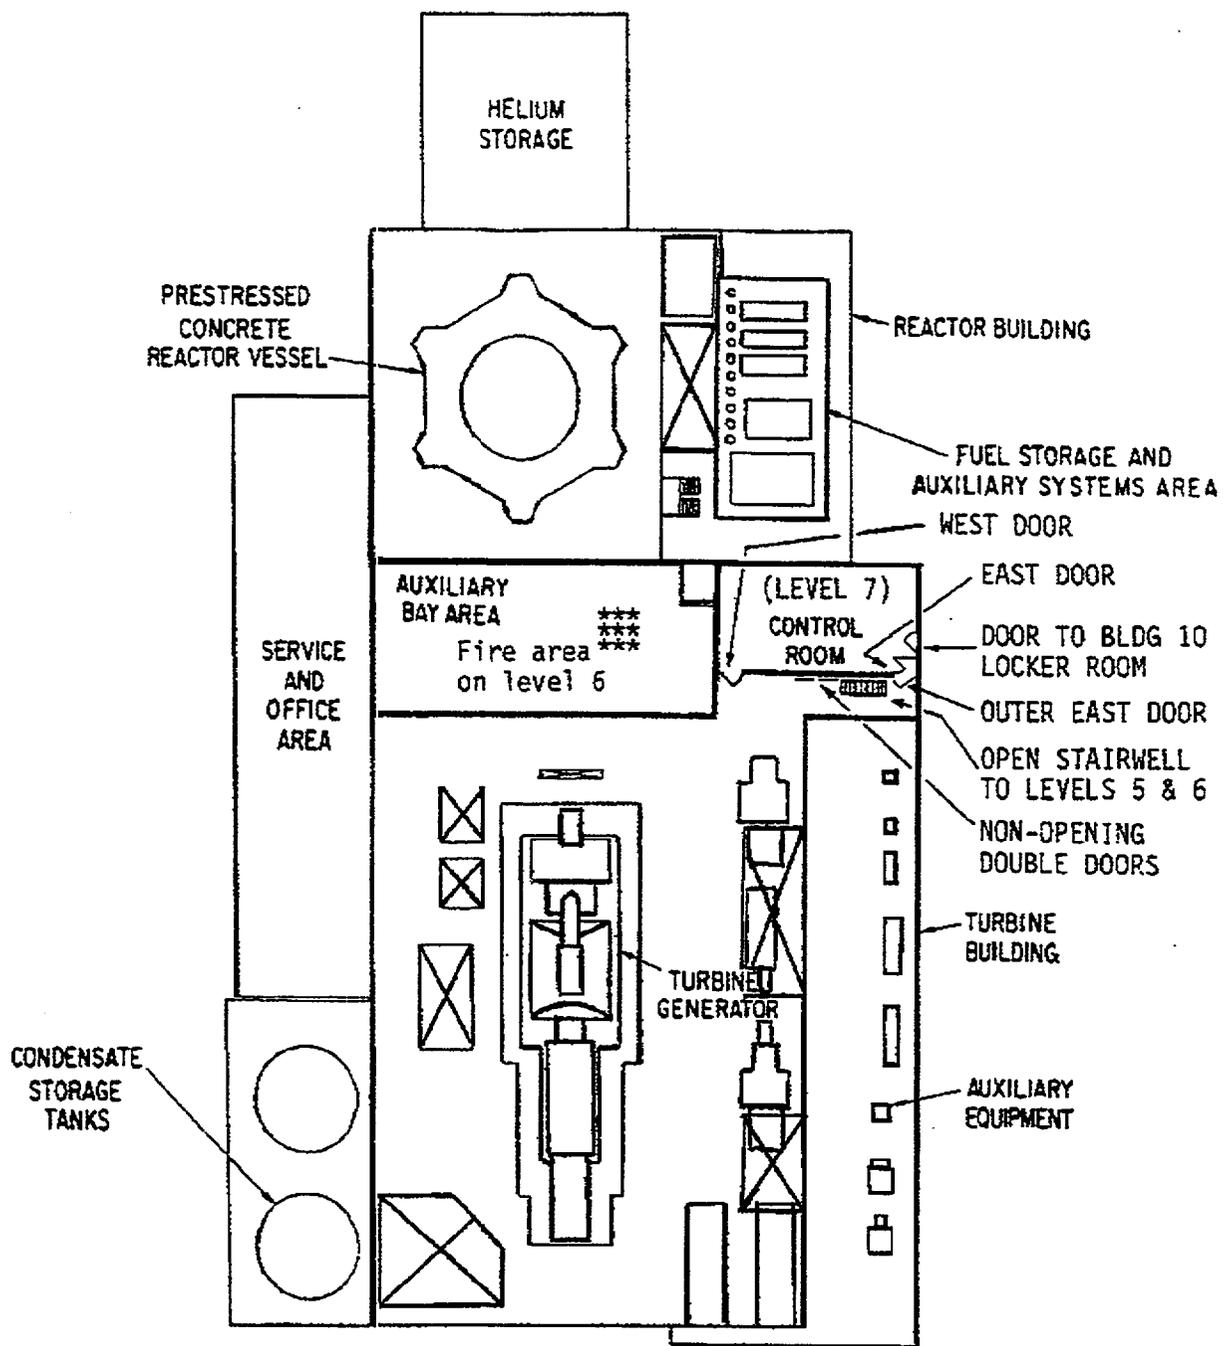
Figure A14-1: Plan view of the reactor building and turbine building including fire area on Level 6 and control room on level 7 (from Reference A14-1).

The damage caused by this fire was limited to the immediate area of the fire at the north end of the turbine building. Several cables were damaged that had some effect on the control room. Valves, instruments and structural elements were affected by the fire. However, there was minor impact on plant shutdown and reactor cooling capability.
