August 31, 2001
IPN-01-063

SUBJECT: Indian Point 3 Nuclear Power Plant
Docket No. 50-286
Thirty-Day Response to NRC Bulletin 2001-01
"Circumferential Cracking of Reactor
Vessel Pressure Vessel Head Penetration Nozzles"

**Thirty-Day Response to NRC Bulletin 2001-01
"Circumferential Cracking of Reactor Vessel
Pressure Vessel Head Penetration Nozzles"**

Entergy Nuclear Operations, Inc.
Indian Point 3 Nuclear Power Plant
Docket No. 50-286

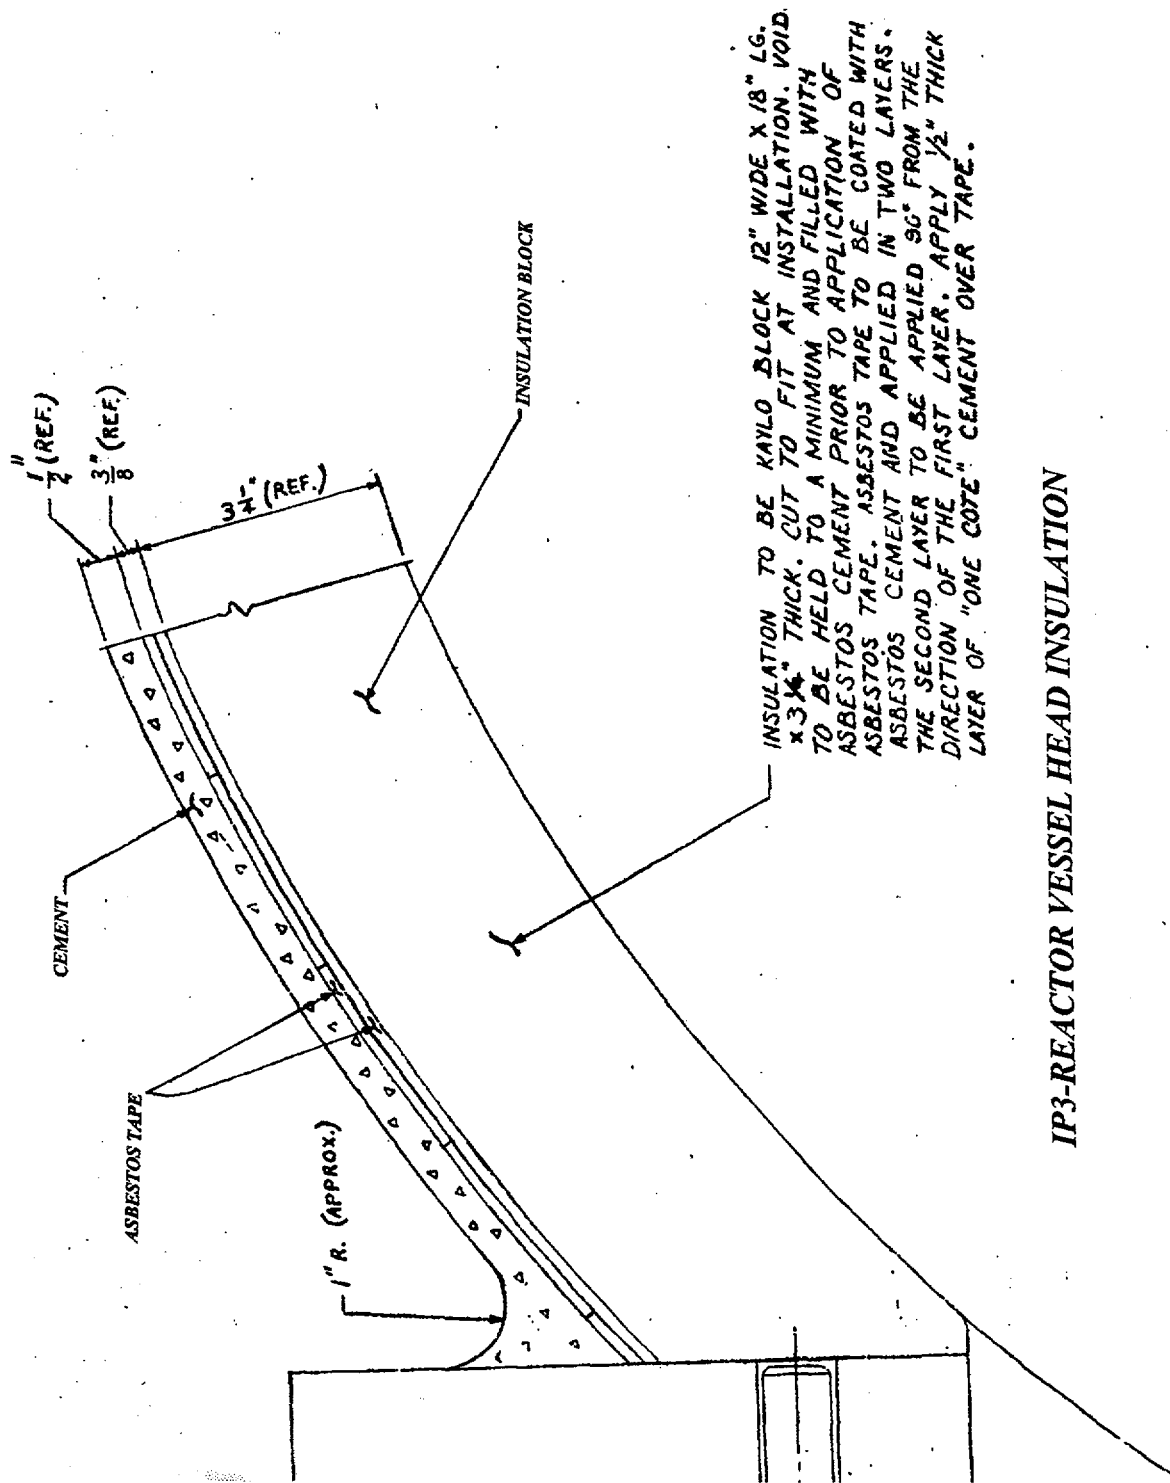
Figure 1
INDIAN POINT 3 REACTOR VESSEL HEAD INSULATION

As reported in Table 2-1 of MRP-48 (Reference 3), Indian Point 3 has block contoured RPV head insulation. A note on a plant drawing (Figure 1, Reference 4) describes it as:

"Insulation to be Kaylo Block 12" wide x 18" lg. x 3-1/4" thick. Cut to fit at installation. Voids to be held to a minimum and filled with asbestos cement prior to application of asbestos tape. Asbestos tape to be coated with asbestos cement and applied in two layers. The second layer to be applied 90 degrees from the direction of the first layer. Apply 1/2" thick layer of 'One Cote' cement over tape."
