SUBJECT: NRC INSPECTION REPORT 40-2259/01-02

U.S. NUCLEAR REGULATORY COMMISSION

Report No. 40-2259/01-02

Facility: Former Lucky Mc Uranium Mill

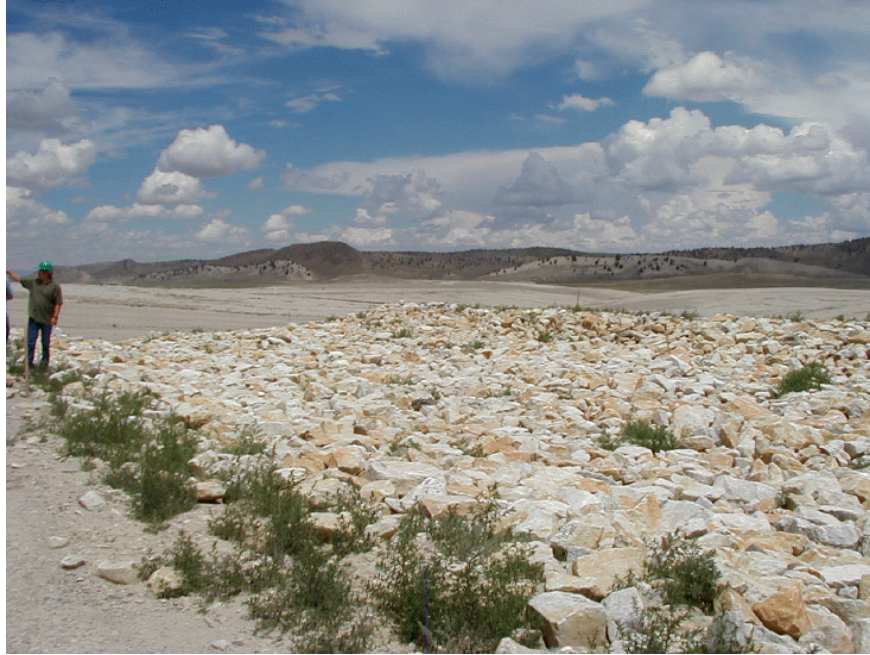
Pathfinder  
Upper  
Channel  
North West
