SUBJECT: NRC INSPECTION REPORT 40-2259/01-02

Pathfinder Mines Corporation  
Former Lucky Mc Uranium Mill

Report No. 40-2259/01-02

Date: July 11, 2001

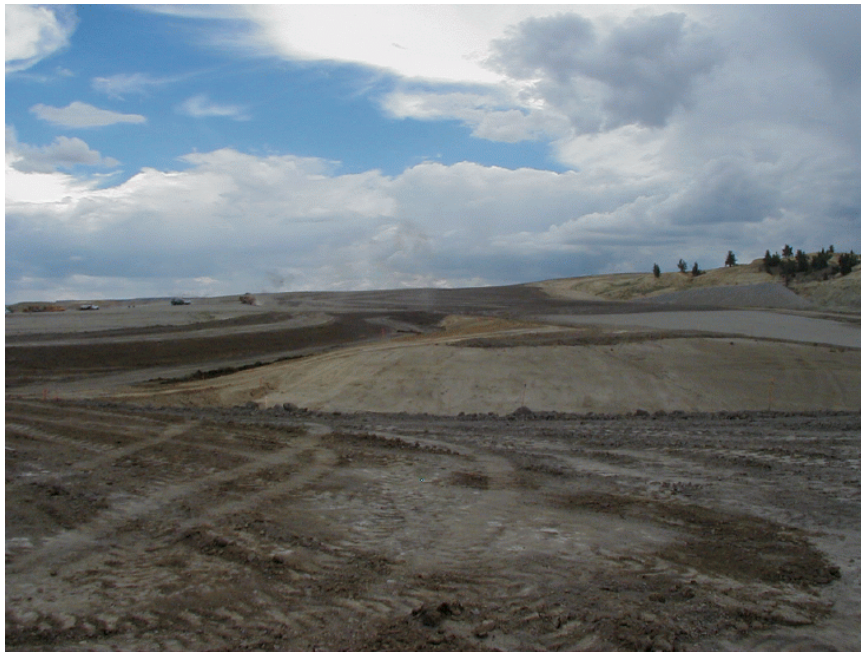
Lucky Mc  
Drainage  
Looking

Placement of Clay liner in Drainage Channel on Ponds 2 & 3 Looking North

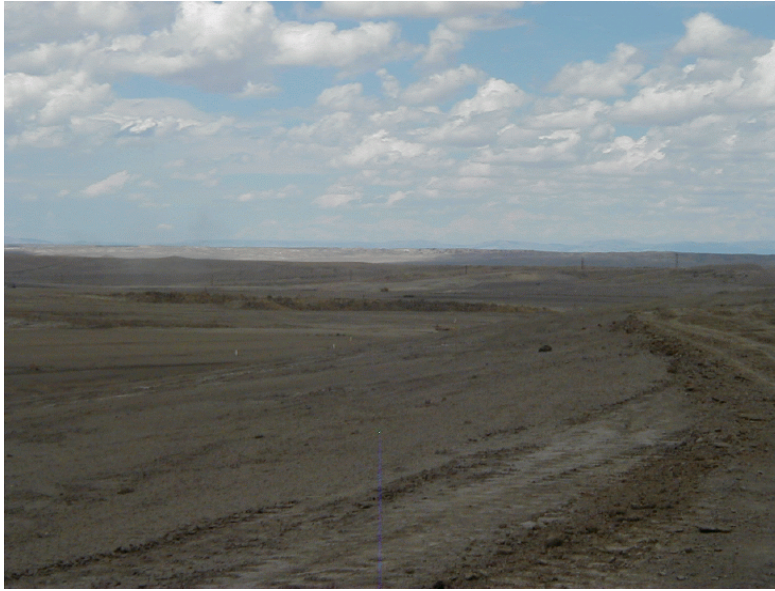
Placement of  
Material in Pond

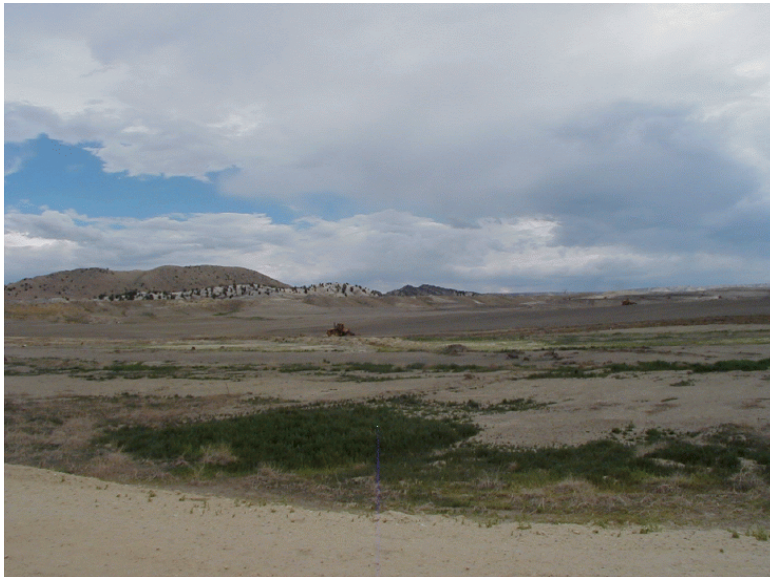
Contaminated  
#3 Looking West

On Pond #4 Dam Looking North East at Pond #4 Bottom
