SUBJECT: TECHNICAL ASSISTANCE REQUEST - REVIEW OF GROUNDWATER
TEST RESULTS SUBMITTED BY VIRGINIA POWER CO. FOR ITS
CATEGORY I SERVICE WATER POND DAM AT NORTH ANNA

Project: Dam Safety Inspection - North Anna Category I Service Water Pond Geochemistry

FIGURE 1
PLAN-CURRENT INSTRUMENTATION
SERVICE WATER RESERVOIR
NORTH ANNA POWER STATION

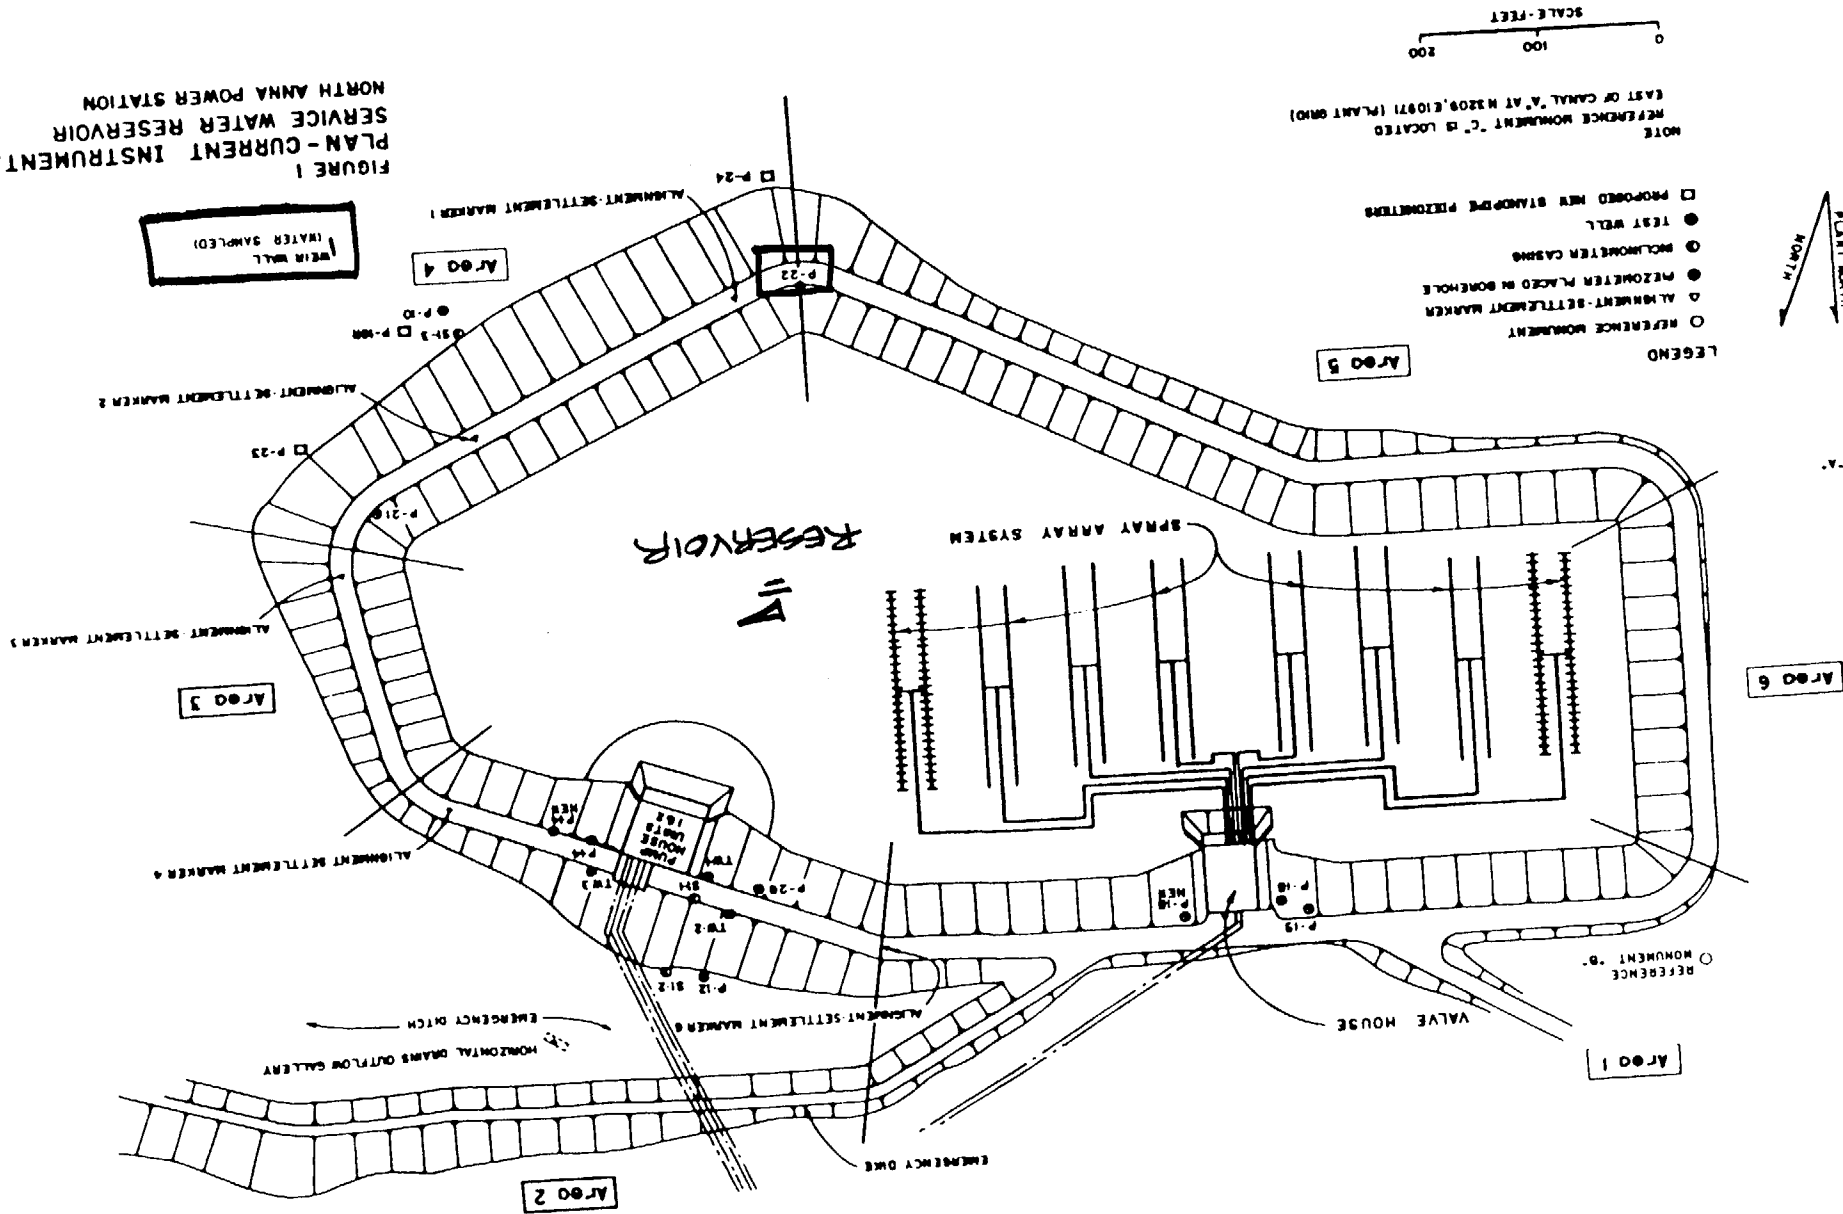
Action: Water samples were taken from three areas around the SWR on January 12, 1998 to measure conductivity. These included water from the service water reservoir, water from piezometer P-22 casing during bailing, and ponded water at the weir wall in the wet area below the SWR dike and adjacent roadway (Attachment 2, Figure 1).

Piezometer P-22	99 micromhos
Weir Wall	123 micromhos
Service Water Reservoir	922 micromhos

Conductivity is a measure of a solutions capacity to conduct electric current and depends on the presence of ions. The more dissolved salts/ions that are present in the solution the higher the conductivity that would be expected. The substantially higher conductivity values obtained from the SWR sample is due to the biocidal and other chemical treatment used in the reservoir.

These conductivity tests clearly indicate the water obtained from piezometer P-22 and the drainage area did not originate from the reservoir and therefore are not the result of seepage from the reservoir. As a comparison, the conductivity of distilled (de-ionized) water ranges from 0.05 to 2.0 micromhos.

Action: Results of the conductivity tests on a water sample taken from the weir wall which is located downstream or downgradient from the other weirs, clearly indicates that the water did not emanate from the reservoir. Therefore, reactivating weir flow measurements would only measure runoff and groundwater movement which would provide extraneous data not pertaining to SWR seepage or stability. In our opinion, such effort is unwarranted.
