SUBJECT: TECHNICAL ASSISTANCE REQUEST - REVIEW OF GROUNDWATER
TEST RESULTS SUBMITTED BY VIRGINIA POWER CO. FOR ITS
CATEGORY I SERVICE WATER POND DAM AT NORTH ANNA

Project: Dam Safety Inspection - North Anna Category I Service Water Pond Geochemistry

FIGURE 1
 PLAN-CURRENT INSTRUMENTATION
 SERVICE WATER RESERVOIR
 NORTH ANNA POWER STATION

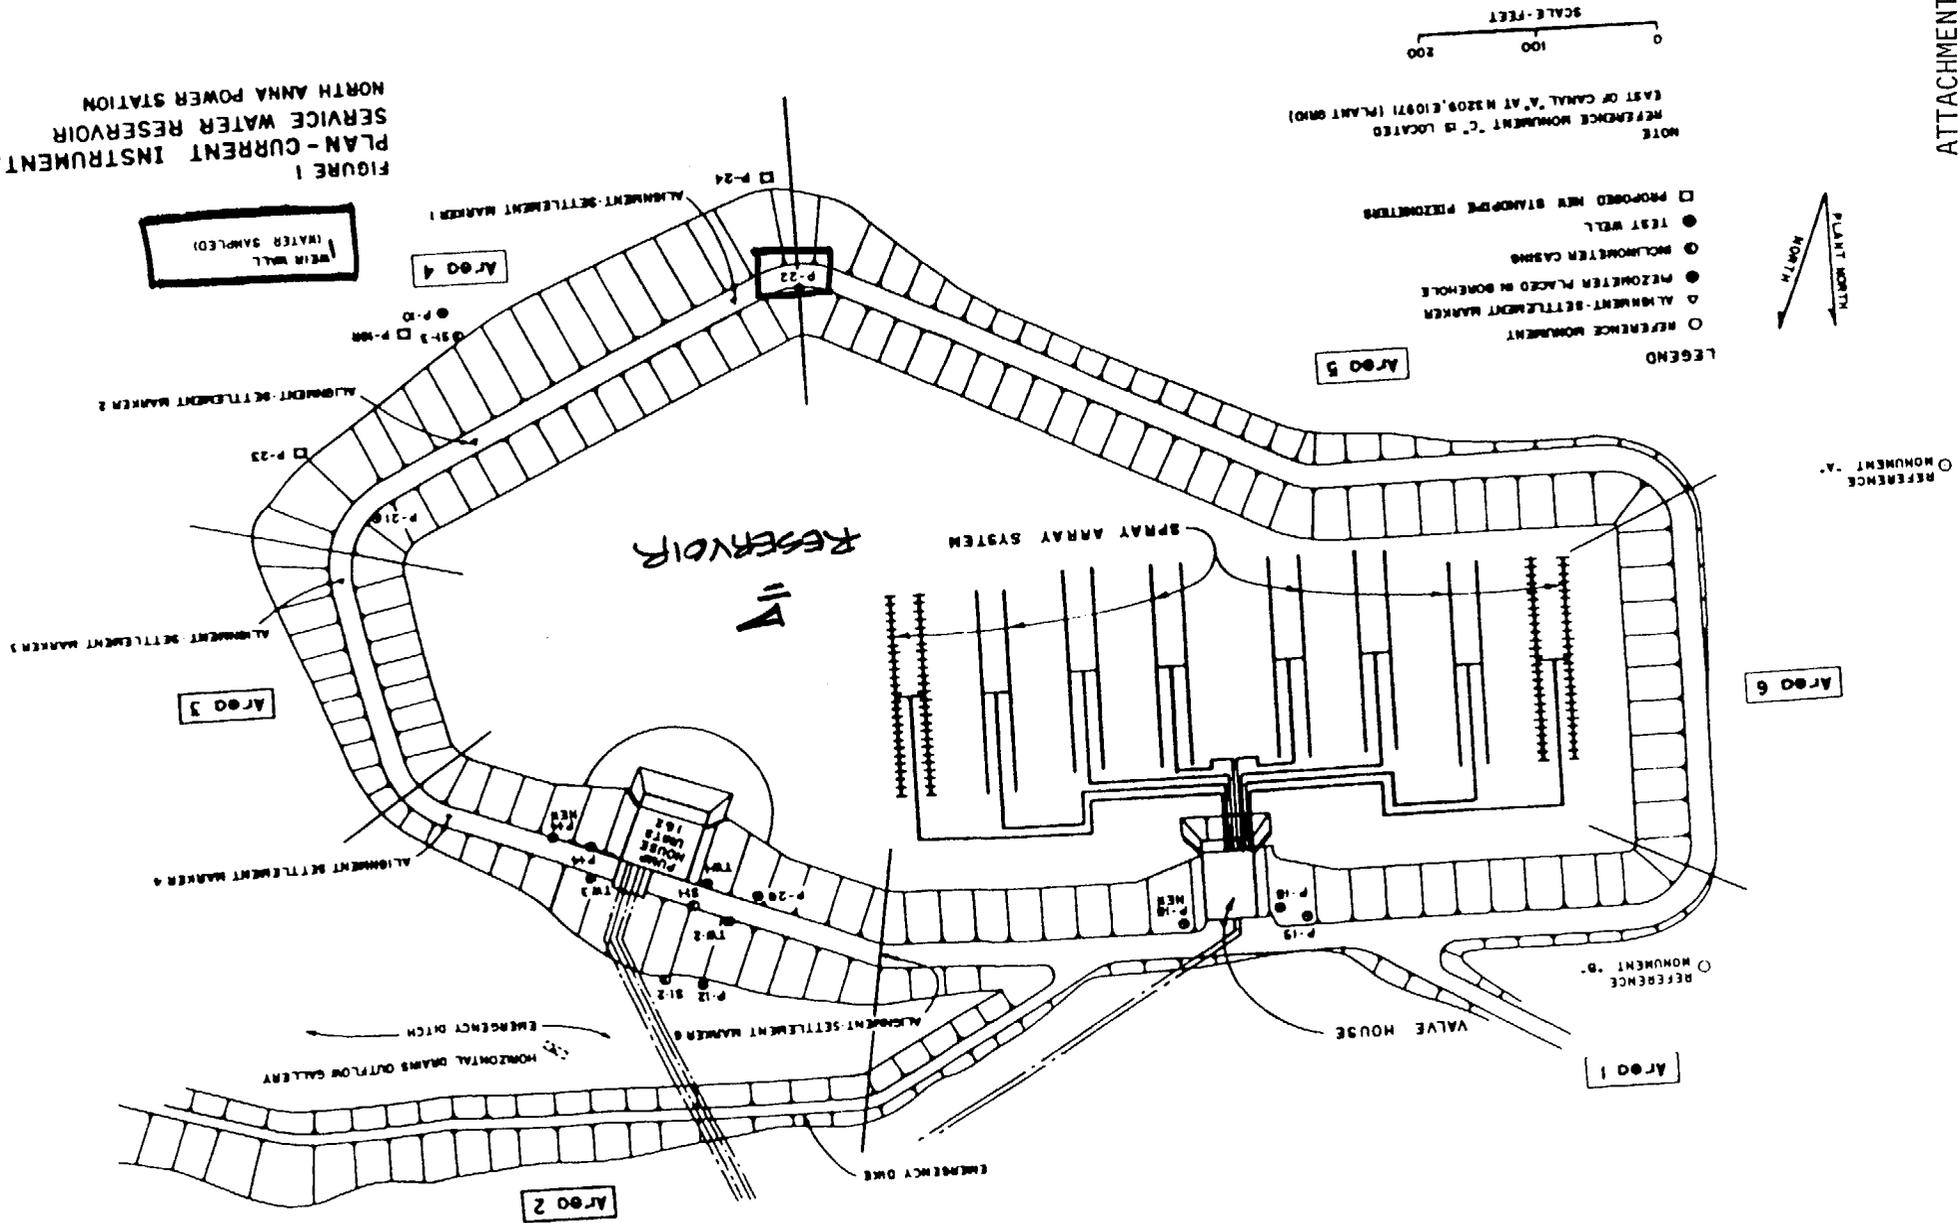
Action: Water samples were taken from three areas around the SWR on January 12, 1998 to measure conductivity. These included water from the service water reservoir, water from piezometer P-22 casing during bailing, and ponded water at the weir wall in the wet area below the SWR dike and adjacent roadway (Attachment 2, Figure 1).

Piezometer P-22	99 micromhos
Weir Wall	123 micromhos
Service Water Reservoir	922 micromhos

Conductivity is a measure of a solutions capacity to conduct electric current and depends on the presence of ions. The more dissolved salts/ions that are present in the solution the higher the conductivity that would be expected. The substantially higher conductivity values obtained from the SWR sample is due to the biocidal and other chemical treatment used in the reservoir.

These conductivity tests clearly indicate the water obtained from piezometer P-22 and the drainage area did not originate from the reservoir and therefore are not the result of seepage from the reservoir. As a comparison, the conductivity of distilled (de-ionized) water ranges from 0.05 to 2.0 micromhos.
