UNITED STATES
NUCLEAR REGULATORY COMMISSION
OFFICE OF NUCLEAR REACTOR REGULATION
WASHINGTON, D.C. 20555-0001

October 3, 2001

NRC INFORMATION NOTICE NO. 2001-14: PROBLEMS WITH INCORRECTLY-INSTALLED
SWING-CHECK VALVES

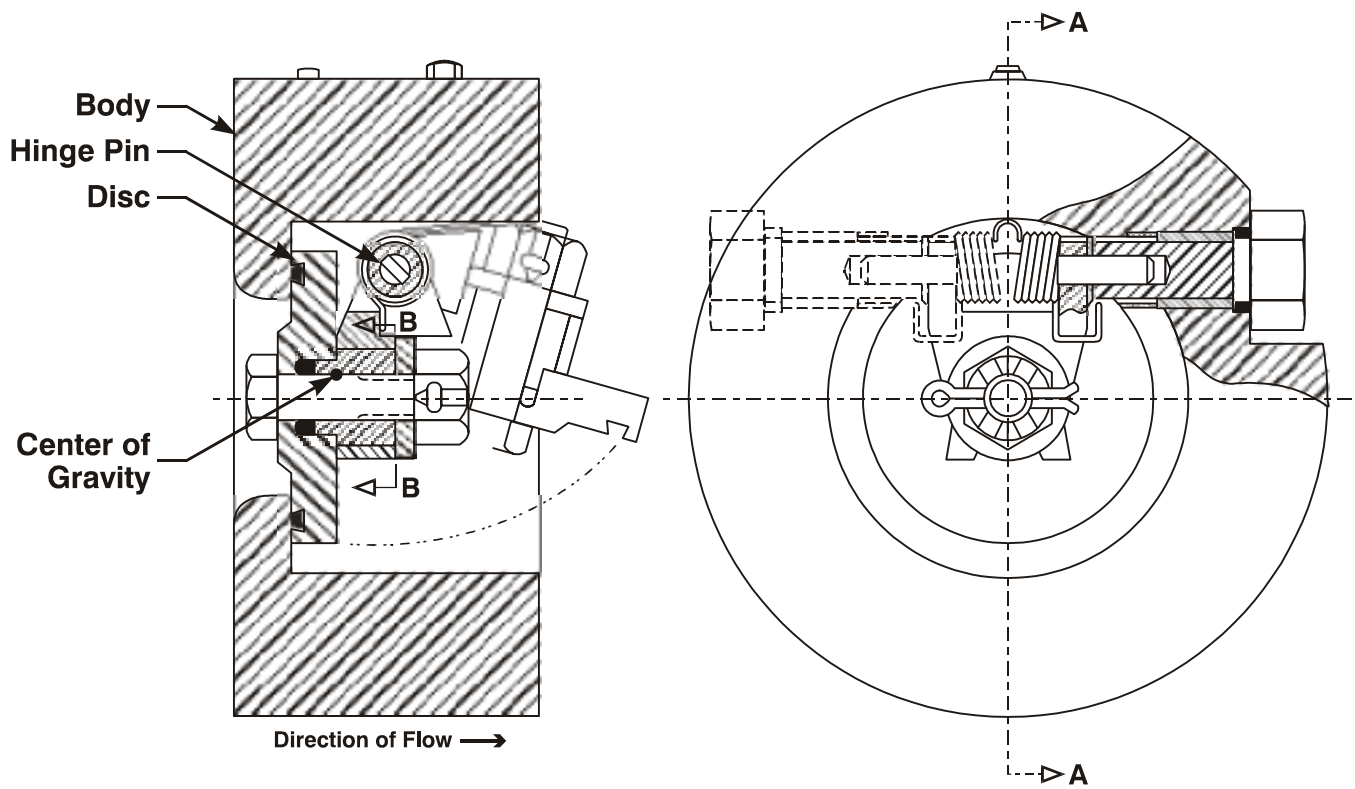
While trouble-shooting a leaking check valve between the reactor core isolation cooling barometric condenser and the suppression pool, the licensee determined that a check valve had been installed rotated 90 degrees away from the orientation recommended by the valve vendor. According to the vendor's technical manual, the valve should have been installed either in a horizontal line with the hinge pin centerline vertical or in a vertical line with flow upward. The staff documents this problem with certain Anderson-Greenwood check valves in Inspection Report 50-298/98-05 (NUDOCS Accession Number 9809240061).^{1*}

The check valves of concern are designed so that, when installed in a horizontal run of piping, the axis of the hinge is vertical and the check valve disc pivots in the horizontal plane, like a door. The licensee incorrectly installed the valves with the hinge pin horizontal, so the disc did not pivot in the horizontal plane as required. The disc face pivoted from a horizontal plane, on forward flow, to a vertical plane on flow reversal. Therefore, the disc tended to hang open on reversal and cessation of flow. This effect can be visualized from attached Figure 1, which shows the relationship of the center of gravity of the disc to the axis of the hinge pin. The spring shown wound around the hinge pin is intended to close the valve against only the design frictional and drag forces expected to exist with the hinge pin vertical or with the valve in a

vertical run of pipe; it was not designed to overcome the gravitational force that would tend to hold the valve open when the hinge pin axis is horizontal and the valve is in a horizontal run of pipe.

Figure 1. Anderson Greenwood Check Valve

highlight the need to install Anderson Greenwood check valves in accordance with vendor guidance and to ensure that the Borg-Warner check valve disc is in its correct vertical position.

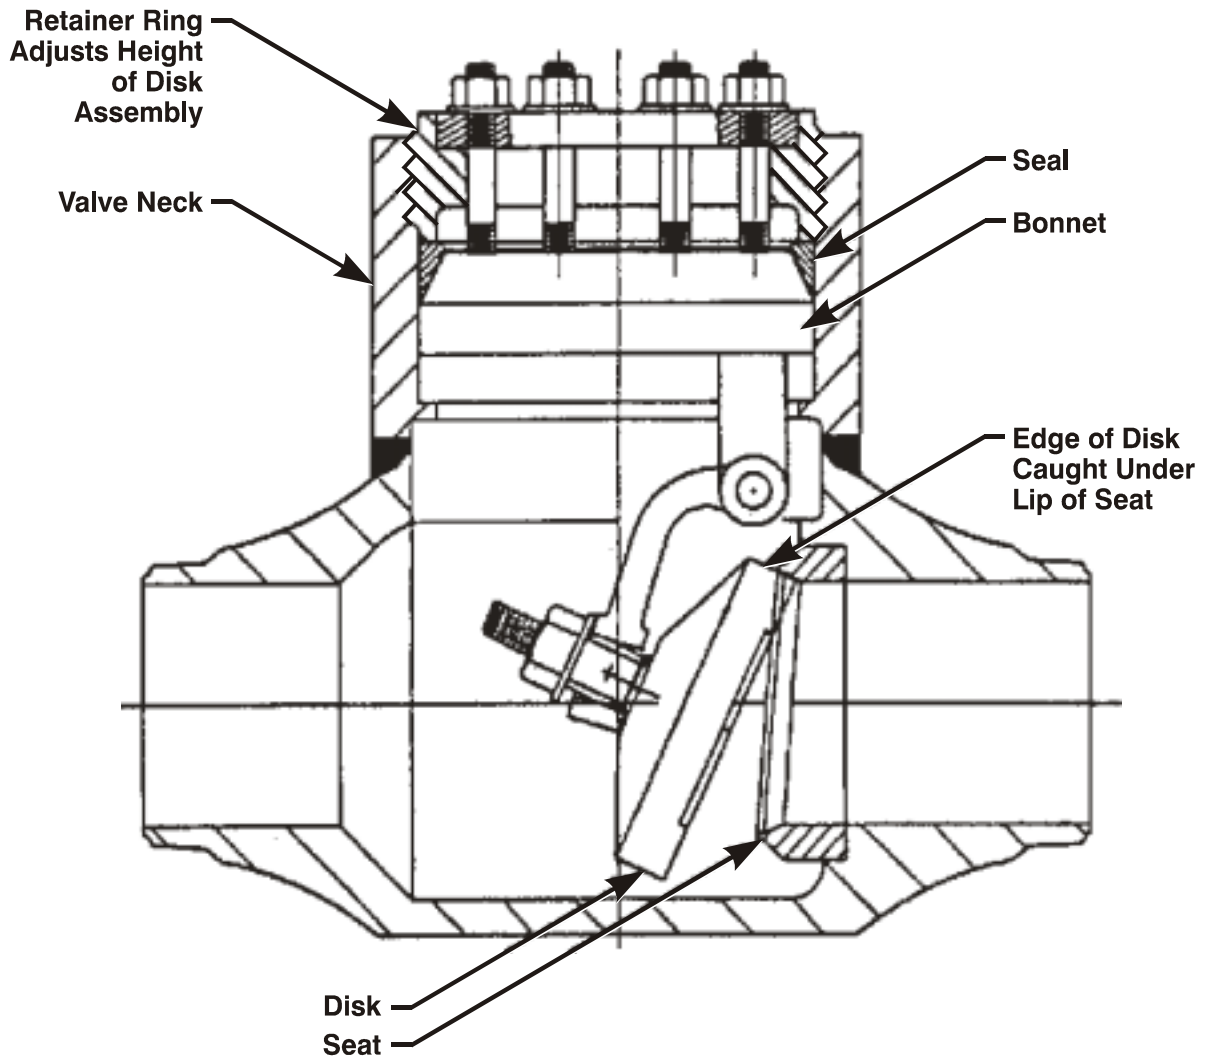
The licensee experienced excessive leakage through some Borg-Warner swing-check valves in the high-pressure safety injection (HPSI) system. The root cause of the problem was determined to be an error in valve assembly during the original installation. As a result, the disc assembly was suspended too low inside the body of the valve. With the disc assembly suspended too low, the valve might have seated acceptably at first but remained partially open after forward flow exercised the valve.

The improper assembly occurred during plant construction. The licensee removed the internals of these valves so the valve bodies could be welded into the piping. During reassembly of the internals, the bonnet retaining ring was threaded into the body until it bottomed. The original factory assembly process included a step that involved backing out the bonnet retaining ring, after it bottomed in the valve body, until the correct disc height was obtained, as visually observed through the open ends of the valve body. At Palo Verde, however, the valve had been installed in the piping and the valve internals could not be observed. Therefore, the disc height adjustment could not be made during valve reassembly, and the disc remained too low in the body to engage the seat properly.

Figure 2. Borg-Warner Check Valve Shown with Disk Jammed in Open Position

The NRC staff had addressed this problem in Information Notice IN 89-62, "Malfunction of Borg-Warner Pressure Seal Bonnet Check Valves Caused by Vertical Misalignment of Disk," dated August 31, 1989 (NUDOCS Accession Number 8908240375). After IN 89-62 was issued, the valve vendor issued maintenance guidance to recommend that measurements of an internal critical dimension be done to ensure that the disc is in the correct position following maintenance.

Until November 1994, the licensee's maintenance procedure for these check valves did not include adequate instructions for ensuring correct vertical positioning of the disc. Once the problem was diagnosed in 1998, the licensee implemented a plan to identify and correct the error on all of the HPSI discharge check valves. The NRC staff described the licensee's actions on this problem in Inspection Report 50-528/529/530 98-14 (NUDOCS Accession Number 9809090298).
