UNITED STATES  
NUCLEAR REGULATORY COMMISSION  
OFFICE OF NUCLEAR REACTOR REGULATION  
WASHINGTON, D.C. 20555-0001

NRC INFORMATION NOTICE NO. 2001-14: PROBLEMS WITH INCORRECTLY-INSTALLED  
SWING-CHECK VALVES

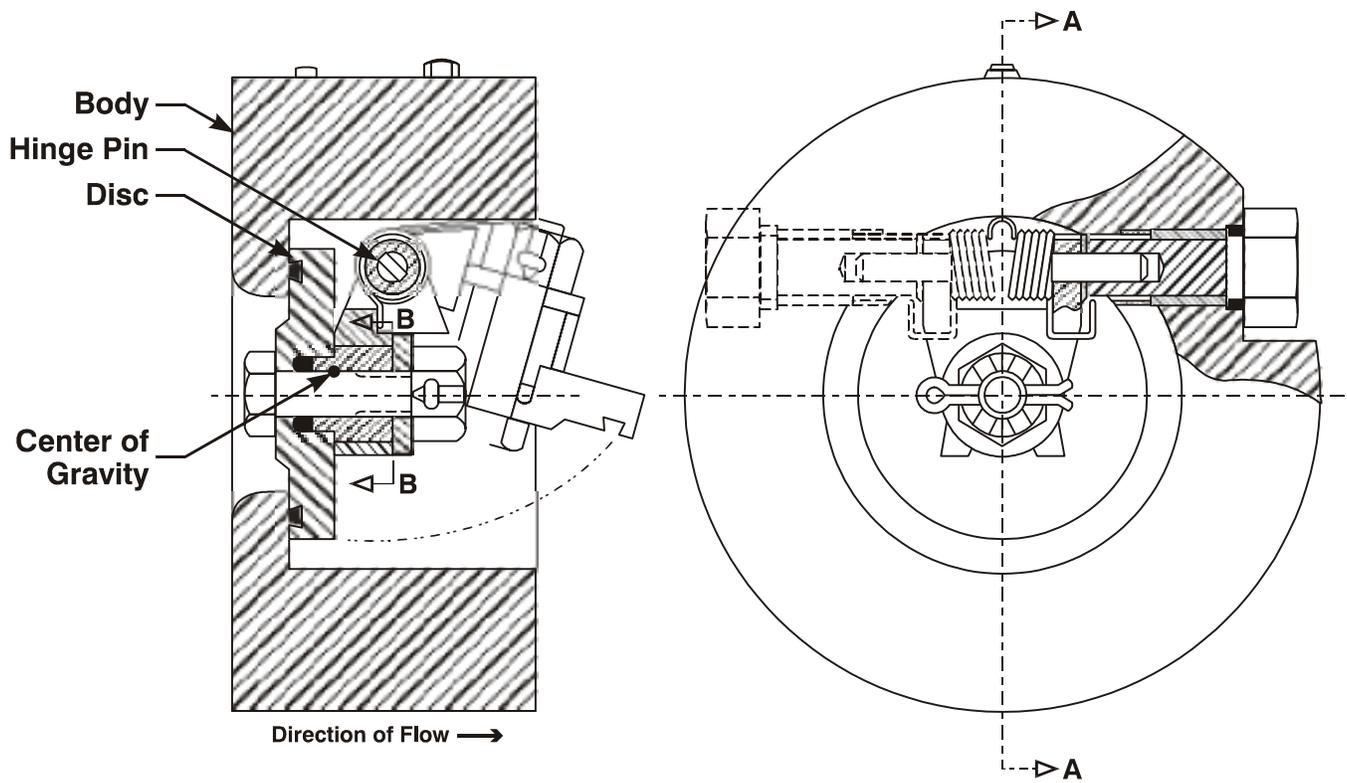
**Figure 1. Anderson Greenwood Check Valve**

While trouble-shooting a leaking check valve between the reactor core isolation cooling barometric condenser and the suppression pool, the licensee determined that a check valve had been installed rotated 90 degrees away from the orientation recommended by the valve vendor. According to the vendor's technical manual, the valve should have been installed either in a horizontal line with the hinge pin centerline vertical or in a vertical line with flow upward. The staff documents this problem with certain Anderson-Greenwood check valves in Inspection Report 50-298/98-05 (NUDOCS Accession Number 9809240061).<sup>1\*</sup>

The check valves of concern are designed so that, when installed in a horizontal run of piping, the axis of the hinge is vertical and the check valve disc pivots in the horizontal plane, like a door. The licensee incorrectly installed the valves with the hinge pin horizontal, so the disc did not pivot in the horizontal plane as required. The disc face pivoted from a horizontal plane, on forward flow, to a vertical plane on flow reversal. Therefore, the disc tended to hang open on reversal and cessation of flow. This effect can be visualized from attached Figure 1, which shows the relationship of the center of gravity of the disc to the axis of the hinge pin. The spring shown wound around the hinge pin is intended to close the valve against only the design frictional and drag forces expected to exist with the hinge pin vertical or with the valve in a

vertical run of pipe; it was not designed to overcome the gravitational force that would tend to hold the valve open when the hinge pin axis is horizontal and the valve is in a horizontal run of pipe.

highlight the need to install Anderson Greenwood check valves in accordance with vendor guidance and to ensure that the Borg-Warner check valve disc is in its correct vertical position.

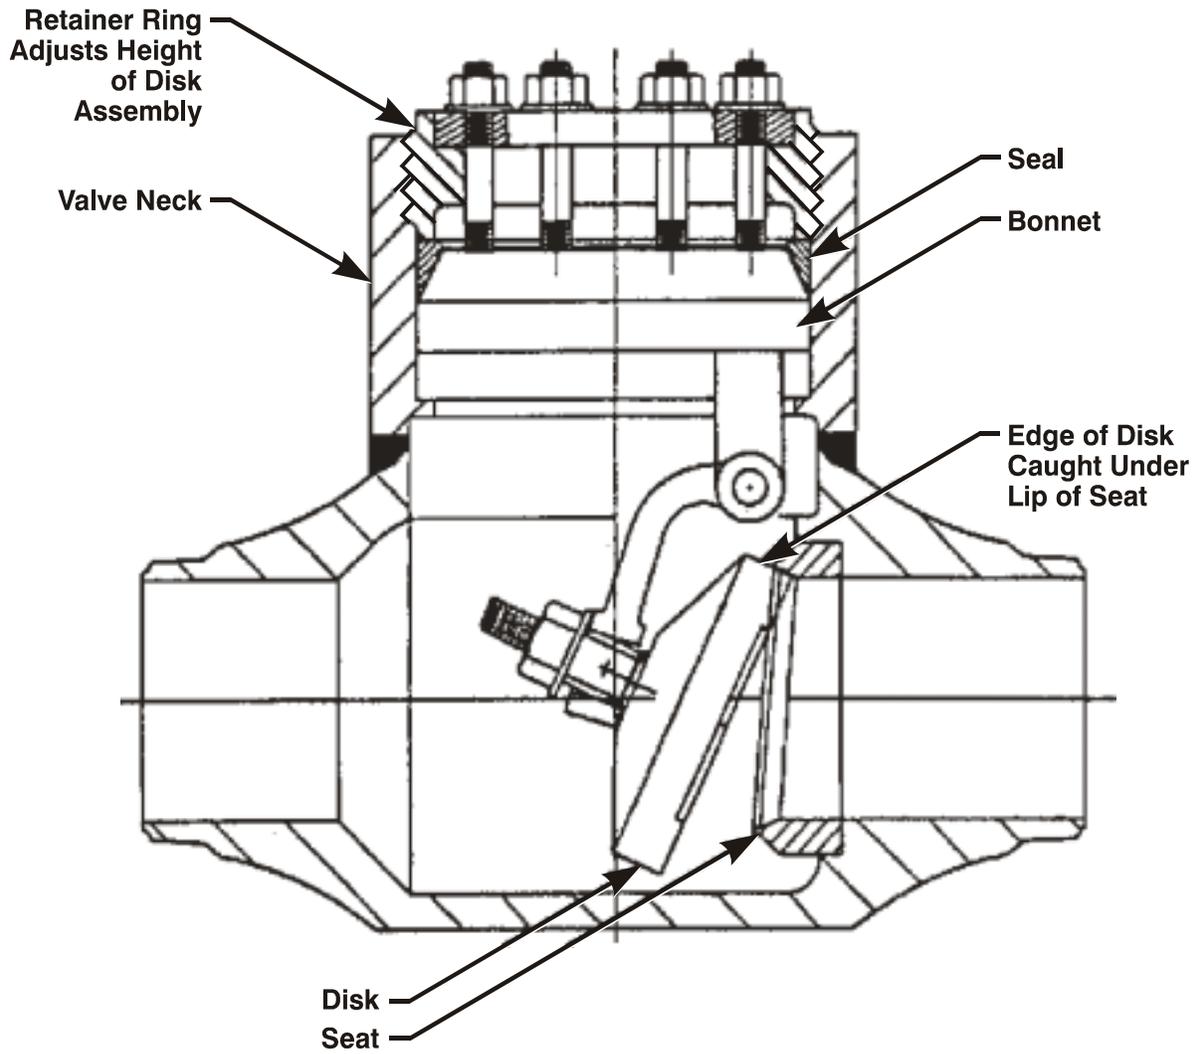
**Figure 2. Borg-Warner Check Valve Shown with Disk Jammed in Open Position**

The licensee experienced excessive leakage through some Borg-Warner swing-check valves in the high-pressure safety injection (HPSI) system. The root cause of the problem was determined to be an error in valve assembly during the original installation. As a result, the disc assembly was suspended too low inside the body of the valve. With the disc assembly suspended too low, the valve might have seated acceptably at first but remained partially open after forward flow exercised the valve.

The improper assembly occurred during plant construction. The licensee removed the internals of these valves so the valve bodies could be welded into the piping. During reassembly of the internals, the bonnet retaining ring was threaded into the body until it bottomed. The original factory assembly process included a step that involved backing out the bonnet retaining ring, after it bottomed in the valve body, until the correct disc height was obtained, as visually observed through the open ends of the valve body. At Palo Verde, however, the valve had been installed in the piping and the valve internals could not be observed. Therefore, the disc height adjustment could not be made during valve reassembly, and the disc remained too low in the body to engage the seat properly.

The NRC staff had addressed this problem in Information Notice IN 89-62, "Malfunction of Borg-Warner Pressure Seal Bonnet Check Valves Caused by Vertical Misalignment of Disk," dated August 31, 1989 (NUDOCS Accession Number 8908240375). After IN 89-62 was issued, the valve vendor issued maintenance guidance to recommend that measurements of an internal critical dimension be done to ensure that the disc is in the correct position following maintenance.

Until November 1994, the licensee's maintenance procedure for these check valves did not include adequate instructions for ensuring correct vertical positioning of the disc. Once the problem was diagnosed in 1998, the licensee implemented a plan to identify and correct the error on all of the HPSI discharge check valves. The NRC staff described the licensee's actions on this problem in Inspection Report 50-528/529/530 98-14 (NUDOCS Accession Number 9809090298).
