CROW BUTTE RESOURCES, INC.

September 26, 2001

Subject: Source Materials License SUA-1534
Docket No. 40-8943
Evaporation Pond 1 Liner Leak – Final Report

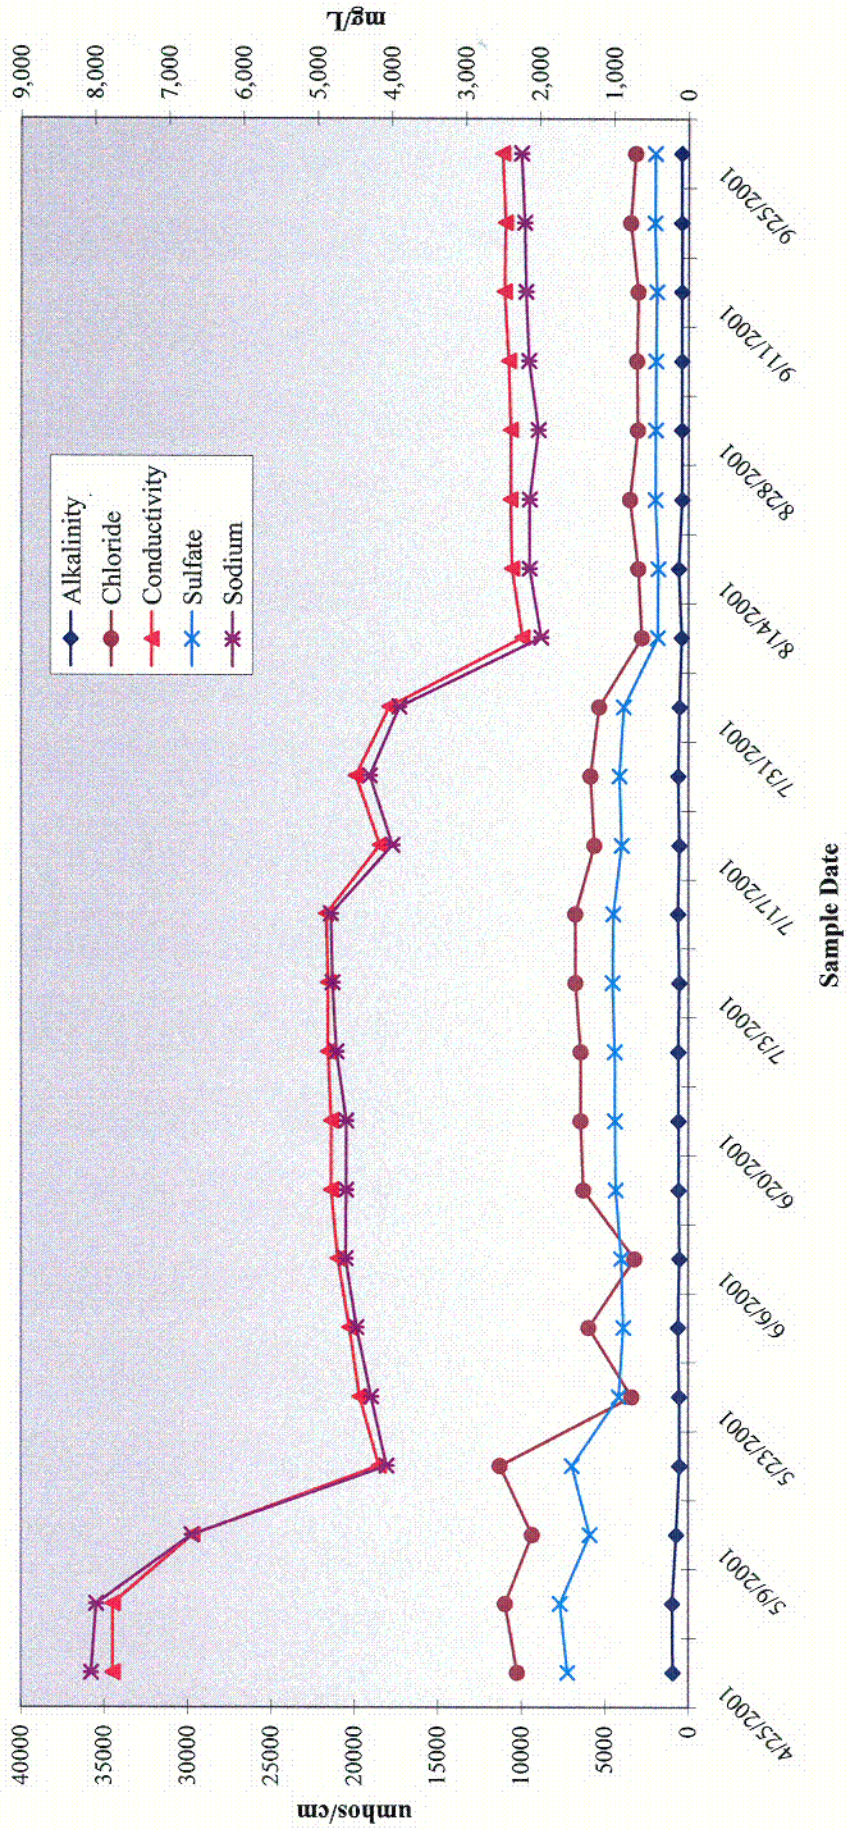
Figure 1
 Pond 1 Southwest Underdrain Monitoring Results

The affect of each flushing operation is apparent in the southwest underdrain analytical results shown in Figure 1. In accordance with the approved CBR Evaporation Pond Onsite Inspection Program, daily underdrain level measurements and weekly analysis of the underdrain contents were performed. The weekly sample was analyzed for sodium, chloride, sulfate, alkalinity, and conductivity. Following the flushing operations on May 11 and July 31, significant decreases were noted in each parameter. Following each flushing and pumping operation, there was little increase in the concentrations of each parameter. In addition, the underdrain water level remained stable with no increase.

The southwest underdrain has been monitored for approximately two months since the last flushing operation. If a significant liner leak were present, it would be evident in an increase in the underdrain water level or in the concentrations of the monitored parameters (or both) and would be detected during an extended period.

Based on the monitoring results, CBR has confirmed that the exceedance of the action level was not due to a liner leak but was likely due to an abnormally low conductivity in the contents of the pond. During the summer months, the pond contents conductivity has returned to a normal level (approximately 85,400 $\mu\text{mhos/cm}$) with the southwest underdrain conductivity reduced to approximately 15 percent of this level through the flushing program. Therefore, the action level is no longer exceeded and there is no indication of a liner leak. CBR will discontinue daily underdrain level measurement and weekly analysis of the underdrain and will return the southwest underdrain in Pond 1 to normal monitoring status.
