# HSA

Historical Site Assessment

**HSA ID# 50**

OPERATIONS DEPARTMENT  
UNUSUAL OCCURRENCE REPORT (UOR)

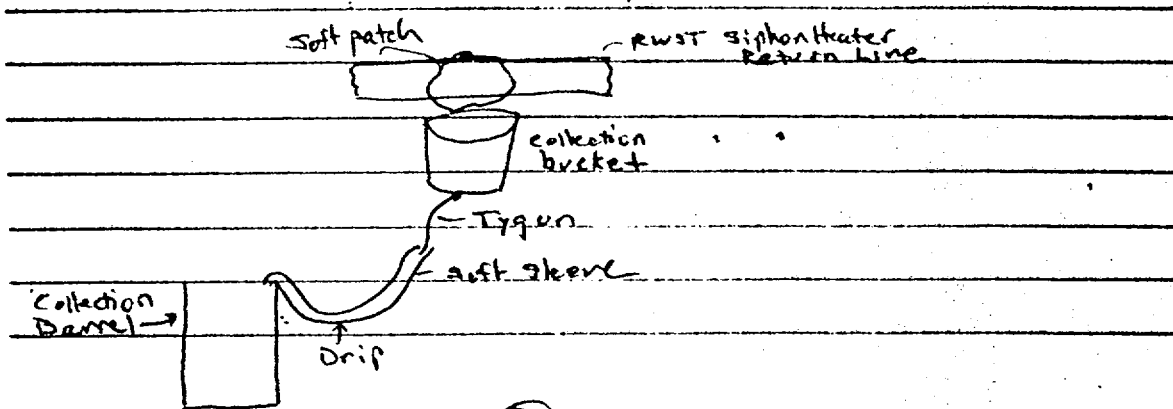
- 10/24/87 A leak was identified on the RWST Siphon Heater return line (ref UOR 159-87 attached). This leak was subsequently evaluated and patched. A drain bucket was placed under the patch to catch any further leakage and collect it in a barrel (see attached figure).

- 0830 4/26/88 The Secondary AO indentified a drip from the leak collection apparatus. The leak had created a 2-3 sq. ft. wet spot on the asphalt below. Not enough liquid had accumulated to flow to the storm drain. Radcon was notified and surveyed the area. The amount of leakage was insignificant and contained within a Radiologically Controlled Area.

- No offsite release occurred.
- The drip was due to a leak in the soft sleeving running from the bucket Tygon to the barrel. The leak was immediately stopped by replacing the soft sleeving with Tygon tubing (see Fig).

- The soft patch will be repumped on 4/27/88.
- Since there was no off site release, this event is not reportable.

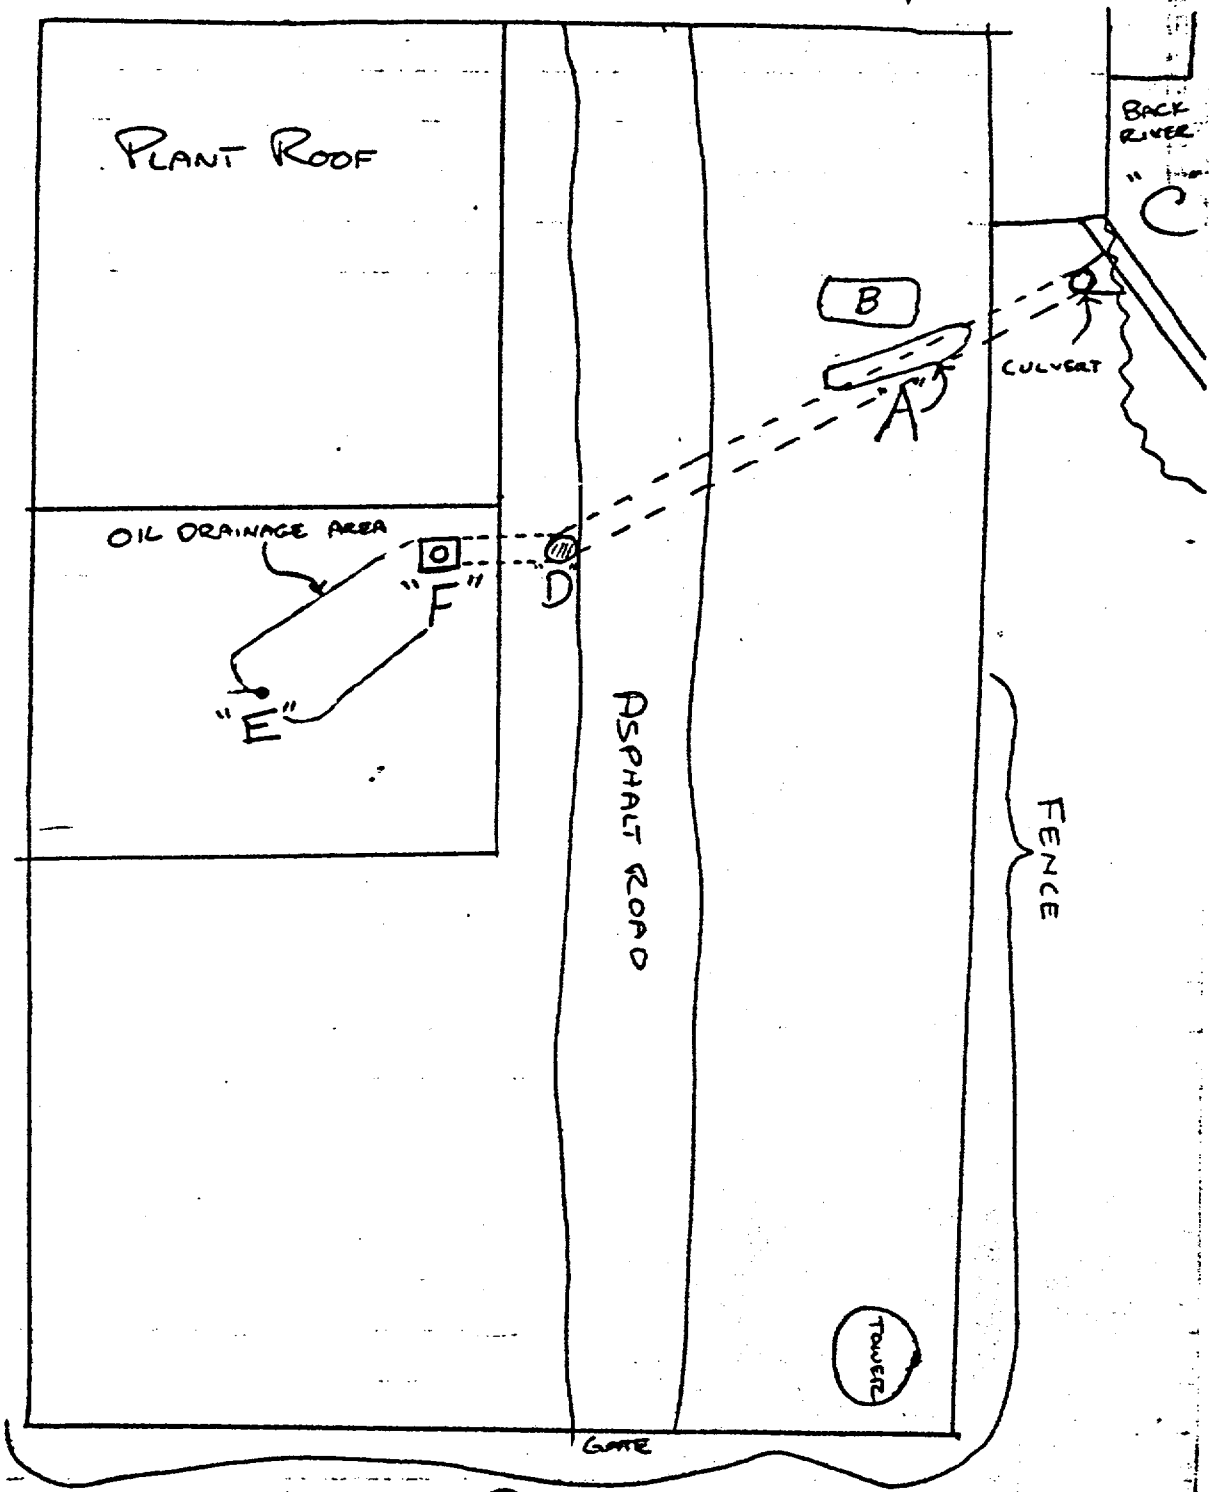
There is no rain forecast for tonight or tomorrow, so there will be no further oil release to the storm sewers via the roof drain. This will have to be cleaned up and the condition of the roof & the roof covering checked.

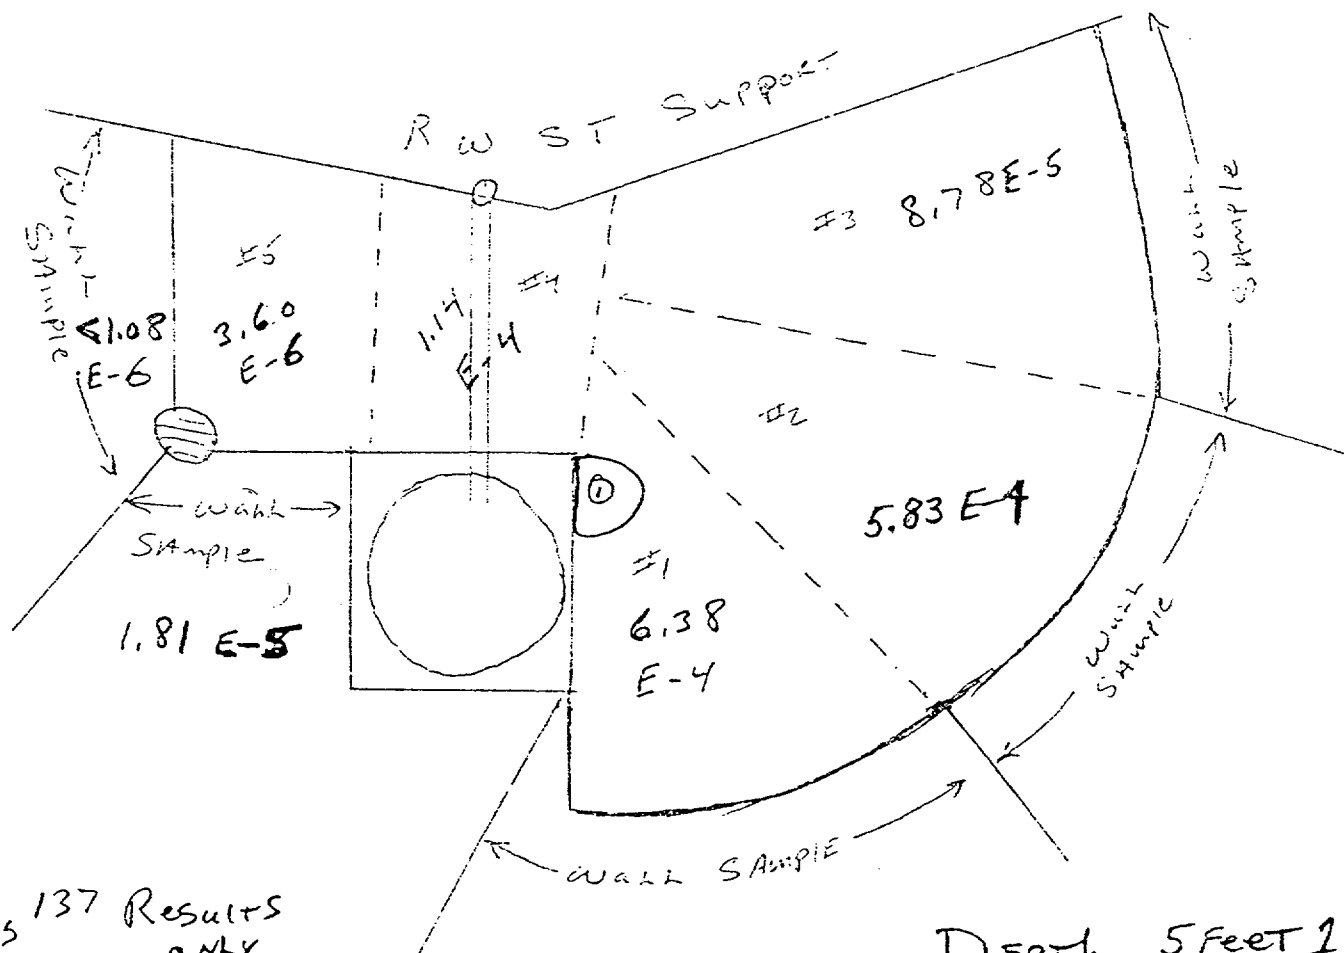
Area/Item RWST AREA

① ROCK SAMPLE LOCATION.  
 Depth ≈ 6' 50"  
 1.12 E-4

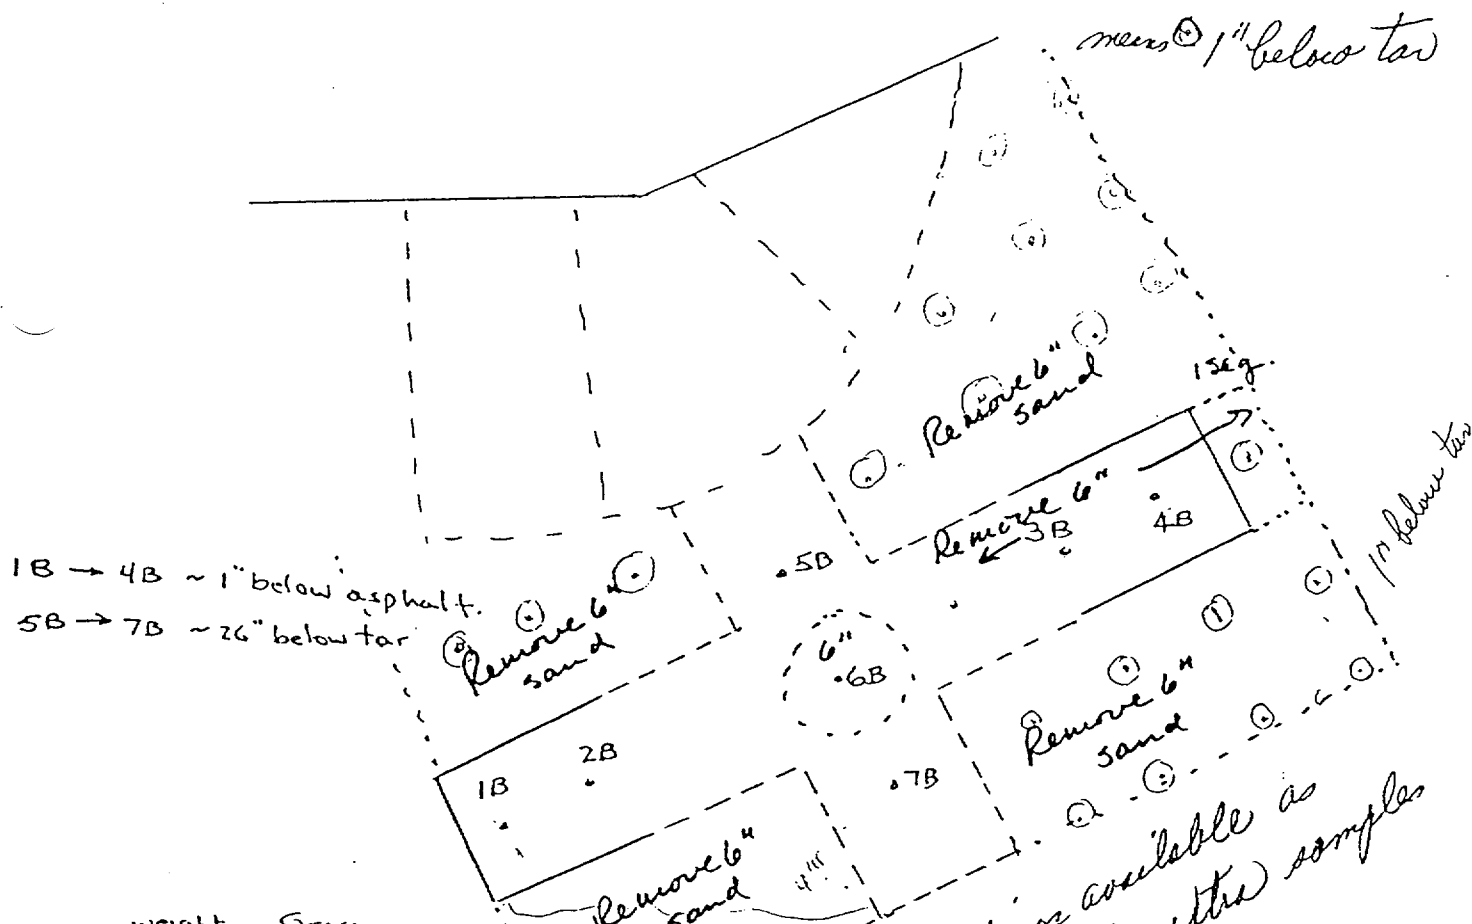
Area/Item RWST SAND SAMPLES

1B → 4B ~ 1" below asphalt.  
 5B → 7B ~ 26" below tar

weight in g.	Gross Activity in $\mu\text{Ci/g}$	CS-137
1B	649	1E-5	1E-5
2B	827	4.9E-6	4.9E-6
3	727	3E-6	3E-6
3	686	3E-5	3E-5
6	708	8.8E-6	8.8E-6
6B	690	5.5E-5	5E-5
7B	679	5E-6	5E-6

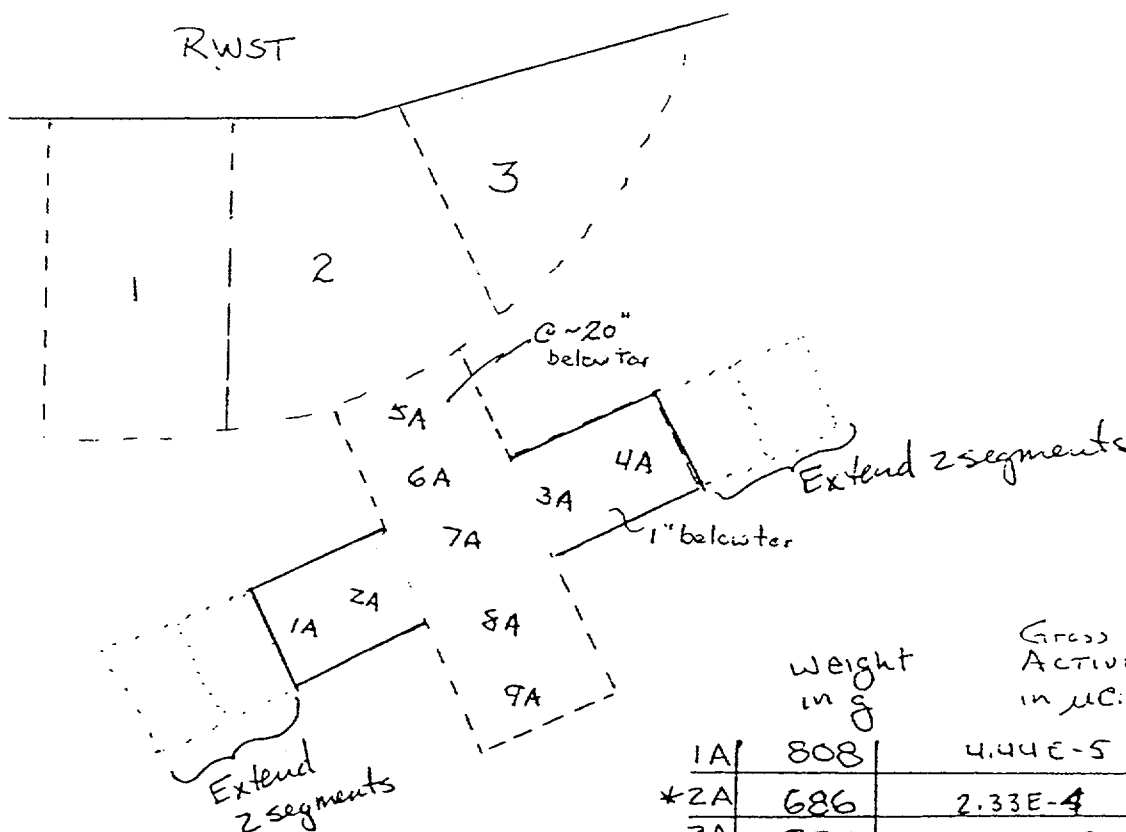
Weight in g	Gross Activity in $\mu\text{C}/\text{g}$ Cs-137
1A	808	$4.44\text{E-}5$ $3.7\text{E-}5$
*2A	686	$2.33\text{E-}4$ $2\text{E-}4$
3A	830	$9.40\text{E-}5$ $7.9\text{E-}5$
4A	733	$6.41\text{E-}5$ $6\text{E-}5$
5A	790	$2.5\text{E-}5$ $1.8\text{E-}5$
*6A	811	$1.69\text{E-}4$ $1.6\text{E-}4$
*7A	684	$9.6\text{E-}5$ $9\text{E-}5$
*8A	797	$2.6\text{E-}5$ $2.6\text{E-}5$
9A	841	$4.9\text{E-}6$ $4.9\text{E-}6$

Remove 6", resample

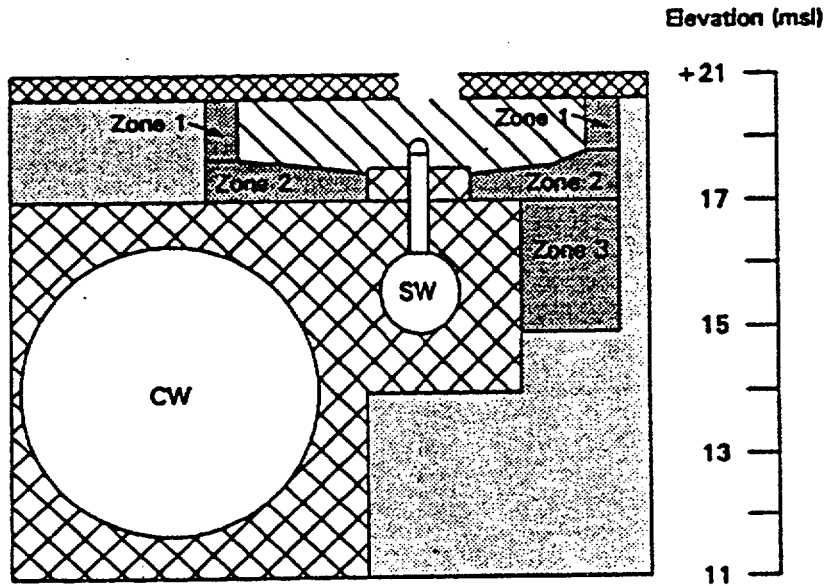
Figure 3.

Estimate of Affected Zone Extent
