**HSA ID# 25**

RADIOLOGICAL INCIDENT REPORT

LOCATION: RWST SIPHON HEATER AREA

MAINE YANKEE ATOMIC POWER COMPANY  
GENERAL SURVEY FORM

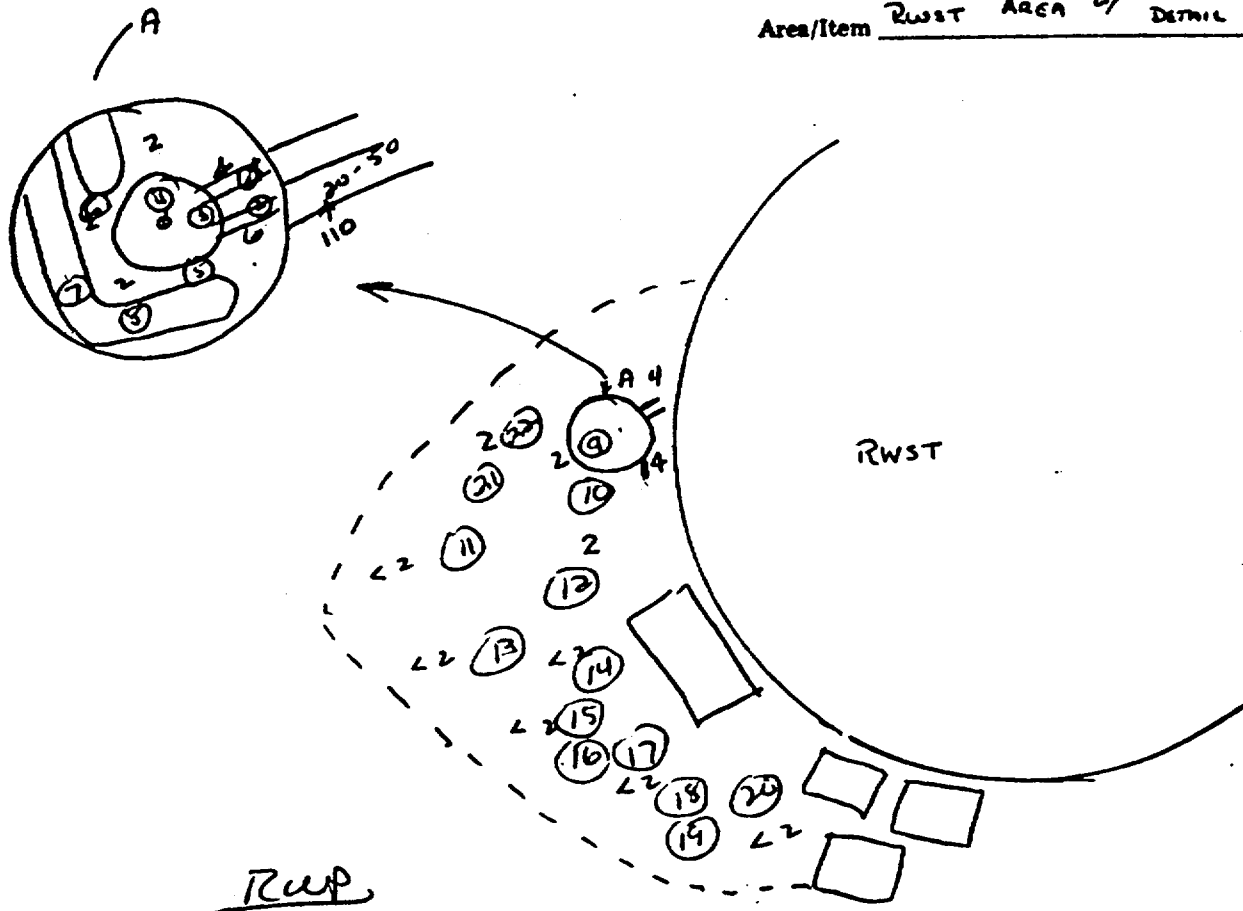
Area/Item RWST AREA 4 SIGNATURE OMR

Notified by Bill Deppmeyer that RWST water was leaking on the ground and running into the storm drain. Affected area was roped off and posted with applicable clothing requirements for entry.

1. WBC & urine bioassay for the RC Tech & A.D. involved.
2. Cleanup/decon of outside area.
3. Chem analysis of release (9.74E-2 Ci; H-3 major isotope).
4. Notifications made via NSE as necessary. (UOR 17-87)
5. The area of the spill was decontaminated and sealed to prevent further release of radioactive materials.

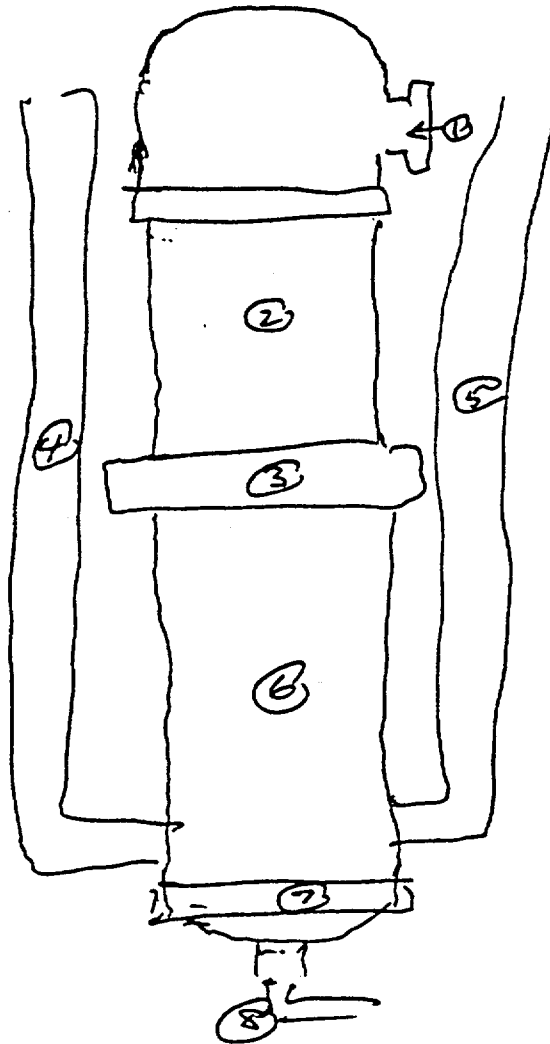
Area/Item A - Bus - Syphon  
Heater

Multiple personnel contaminations occurred when the BWST-A siphon header leaked and overflowed the header well. The apparent cause of the event was releasing the area (depositing) as free of contamination based on an inadequate survey. The survey for surface contamination was taken on a snow/ice surface.

Represents internals  
of heater

- 1 - 55.6 K
- 2 - 1800 dpm
- 3 - 4197 -
- 4 - 1015 -
- 5 - 1535 -
- 6 - 2412 -
- 7 - 8298 -
- 8 - 20.6 K

1. Review what constitutes adequate surveys for area release with Techs. (Resp. P.C. Sups)
2. Decon the contaminated area. (Resp. decon)
3. Address recommendations/findings of the HPES evaluation. (Resp. Indl by n)

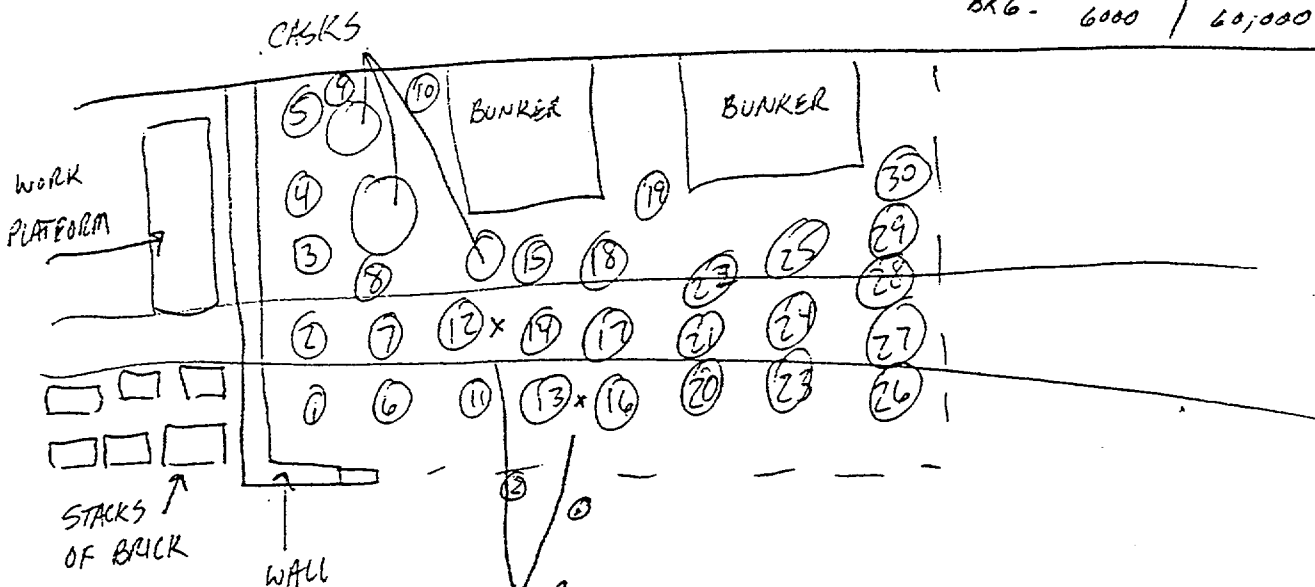
WESC. WALL  
Area/Item \_\_\_\_\_  
LUDLUM MODEL 3  
SN 60769 / 60781  
EFF. 10% / 10%  
BKG. 6000 / 60,000 CPM

AREA DIRECT FRISKED WITH  
LUDLUM MODEL 3 WITH  
BACKGROUND VARIATION FROM  
6000 CPM TO 40000 CPM.

POSSIBLE HOT PARTICLES

- ① 25,000 cpm BKG, 60,000 cpm ON X
- ② 20,000 cpm BKG, 45,000 ON X

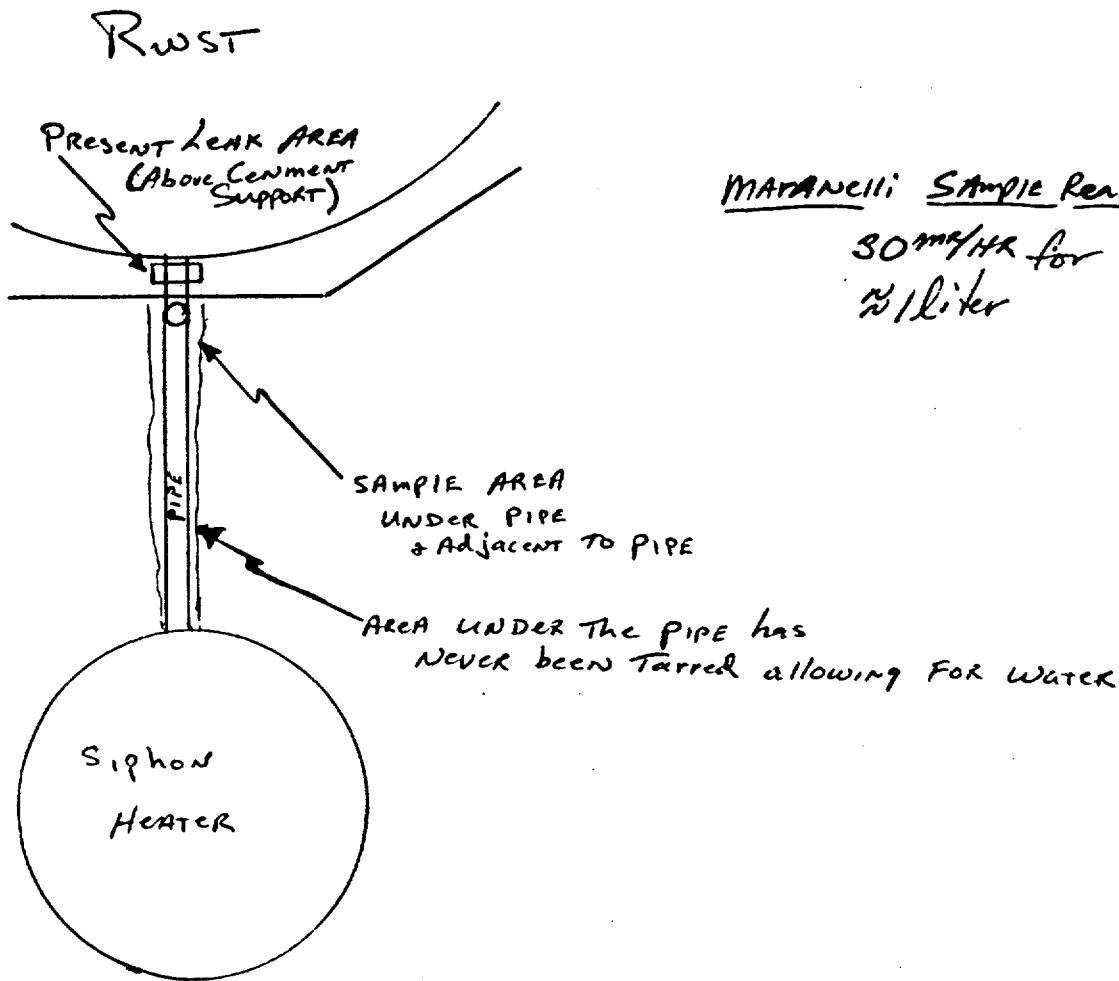
Area/Item RWST Siphon Heater

MARANELLI SAMPLE READ  
30 MR/HR for  
25 liter

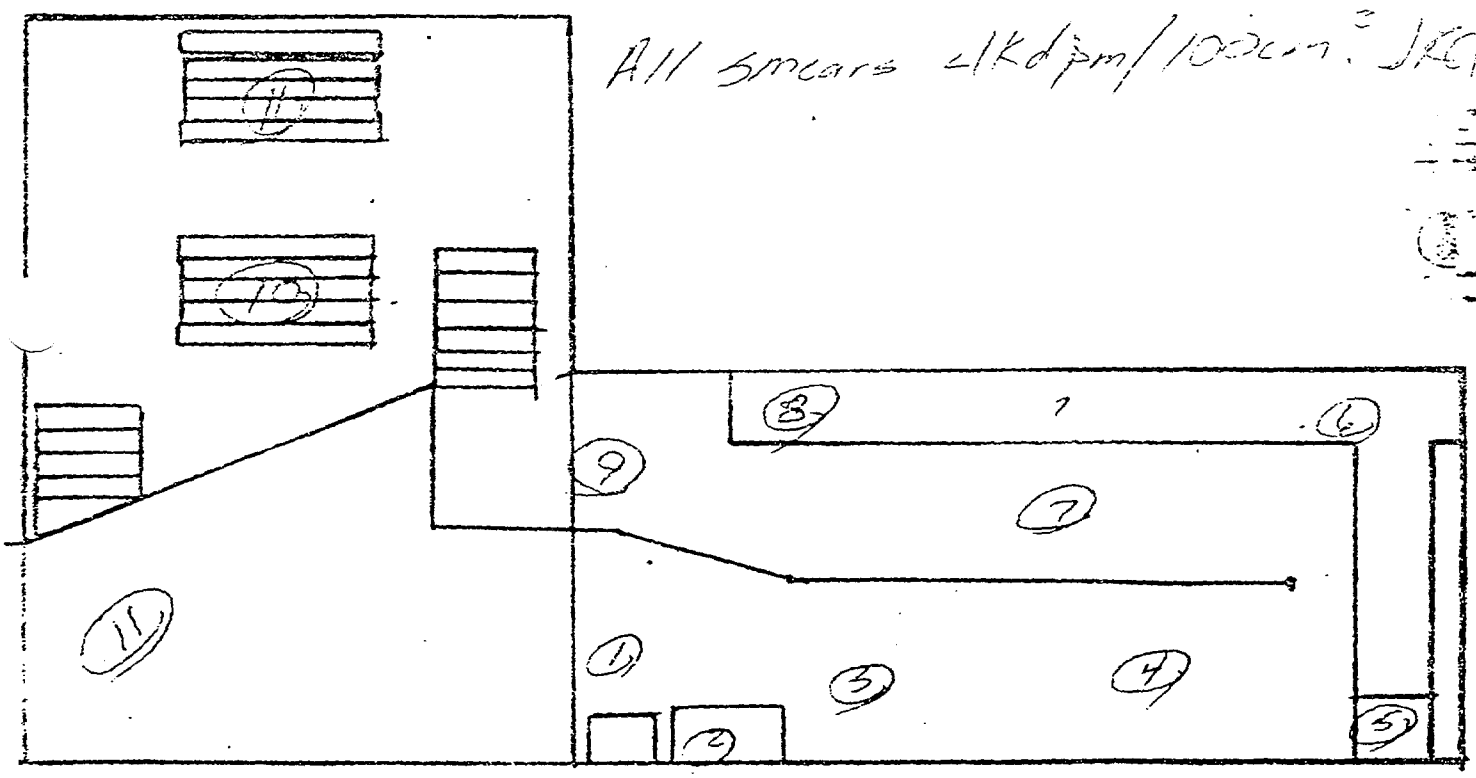
Area/Room DOALIT TRAILER

All smears  $< 1\text{Kdpm}/100\text{cm}^2$  JRA

Passive swipe of floor, found  $10\text{Kdpm}/100\text{cm}^2$   
 chip on map - Recommended thorough decon. JRA  
 Direct frisk following showed  
 $< 1\text{Kdpm}/100\text{cm}^2$  JRA

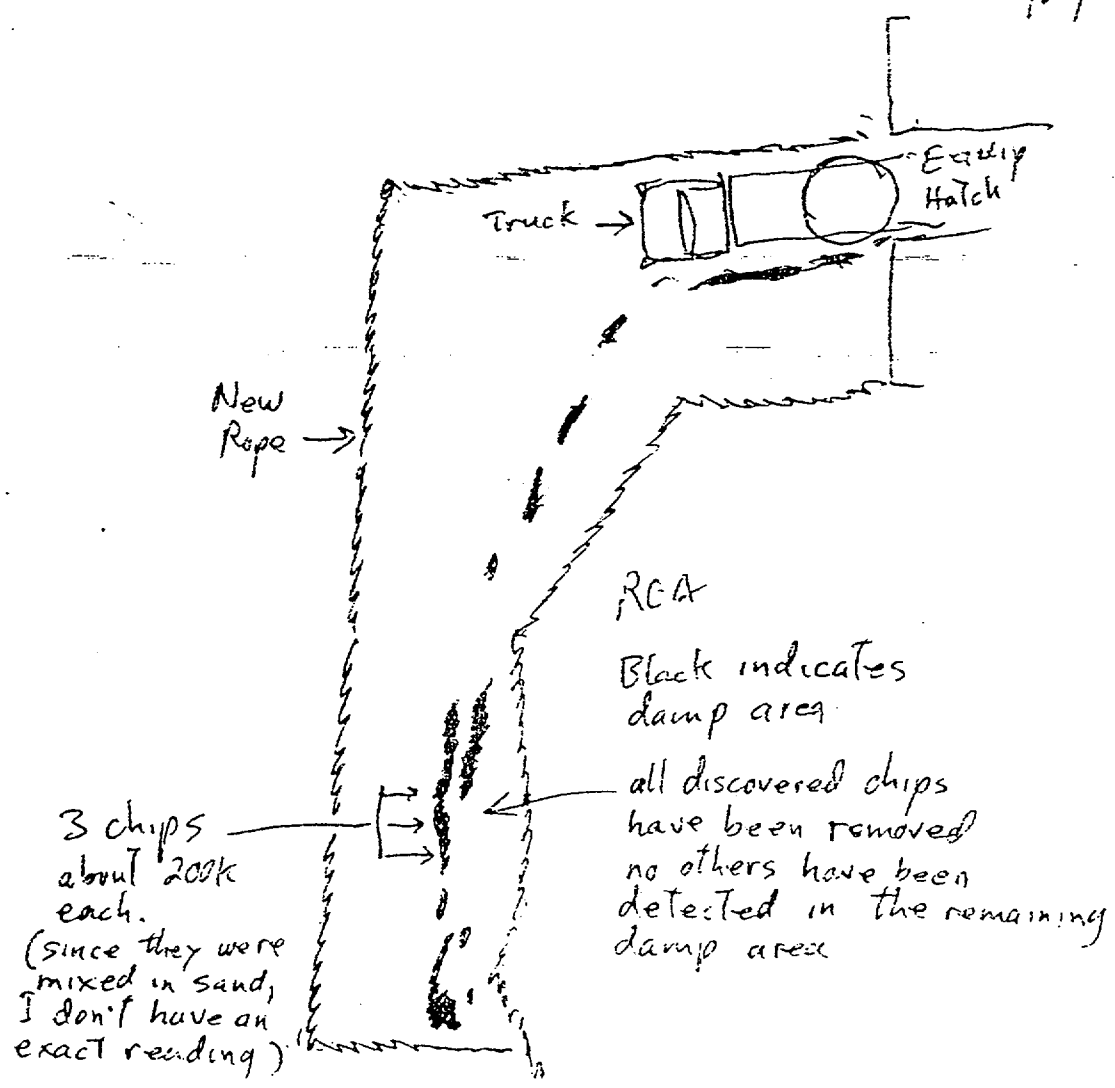
Area/Item Yard Vic. Equip Hatch

Damp area where water dripped from core barrel shield while it was moved to Equip Hatch

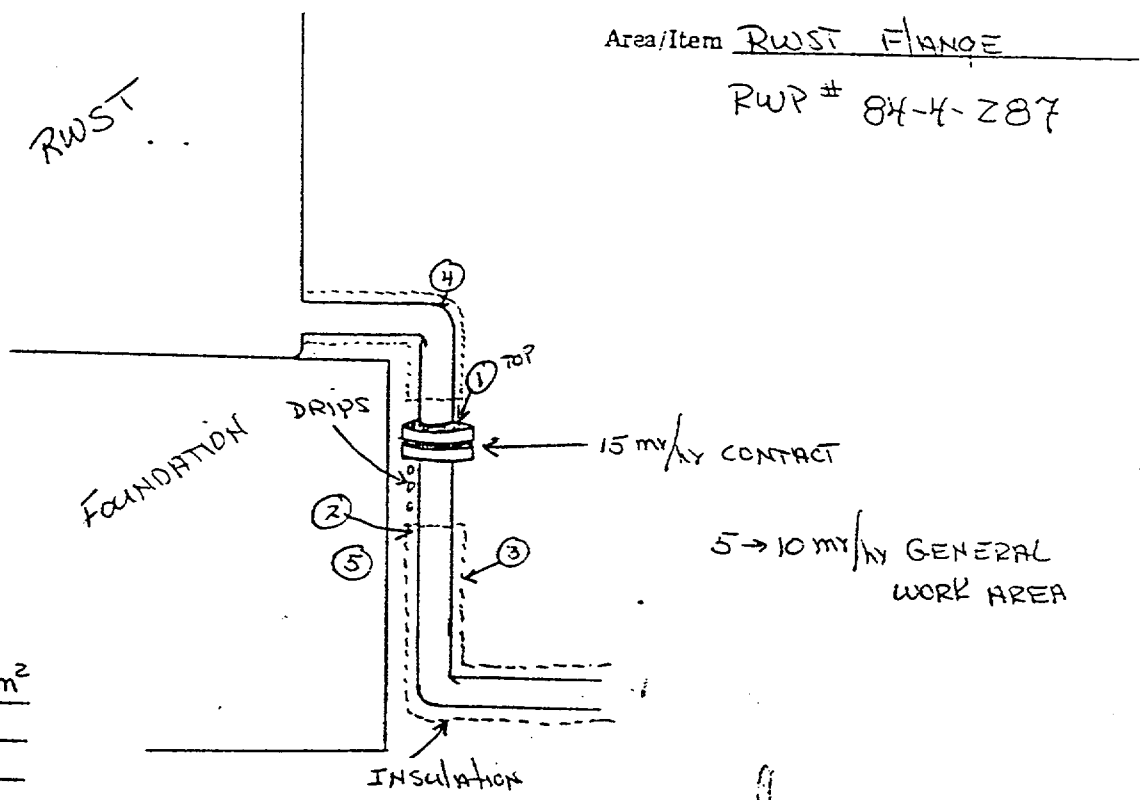
SMEAR No. #	DPM/100cm <sup>2</sup>
1	5000
2	200,000
3	50,000
4	1000
5	1500

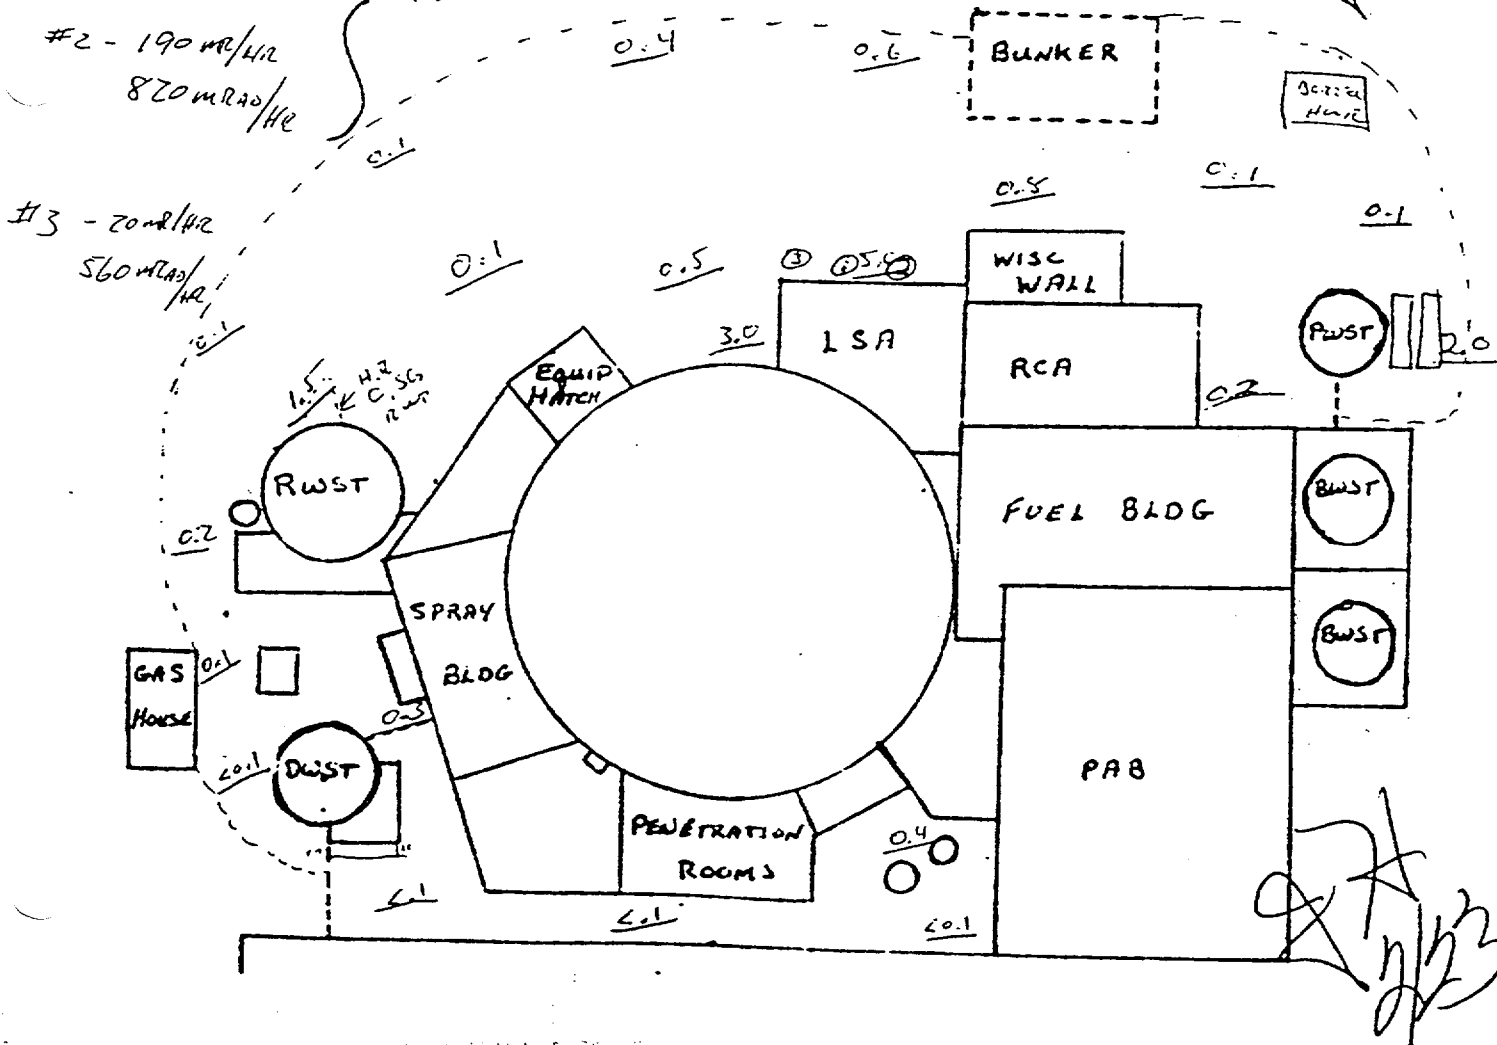
ISO'd - both pure Co-60

1. Recover 3<sup>rd</sup> chip.
2. Look for more
3. Thoroughly vacuum LSA Bldg. Move containers, wipe bottoms of panels, etc.

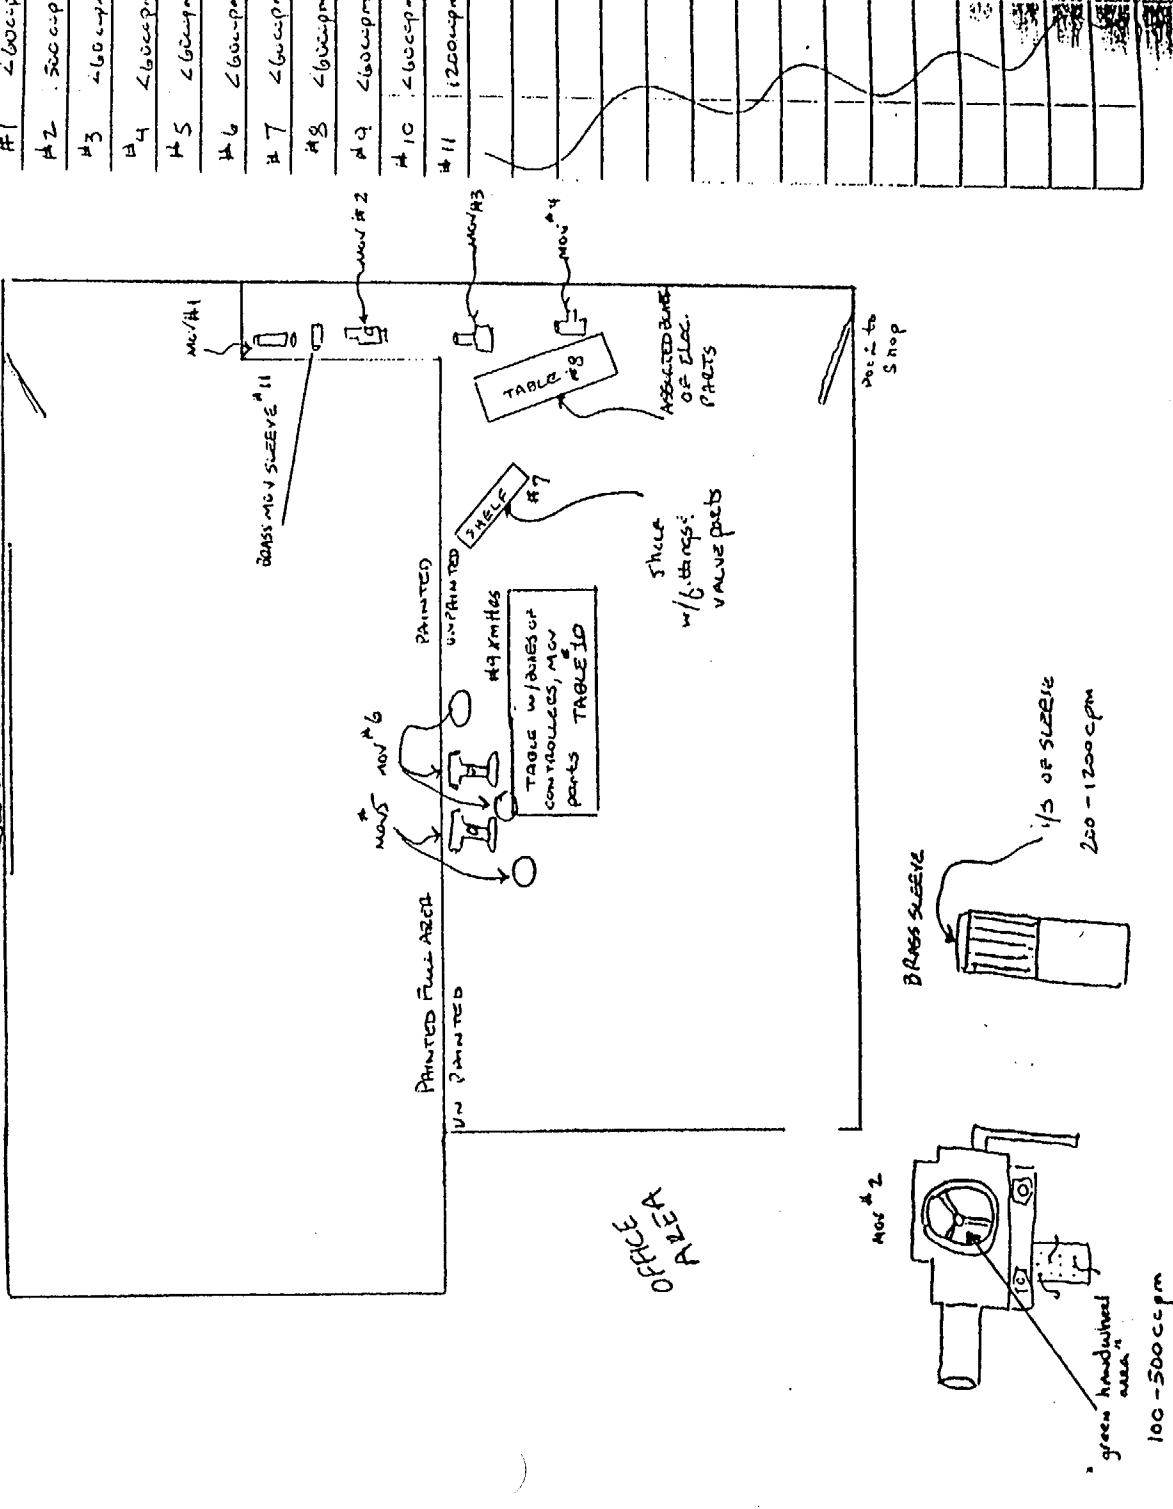
Caution: Tagged items #2/#11 and notified Mark Neudinger; locked door & exit

Contamination Sample Results	Rate
#1	< 600cpm
#2	500ccpm
#3	< 600cpm
#4	< 600cpm
#5	< 600cpm
#6	< 600cpm
#7	< 600cpm
#8	< 600cpm
#9	< 600cpm
#10	< 600cpm
#11	1200cpm
