HSA ID# 78

OPERATIONS DEPARTMENT  
UNUSUAL OCCURRENCE REPORT (UOR)

- A. TITLE OF UOR: SCAT TANK LEAK IN LINE TO LT 3201
- B. DATE/TIME OF EVENT: 9/19/90 1700
- C. DATE/TIME UOR COMPLETED: 9/19/90 2000

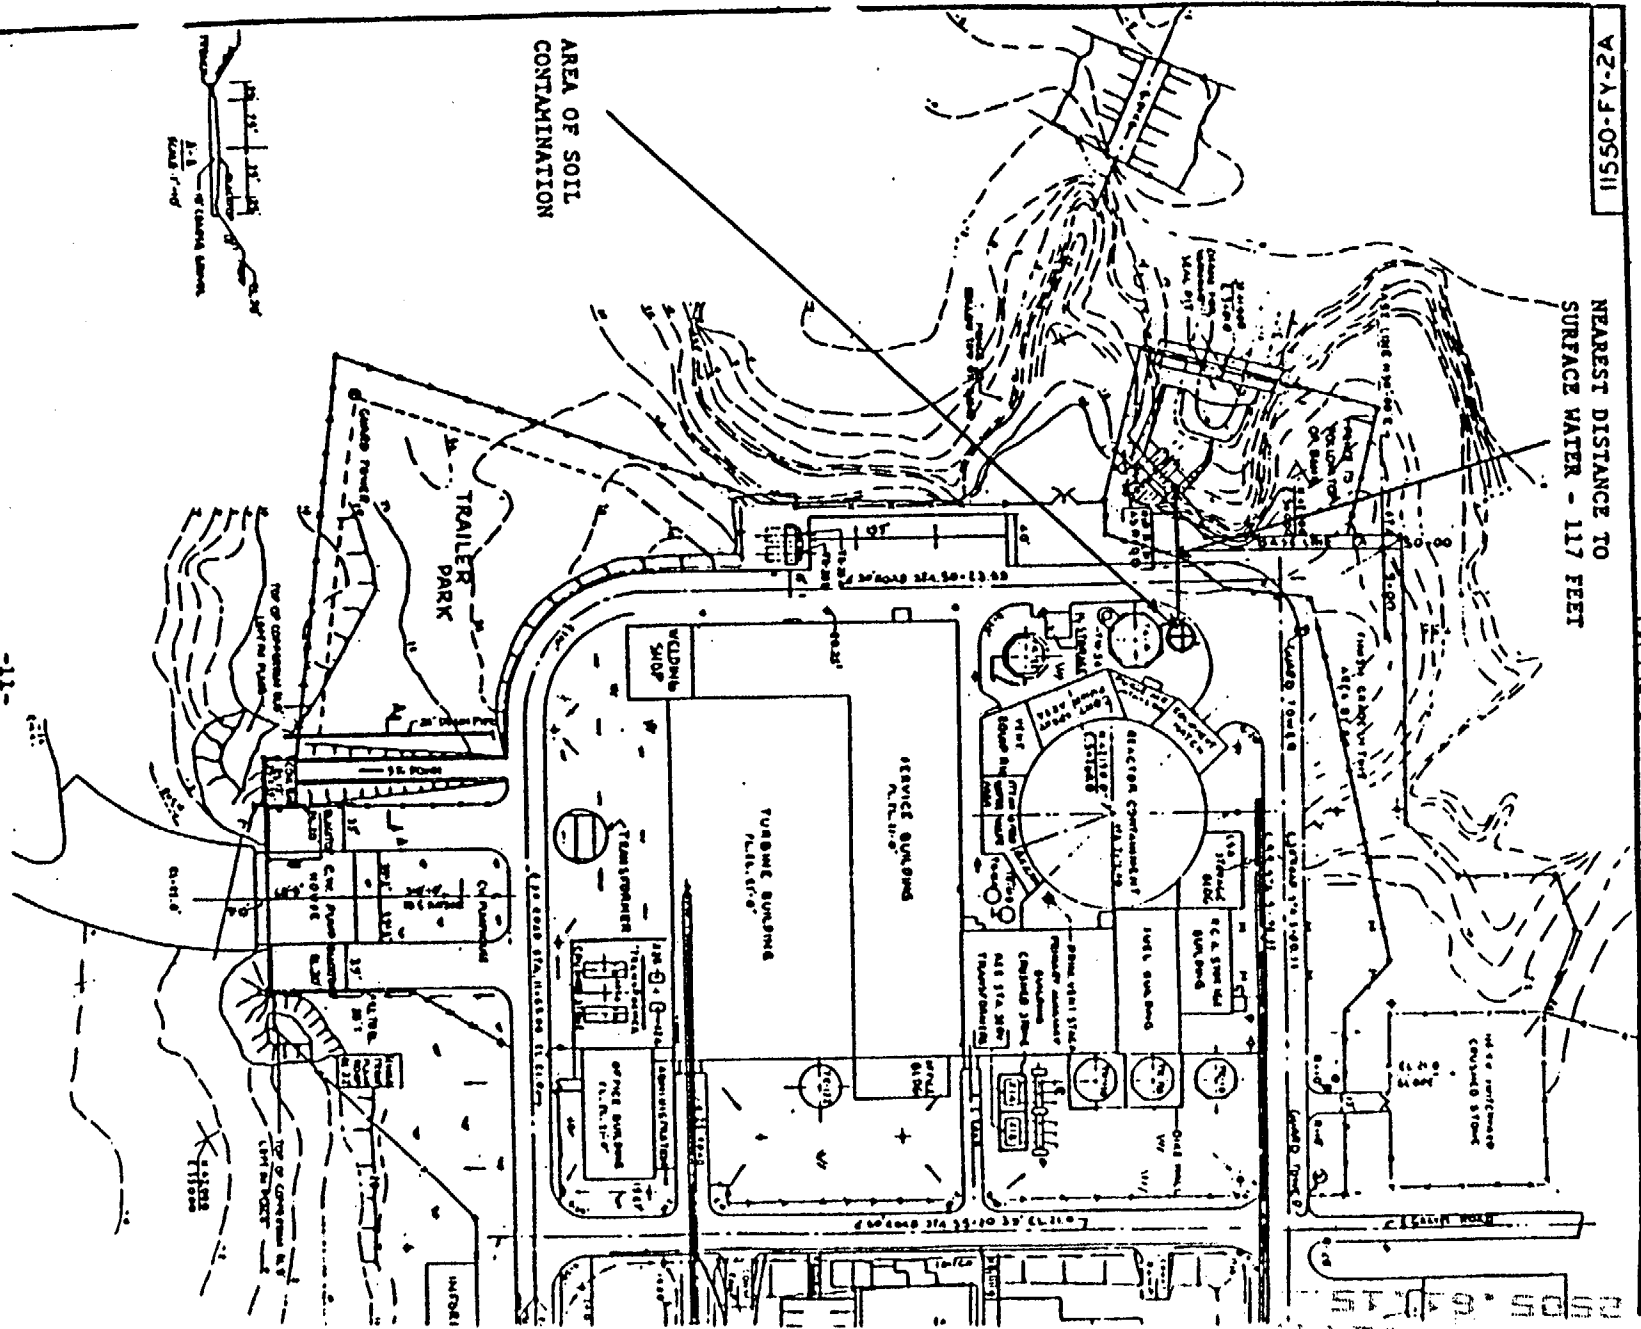
FIGURE 1

The flow of groundwater in the vicinity of the RWST is towards the surrounding adjacent tidal waters. There are no potable groundwater wells in the vicinity of the RWST which could be contaminated as a result of the RWST related leaks.

NEAREST DISTANCE TO  
SURFACE WATER - 117 FEET

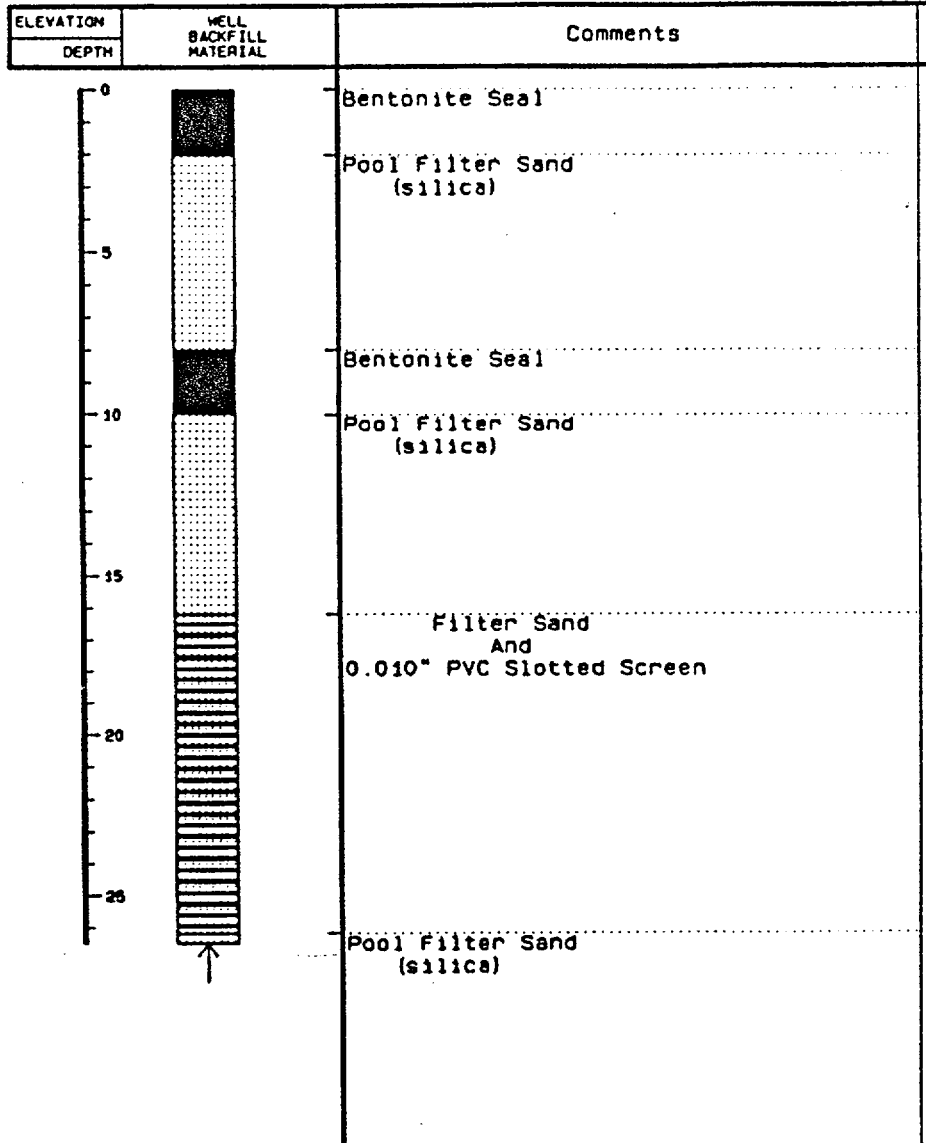
Figure 4

A 2" PVC well was installed and a road box utilized as protective casing.
