HSA

Historical Site Assessment

MYAPC

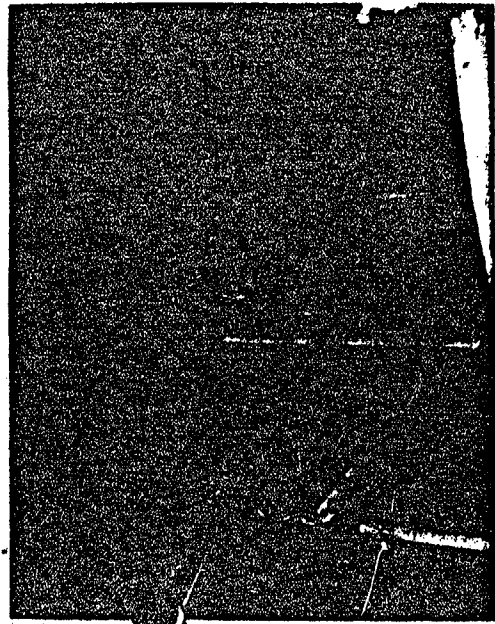
Access to pit below E-3A
-6 ft elevation

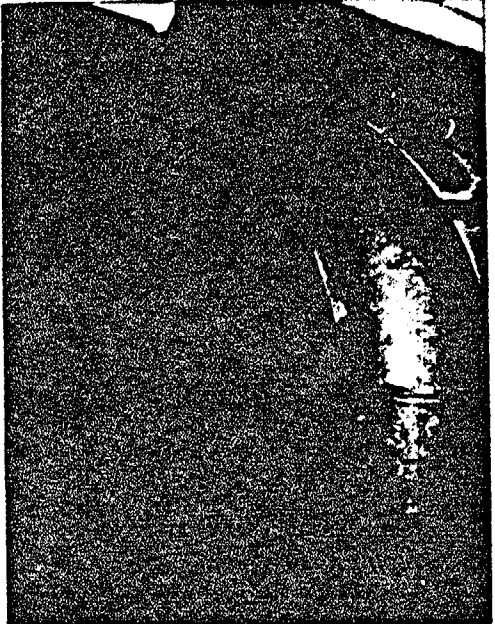
Pit below E-3A
-11 ft elevation

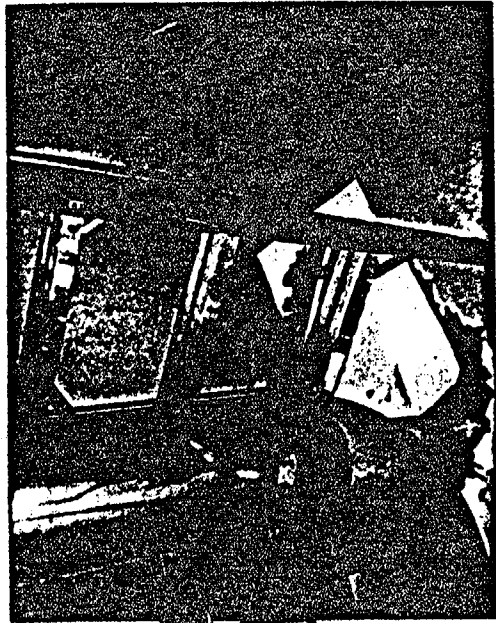
Northwest Corner
By E-3A
-6 ft elevation

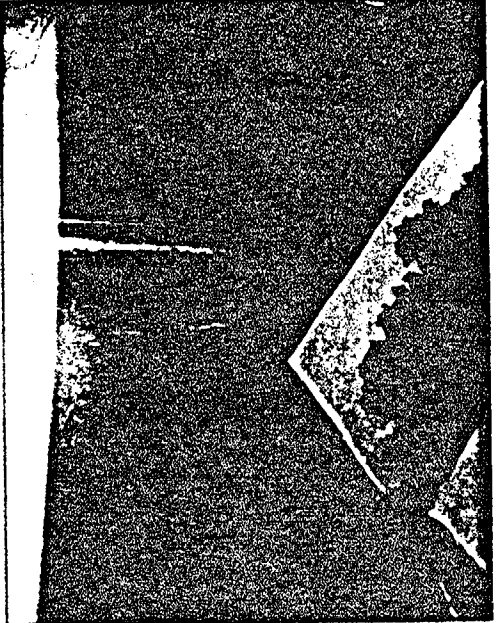
Close-up of NW
corner by E-3A
-6 ft elevation

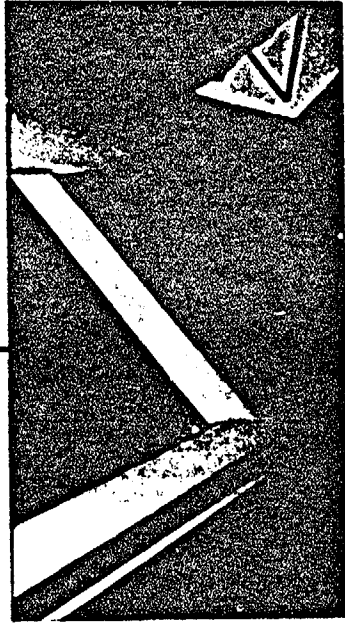
Pit below E-3A
-11 ft elev

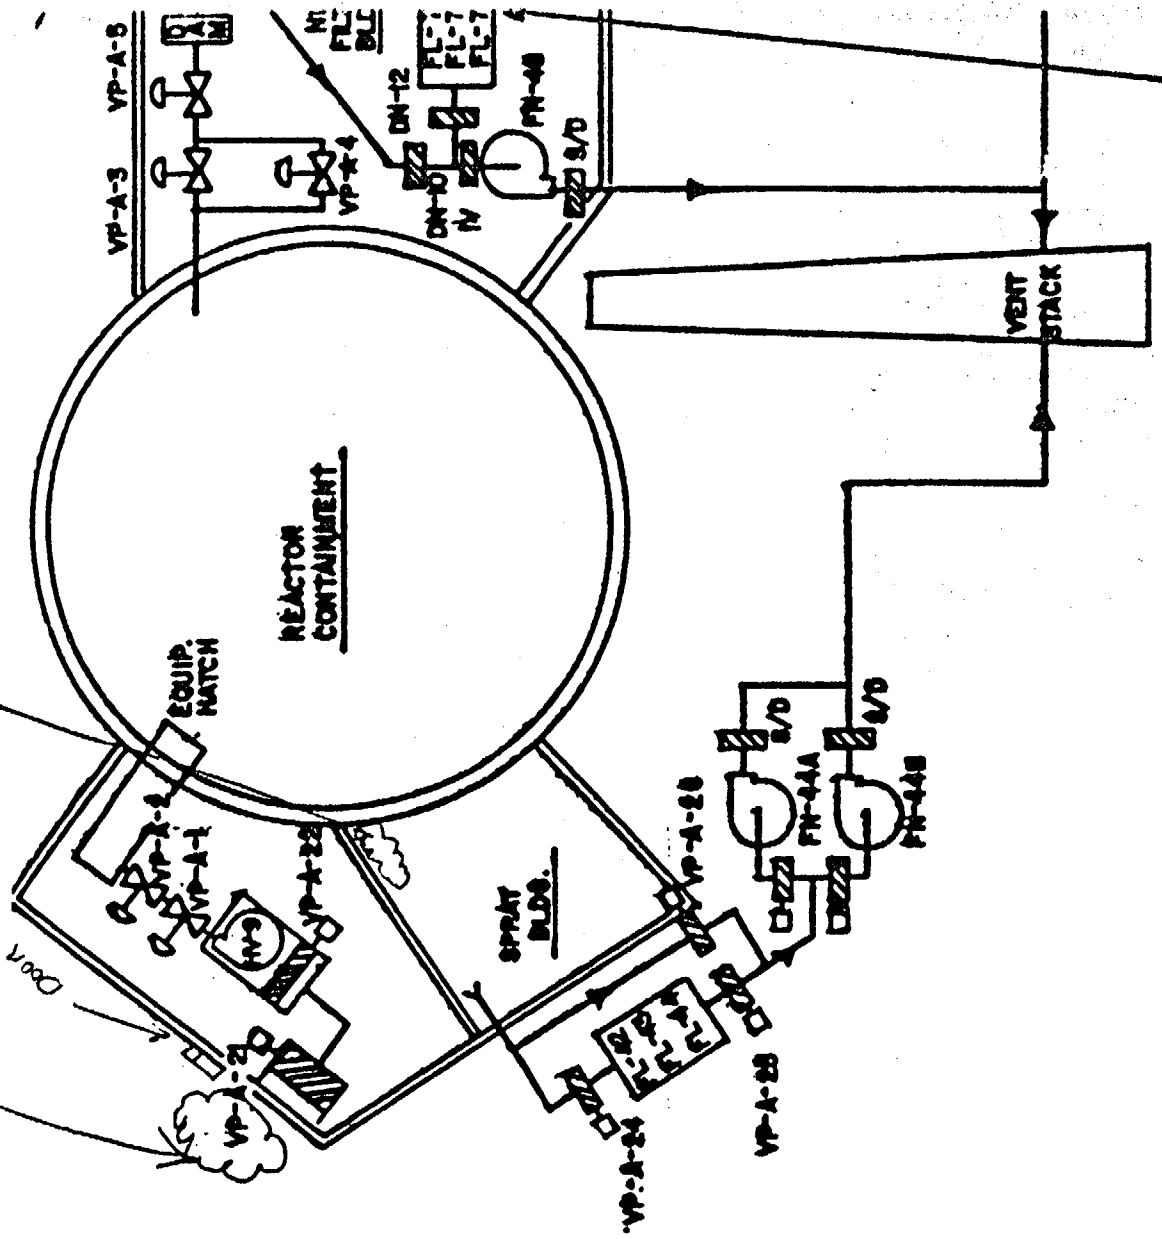
AREA OF F.O. LEAK
 AREA OF INGRESS
 LOWER SPRAY BUILDING

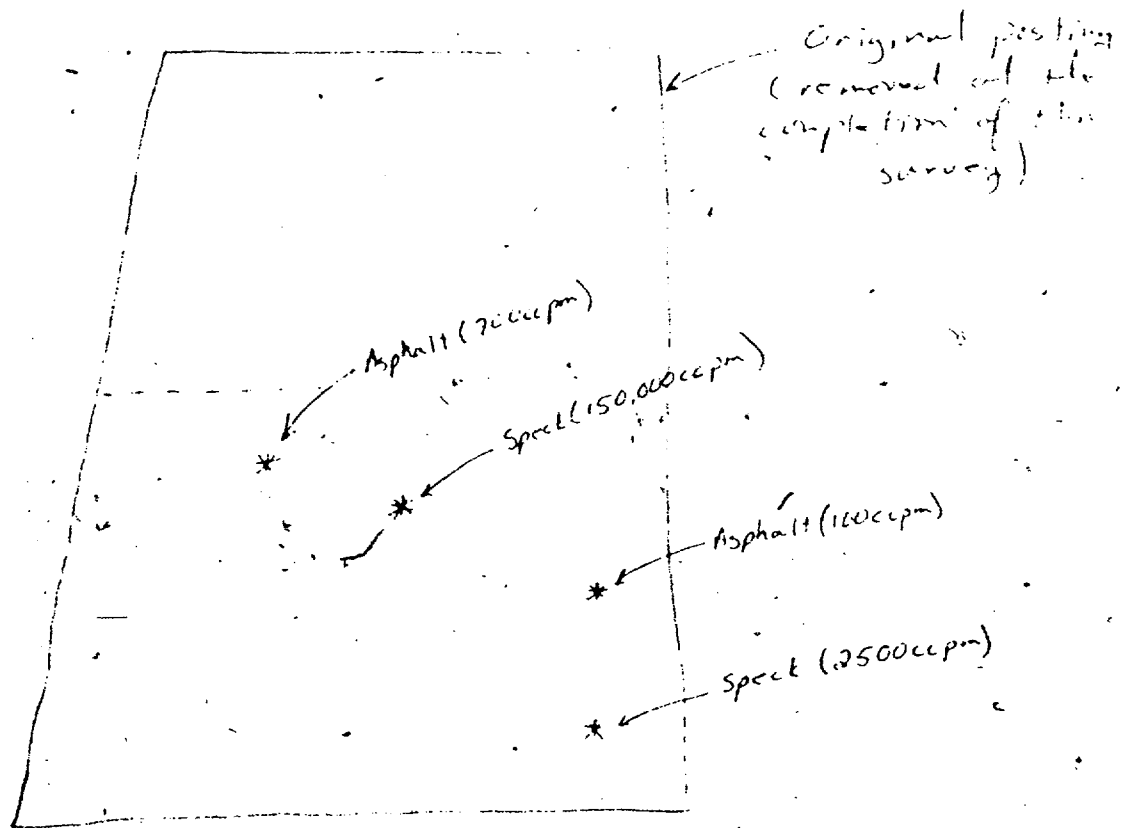
Area/Item Burley Point sand

Area from the dotted line down was direct frisked (100% of area).
~~Contaminated asphalt and specks were removed and the immediate areas~~
 were < 100cpm. The entire area was < 100cpm.

* Speck (100,000cpm)
