MEMORANDUM

YANKEE ATOMIC - BOLTON

To	P.L. Anderson	Date	June 24, 1994
From	E.R. Cumming	Group #	REG 121/94
Subject	RESULTS OF MAY 1994 CLAM AND SEDIMENT SAMPLING	W.O.#	
		I.M.S.#	
		File #	REG121.94

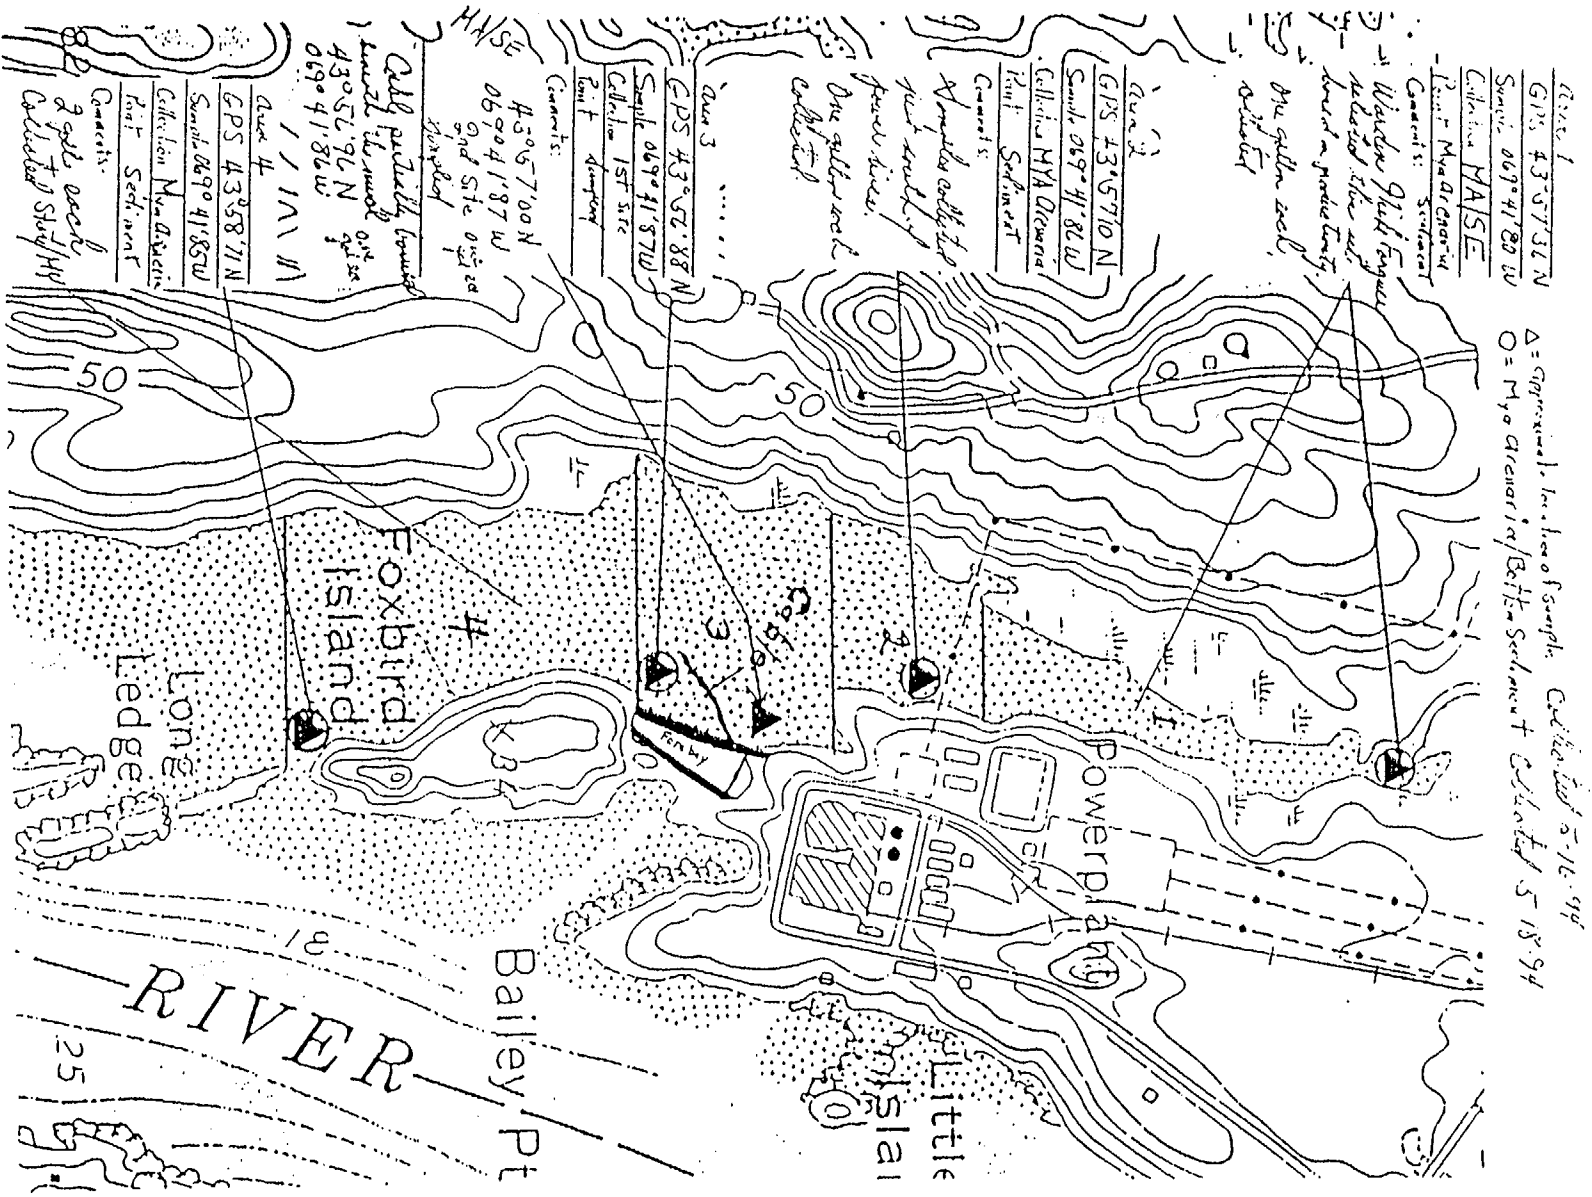
Samples of soft-shell clam (*Mya arenaria*) were collected from four locations in Bailey Cove on May 16, 1994, and from two control locations (in Harpswell and Damariscotta) on May 19, 1994. (See Figure 1, provided by R. O'Clair, for the locations of the four areas sampled for clams.) The body portions were analyzed by gamma spectroscopy at the Yankee Environmental

Sediment core samples were collected from three sites within Bailey Cove on May 18, 1994. (See Figure 1 for the locations of the three areas sampled for sediment.) The core samples were segmented into 5-cm increments, dried and analyzed by gamma spectroscopy at the YAEL.
