**Pacific Gas and
Electric Company**

PG&E Letter DCL-01-099

Diablo Canyon Units 1 and 2
Licensee Event Report 1-2001-002-00
System Actuation: Unplanned Diesel Start Due to Loss of Startup Power

TITLE (4)
System Actuation Unplanned Diesel Start Due to Loss of Startup Power

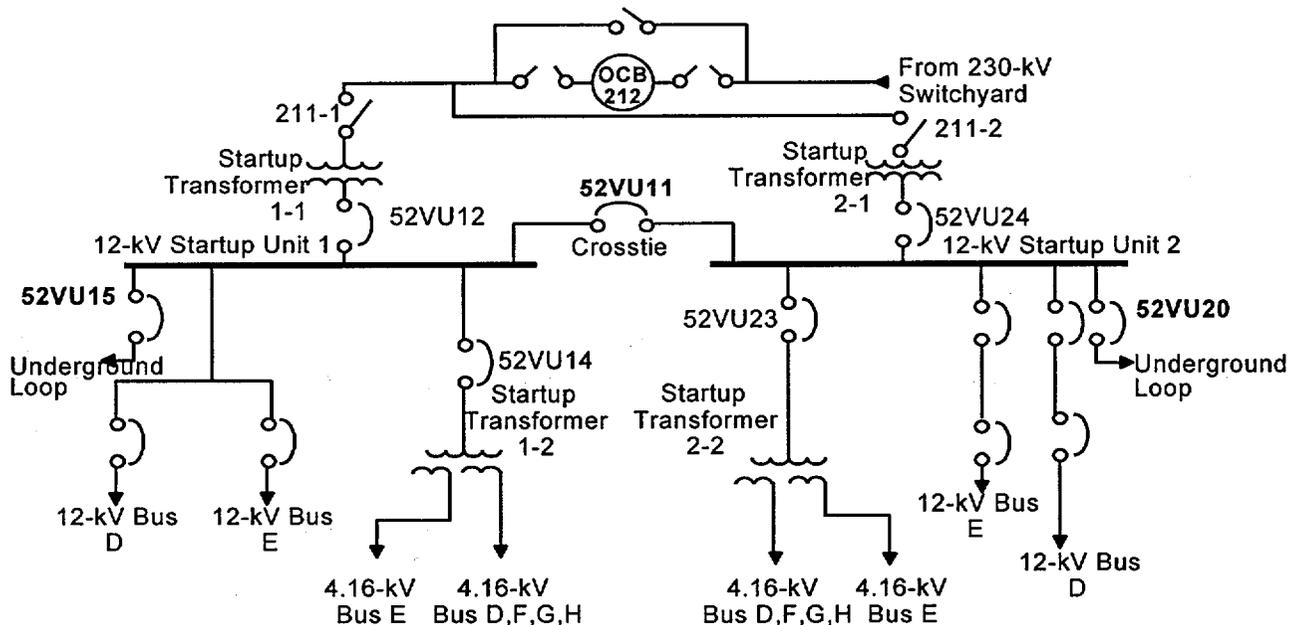
Figure 1: Startup Power Diagram

Oil Circuit Breakers (OCB) are used in the 230kV switchyard to connect and disconnect the 230kV system from the plant. The 230kV system provides power through OCB 212 to Startup Transformers (SUT) 1-1 and 2-1 (230kV to 12kV) [EA][XFMR]. SUTs 1-1 and 2-1 then distribute power to the Unit 1 and Unit 2 Startup Buses, respectively. The Unit 1 and Unit 2 Startup Buses then feed SUT 1-2 and SUT 2-2 (12kV to 4160 V) [EA][XFMR], respectively. SUTs 1-2 and 2-2 can then supply power to each unit's 4160 V vital and nonvital buses. Figure 1 provides additional detail of the startup power system.
