C1001-08

Donald C. Cook Nuclear Plant Units 1 and 2
REVISED RESPONSE TO
NUCLEAR REGULATORY COMMISSION (NRC) BULLETIN 2001-01:
CIRCUMFERENTIAL CRACKING OF REACTOR PRESSURE VESSEL
HEAD PENETRATION NOZZLES
(TAC numbers MB2624 and MB2625)

ATTACHMENT 1 TO C1001-08

NUCLEAR REGULATORY COMMISSION (NRC) BULLETIN 2001-01:
CIRCUMFERENTIAL CRACKING
OF REACTOR PRESSURE VESSEL HEAD PENETRATION

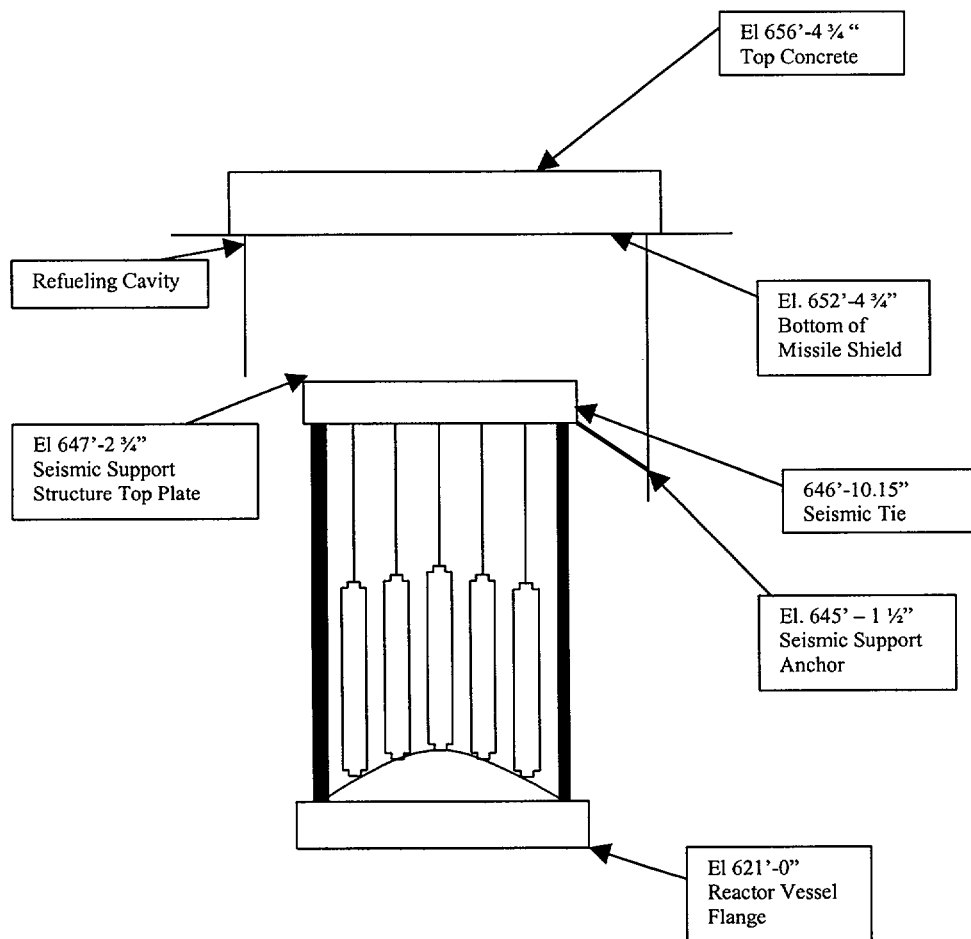
Encircling the reactor head and extending approximately 90 inches is the shroud. This shroud provides the ducting for the head ventilation system. The air is fed into the shroud by external ductwork, which is attached to the shroud. Outside the shroud is a radiation shield that extends approximately 8 feet up from the reactor head. This shield reduces the radiation dose of the workers during refueling preparations.

The following sketch provides the relative elevation of the various components.
