C1001-08

Donald C. Cook Nuclear Plant Units 1 and 2
REVISED RESPONSE TO
NUCLEAR REGULATORY COMMISSION (NRC) BULLETIN 2001-01:
CIRCUMFERENTIAL CRACKING OF REACTOR PRESSURE VESSEL
HEAD PENETRATION NOZZLES
(TAC numbers MB2624 and MB2625)

ATTACHMENT 1 TO C1001-08

NUCLEAR REGULATORY COMMISSION (NRC) BULLETIN 2001-01:
CIRCUMFERENTIAL CRACKING
OF REACTOR PRESSURE VESSEL HEAD PENETRATION

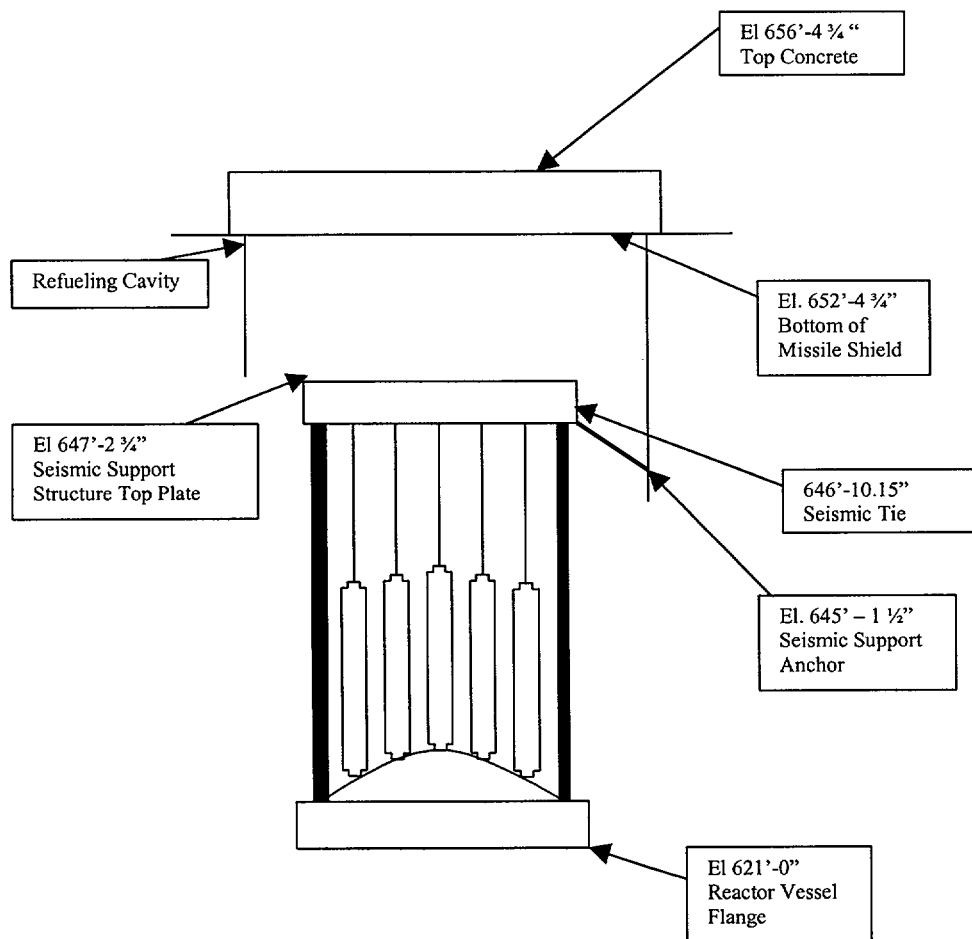
The missile shield is a set of removable concrete structures that also act as the divider barrier between the upper and lower containment. These blocks are approximately 5 feet above the seismic support structure. They are 4 feet thick and are made of reinforced concrete. Their design function is to divide the upper containment from the lower containment. This divider barrier forces the Loss-of-Coolant-Accident steam through the ice condenser. The blocks are also designed to resist a missile from a rod ejection event.

The seismic support structure is located approximately 25 feet above the reactor vessel flange. It provides lateral stability for the CRDM housings as well as access for the interconnecting cables.

Encircling the reactor head and extending approximately 90 inches is the shroud. This shroud provides the ducting for the head ventilation system. The air is fed into the shroud by external ductwork, which is attached to the shroud. Outside the shroud is a radiation shield that extends approximately 8 feet up from the reactor head. This shield reduces the radiation dose of the workers during refueling preparations.

The following sketch provides the relative elevation of the various components.
