Donald C. Cook Nuclear Plant Units 1 and 2
REVISED RESPONSE TO
NUCLEAR REGULATORY COMMISSION (NRC) BULLETIN 2001-01:
CIRCUMFERENTIAL CRACKING OF REACTOR PRESSURE VESSEL
HEAD PENETRATION NOZZLES
(TAC numbers MB2624 and MB2625)

ATTACHMENT 1 TO C1001-08

NUCLEAR REGULATORY COMMISSION (NRC) BULLETIN 2001-01:
CIRCUMFERENTIAL CRACKING
OF REACTOR PRESSURE VESSEL HEAD PENETRATION

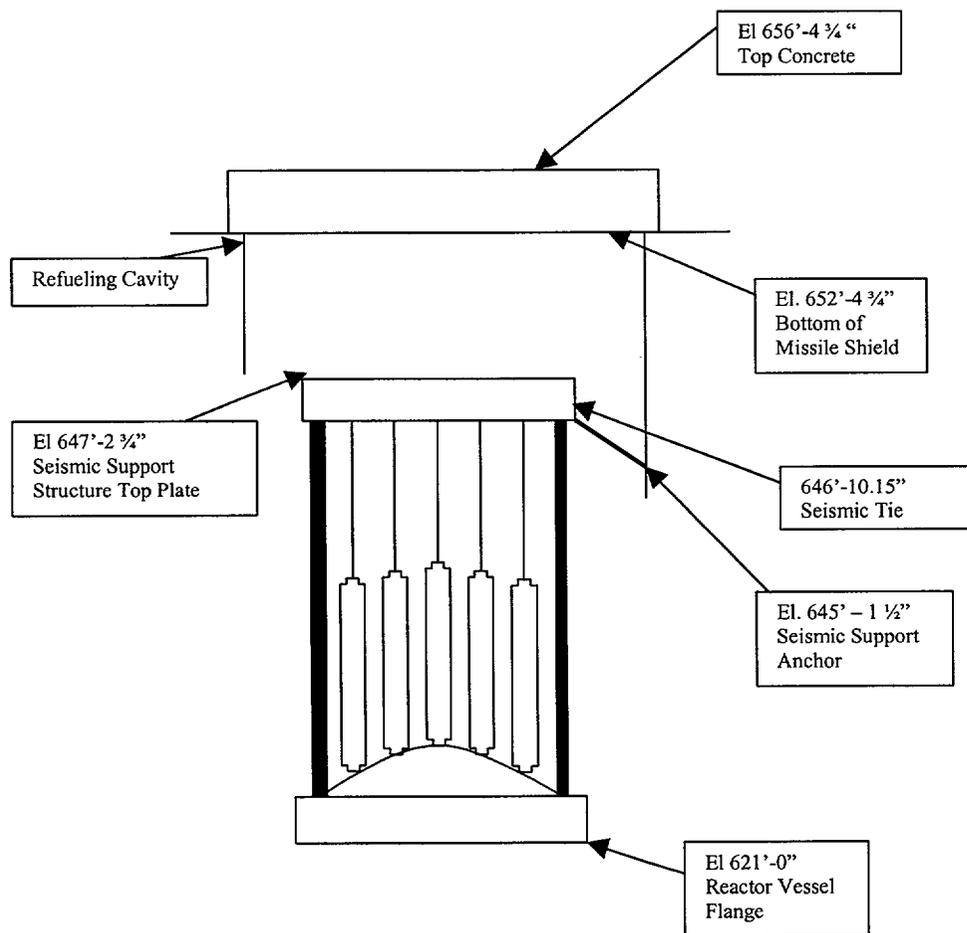
The following sketch provides the relative elevation of the various components.
