TRIP REPORT

SUBJECT: Trip Report for Busted Butte Rock Sampling and Observations of PTn on West Flank of Yucca Mountain (20.01402.861)

DATE/PLACE: May 22-23, 2000
Yucca Mountain, Nevada

AUTHORS: R. Fedors and J. Evans

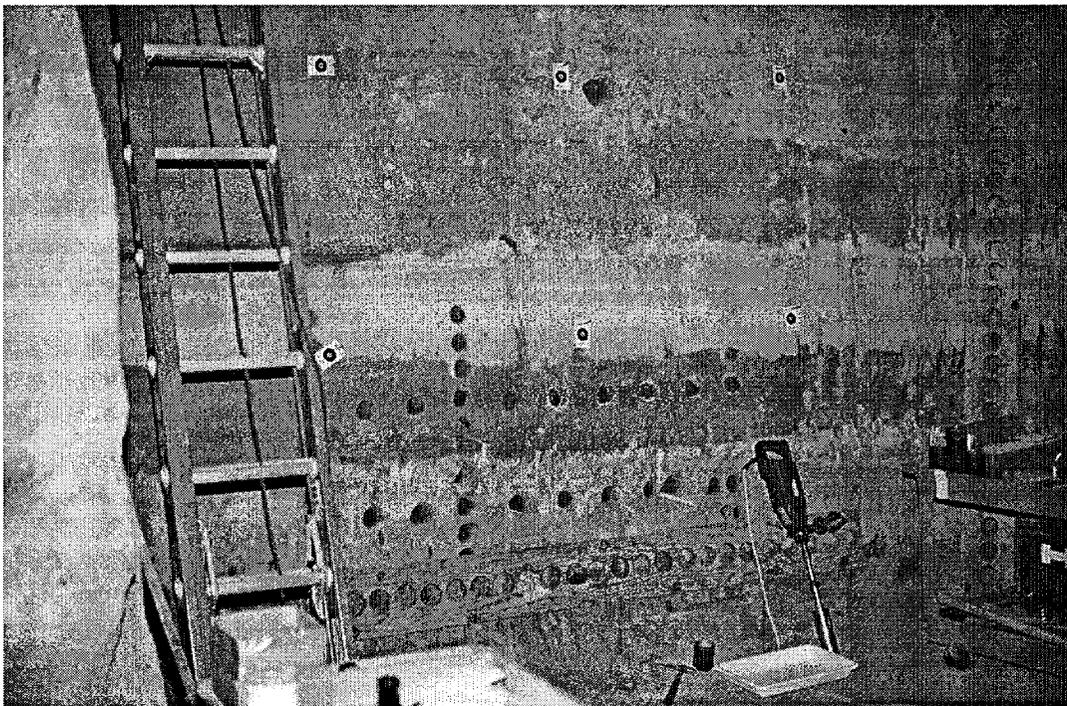
During the week of May 21–25, 2001, Los Alamos National Laboratory (LANL) and YM project (YMP) staff were analyzing the 4th mineback face and obtaining samples from the injection/collection area (figure 1). Each face is scraped by a front-end loader to a depth of about 30–40 cm. The tuff is extremely friable when dry. A soil coring device was used to collect samples (figure 2). Project scientists also used an ultraviolet light to observe the pattern of fluorescent tracers migrating through the rock below injection boreholes. The walls of the mineback area were wetted with a high-pH solution to bring the fluorescent tracers to the surface of the wall; ventilation in the Busted Butte facility rapidly dries out the rock. LANL staff assumes that the 20–30 cm core sampling depth is significantly beyond the drying front of the scraped faces.

Figure 2. Photograph of 4th face of mineback in Phase 2 test and power core sampler at the Busted Butte facility. Horizontal banding in the lower portion of the photograph is due to wetness variations caused by the recent removal of wood template used for core sampling.

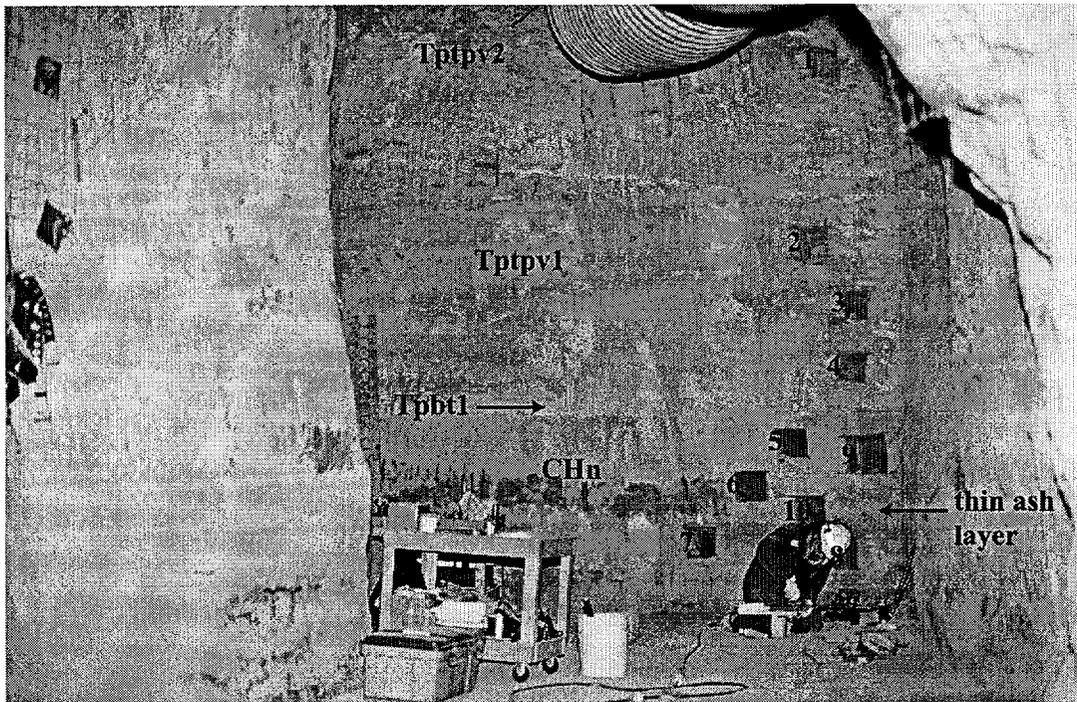
Four sample blocks (#1-4 of figure 3) were obtained from the basal Topopah Spring vitric tuff (Ttpv2, Ttpv1), which grades from partially welded to nonwelded as the CHn contact is approached. A thin (12–15 cm) horizon of bedded tuff separates the Ttpv1 from the CHn. Four sample blocks (#5-8 of figure 3) were obtained from the CHn, both above and below a thin (10–12 cm) indurated ash layer. Plugs will be cut from the blocks for geochemical and hydrological characterization before and after experiments to alter the vitric material to zeolites. Two blocks (#9-10 of figure 3) were obtained for thin section observation of fault features, such as solution features or mechanical grain deformation, by James Evans of USU. Block 10 includes the indurated ash layer within the CHn.

Figure 3. Sample locations 1-10 from Busted Butte mineback wall (see figure 1). The labeled units are the basal nonwelded Topopah Springs vitric (Tptpv2 and Tptpv1) and bedded (Tpbt1) tuffs and the Calico Hills tuff (CHn).

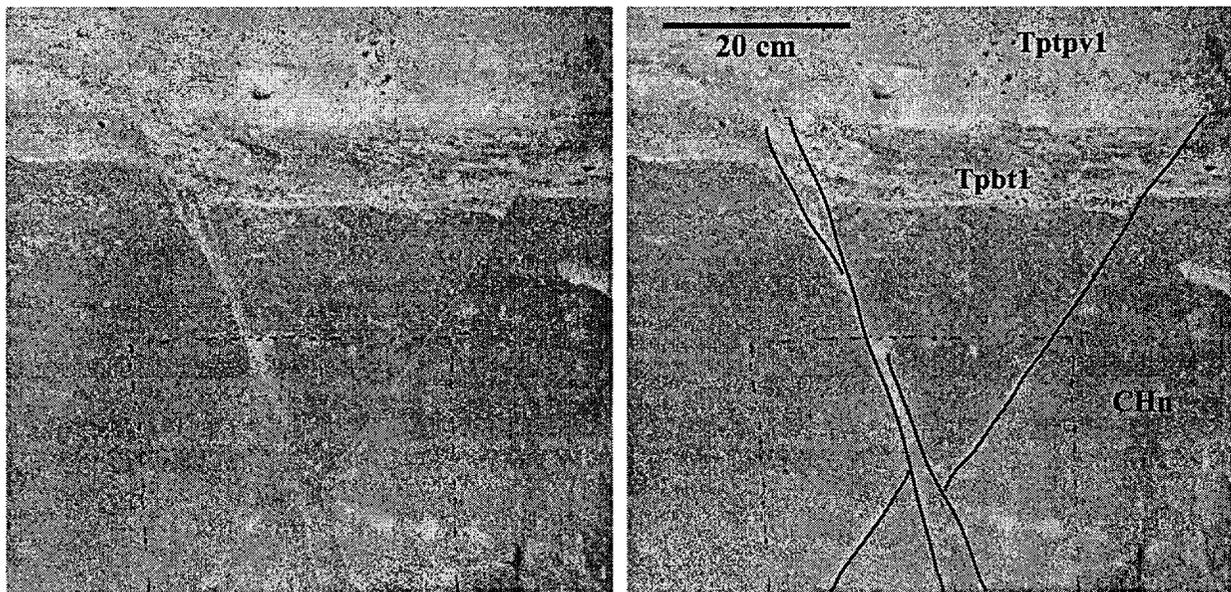
Mined-out walls enabled observation of several small faults on an east-west striking face (figure 4) and a north-south access wall. The small faults in the excavation are normal faults with several centimeters of slip. They are marked by a distinct lighter color that appears as thin, white planar zones. The whiter color may be caused by leaching along preferential flowpaths along the discontinuities. The faults appear to have mutually cross-cutting relationships and have several centimeters of slip where they cross the primary layering of bedded tuff and ash layers. Block samples collected from the wall appear to dry out quickly, leaving a moist trace along the fault surfaces. This suggests the small faults are able to retain moisture more readily than the matrix, likely due to the finer grain size associated with grain crushing on the fault plane. Because of the physics of UZ flow, the finer grain size along the fault would be associated with enhanced flux at the low percolation rates estimated for YM.

Figure 4. Cross-cutting faults near the contact between the basal nonwelded Topopah Springs vitric (Tptpv1) and bedded (Tpbt1) tuff and the Calico Hills tuff (CHn). Faults are highlighted on righthand side photograph. Part of sample block 9 outline (see figure 3) is shown in photograph.

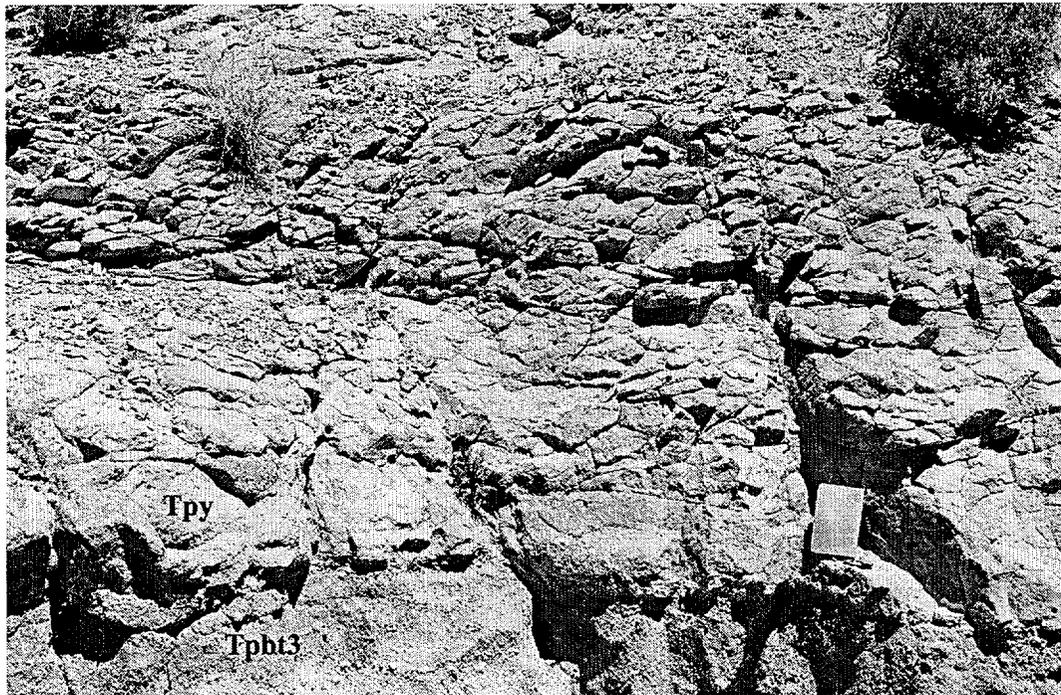
Fracture characteristics of the units are highly variable vertically in the sequence. As noted by Sweetkind et al. (1995, 1996), the more densely welded units exhibit the highest density of fractures. Uppermost in the sequence of exposures, the vitrophyre at the base of the Tiva Canyon and the Yucca Tuff vary in degree of welding from moderate to partial. The term "partially welded" is used by Moyer et al. (1995) and is intended to describe a degree of welding between nonwelded and moderately welded. Abundant vertical fractures are present in the Tpcpv2, Tpcpv1, and Tpy units. A small outcrop of the nonwelded bedded Tpbt4, which fits the light-colored, pumice-supported fallout description in Moyer et al. (1995) was only noted at the second site. The Tpy unit is massive with near-vertical fracture density variable in the range of 3-10 fractures/m (figure 5). There is a sharp contact with the Tpbt3 underlying the Tpy.

Figure 5. Yucca Tuff (Tpy) contact with Pre-Yucca bedded tuff (Tpbt3). Note the extent of fracturing in the partially welded Tpy. The field notebook is 19 cm tall.

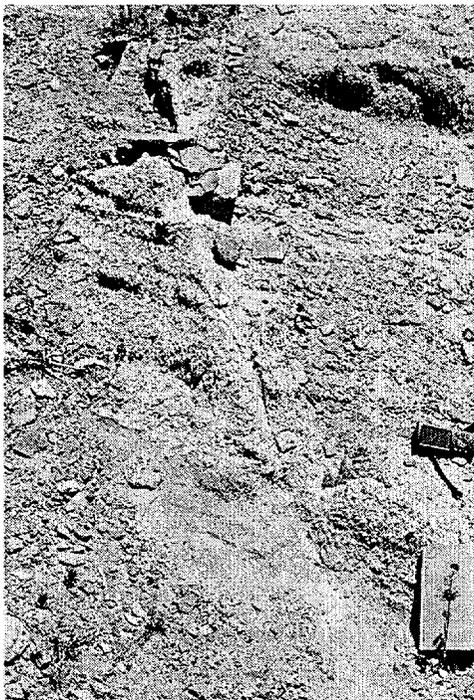
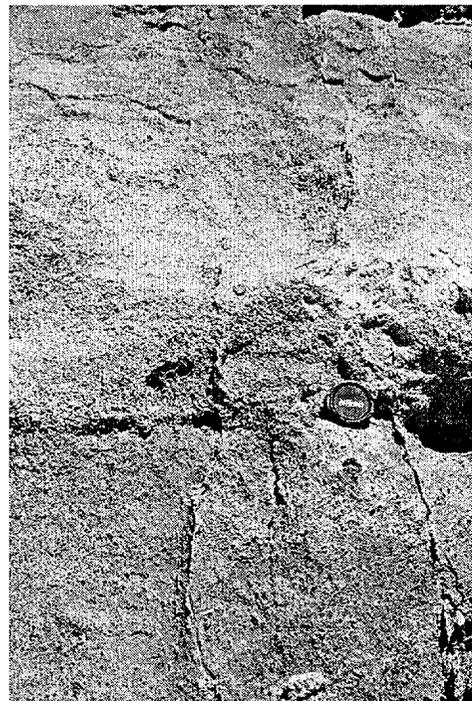
The six units of the nonwelded fallout and bedded Tpbt3 are also variable in their fracture character. Fractures in the pumiceous and poorly welded units (Tpbt3) are less abundant than in the partially welded sequences. Fractures are oriented dominantly with a north-south or east-west strike, and spacing in the upper units of the Tpbt3 is 20–50 cm. Notable in these outcrops, however, are some fractures and calcite-lined small faults that cut both the overlying densely welded sequences and the poorly welded tuffs. Figure 6 illustrates a fault and a set of calcite-filled fractures in the nonwelded fallout and bedded tuffs of Tpbt3. Both calcite-filled and other fractures cross the abrupt contact between the partially welded Tpy and the nonwelded Tpbt3, though generally they did not continue vertically downward in the Tpbt3 more than a

Figure 6. Discontinuities in the nonwelded Pre-Yucca bedded tuff (Tpbt3): a) fault with leached, fined grained core, and b) fractures with caliche. The field notebook is 19 cm tall.
