Entergy Nuclear Generation Co.
Pilgrim Nuclear Power Station
600 Rocky Hill Road
Plymouth, MA 02360

The enclosed Licensee Event Report (LER) 2001-006-00, "Automatic Scram During Surveillance Test and Subsequent Reactor Water Level Anomalies," is submitted in accordance with 10 CFR 50.73.

FACILITY NAME (1)
PILGRIM NUCLEAR POWER STATION

TITLE (4)
Automatic Scram During Surveillance Test and Subsequent Reactor Water Level Anomalies

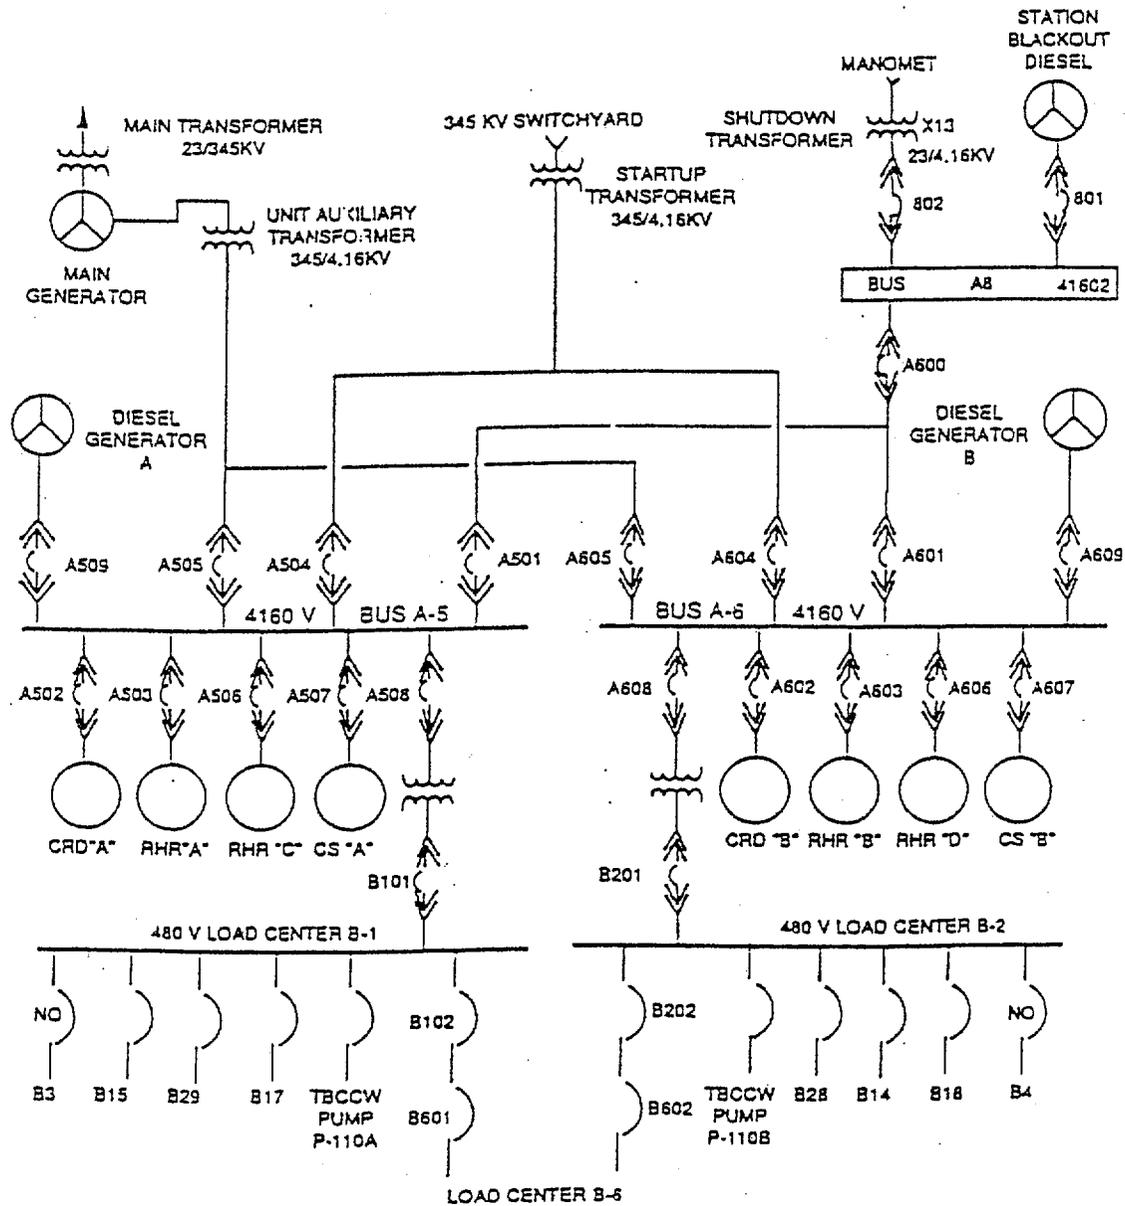
SIMPLIFIED DRAWING of
PREFERRED and SECONDARY OFFSITE POWER SOURCES
and
EMERGENCY SERVICE PORTION of the
AUXILIARY POWER DISTRIBUTION SYSTEM

On August 13, 2001, at 1108 hours, Emergency Diesel Generator (EDG) "A" was removed from service for a planned surveillance activity. When EDG "A" was removed from service all of the offsite and onsite power sources were available, and all of the 345 kV switchyard breakers were closed. The 4.16 kV auxiliary power distribution system (APDS), including nonsafety-related 4.16 kV Buses (A1, A2, A3, A4) and safety-related 4.16 kV Buses A5 and A6 and related AC electrical system and loads, were powered from the Main Generator via the Main Transformer and Unit Auxiliary Transformer. The control switches for a fast transfer of the 4.16 kV buses were in the ON position. A simplified one-line drawing of the offsite power sources, EDGs, and emergency service portion of the APDS and related electrical system is provided at the end of this report.

At 1753 hours, a utility licensed operator at the EDG "A" control panel placed the EDG "A" test control switch in the NORMAL position in accordance with PNPS Procedure 3.M.3-1 (Rev.. 51) Attachment 8A step [6]. When the test control switch was placed in the NORMAL position, the EDG "A" operational mode automatically changed from DROOP to ISOCHRONOUS mode and caused the logic circuitry to sense that both Bus A5 supply breakers 152-505 (A505) and 152-509 (A509) were closed at the same time even though breaker 152-509 was not actually connected to Bus A5 (breaker 152-509 in the TEST position and closed in accordance with PNPS Procedure 3.M.3-1). Consequently, breaker 152-505 opened automatically as designed and caused Bus A5 to de-energize. The loss of power to Bus A5 resulted in the de-energizing of the related AC electrical system and components powered from Bus A5 including breakers that power the Control Rod Drive (CRD) train "A" pump, Residual Heat Removal (RHR) System train "A" pumps, Core Spray System train "A" pump, and Bus B1. Bus B1 electrical loads include safety-related 480-volt Buses B6, B15, B17 and respective loads, and nonsafety-related Bus B29 and TBCCW loop "A" pump.

The direct cause of Bus A5 de-energizing was procedure error. The root cause was a utility non-licensed electrical maintenance engineer personnel error that introduced the error when PNPS Procedure 3.M.3-1 was revised. The procedure revision (to Rev.. 50) was made to separate the testing of Technical Specifications related relays and relays that are not related to Technical Specifications. The revision included the addition of two new attachments, 8A and 19A. Attachment 8A (19A) was added to test the EDG "A" breaker 152-509 relays (EDG "B" breaker 152-609 relays). The procedure error was introduced into both attachments and involved the restoration of the circuitry after relay testing. Specifically, the error consisted of not including a step to open breaker 152-509 (152-609) prior to restoring the circuitry to normal. Attachment 8A step [6] is part of the sequence of steps for restoring the circuitry to normal after the EDG "A" to Bus A5 relays are tested. Neither Attachment 8A nor Attachment 19A had been performed until the EDG "A" relay test on August 13, 2001.

PNPS Procedure 3.M.3-1 Attachment 8A and Attachment 19A are being revised. The corrective action program (PR 01.9779) will track this action and any additional corrective actions.

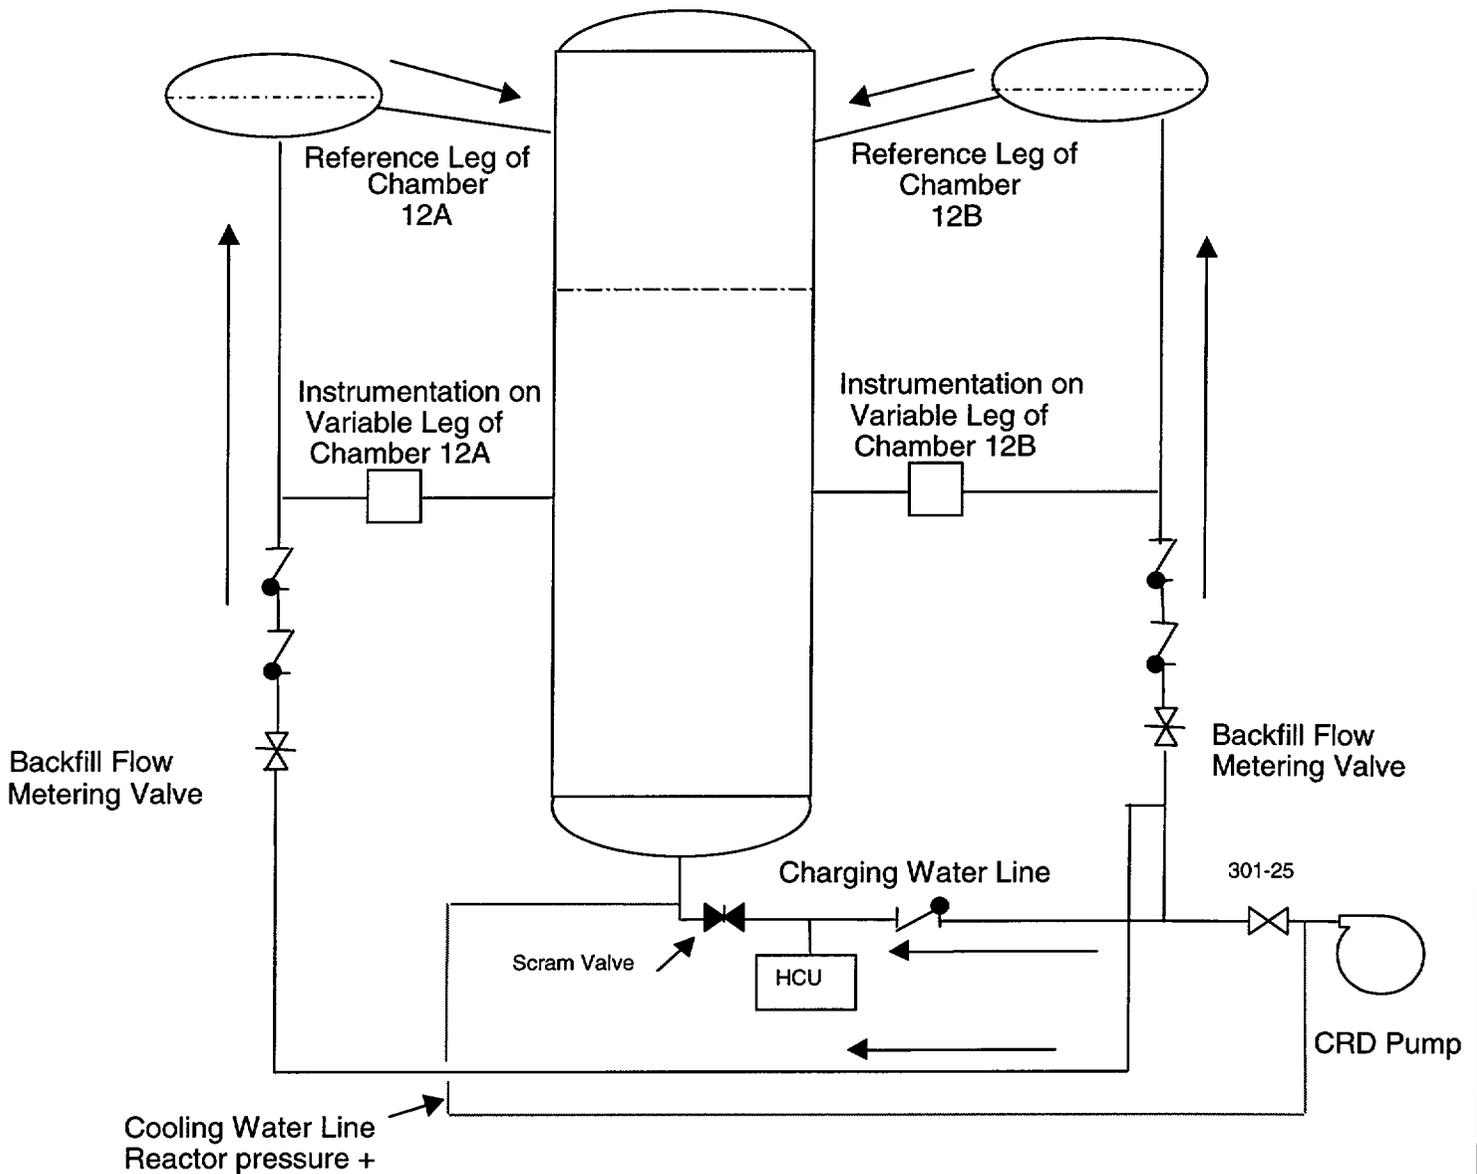
Simplified Drawing of Reference Leg Backfill System
(Condensing Chambers 12A & 12B)

Analysis indicates the water level changes sensed by the related reactor vessel water level instrumentation resulted from the draining of water from the reference legs connected to Condenser Chambers 12A/B. The draining of water was the result of reverse flow past the reference legs' backfill system check valves. The draining reduced the water inventory from the reference legs and caused the instrumentation (level transmitters) to sense a higher than actual reactor water level.

The backfill system for the reference legs connected to Condensing Chambers 12A/B was designed to be backfilled with water from the CRD System charging water piping. The backfill flow was interrupted when the CRD charging water block valve (HO-301-25) was closed to allow all CRDs to settle and achieve a fully inserted position indication on the reactor control panel after the scram. Later, the reset of RPS was performed when the reactor vessel pressure was approximately 725 psig. The 725 psig pressure was greater than the CRD System HCUs' accumulator pressure of approximately 570 psig. The reset of the RPS includes the automatic closing of the CRD scram valves which result in the HCUs' accumulators being available to accept water displaced from the reference legs. The resulting hydraulic conditions of reactor pressure greater than CRD charging water header pressure (downstream of valve HO-301-25), no backfill flow from a CRD pump (valve HO-301-25 closed), and reverse flow through the backfill system check valves, allowed the displacement of water from the reference legs to the HCUs' accumulators.

The displacement occurred past the backfill system check valves and was greater than would be normally experienced because the backfill system flow metering valves were at a maximum flow setting. The check valves did not actuate because the differential pressure across the check valves was not sufficient to cause the check valves to close. The check valves are designed to close at a differential pressure of six psi (psid) or less. After the event, calculations were performed and the check valves were tested. The calculations concluded the check valves experienced a differential pressure of approximately one and one-half psid for this event. The results of the as-found check valve testing determined the valves closed between two and six psid. Therefore, the check valves would not have been expected to close under the conditions experienced for this event.

As an immediate action, the backfill system was isolated from both reactor vessel reference legs connected to Condensing Chambers 12A/B. An engineering evaluation provided the basis for operability of the related reactor vessel instrumentation with the backfill system isolated. Longer term corrective action(s) were being considered when this report was prepared. The focus of the corrective action(s) is to preclude the draining of water from the reference legs connected to Condensing Chambers 12A/B. This action(s) will be tracked in the corrective action program (PR 01.9774).
