Technical Report  
Additional Site Characterization Activities  
Former Kaiser Aluminum Specialty Products Facility  
Tulsa, Oklahoma

# **Additional Site Characterization Activities**

**Former Kaiser Aluminum Specialty Products Facility  
Tulsa, Oklahoma**

**Project No. 5427G  
November 2001**

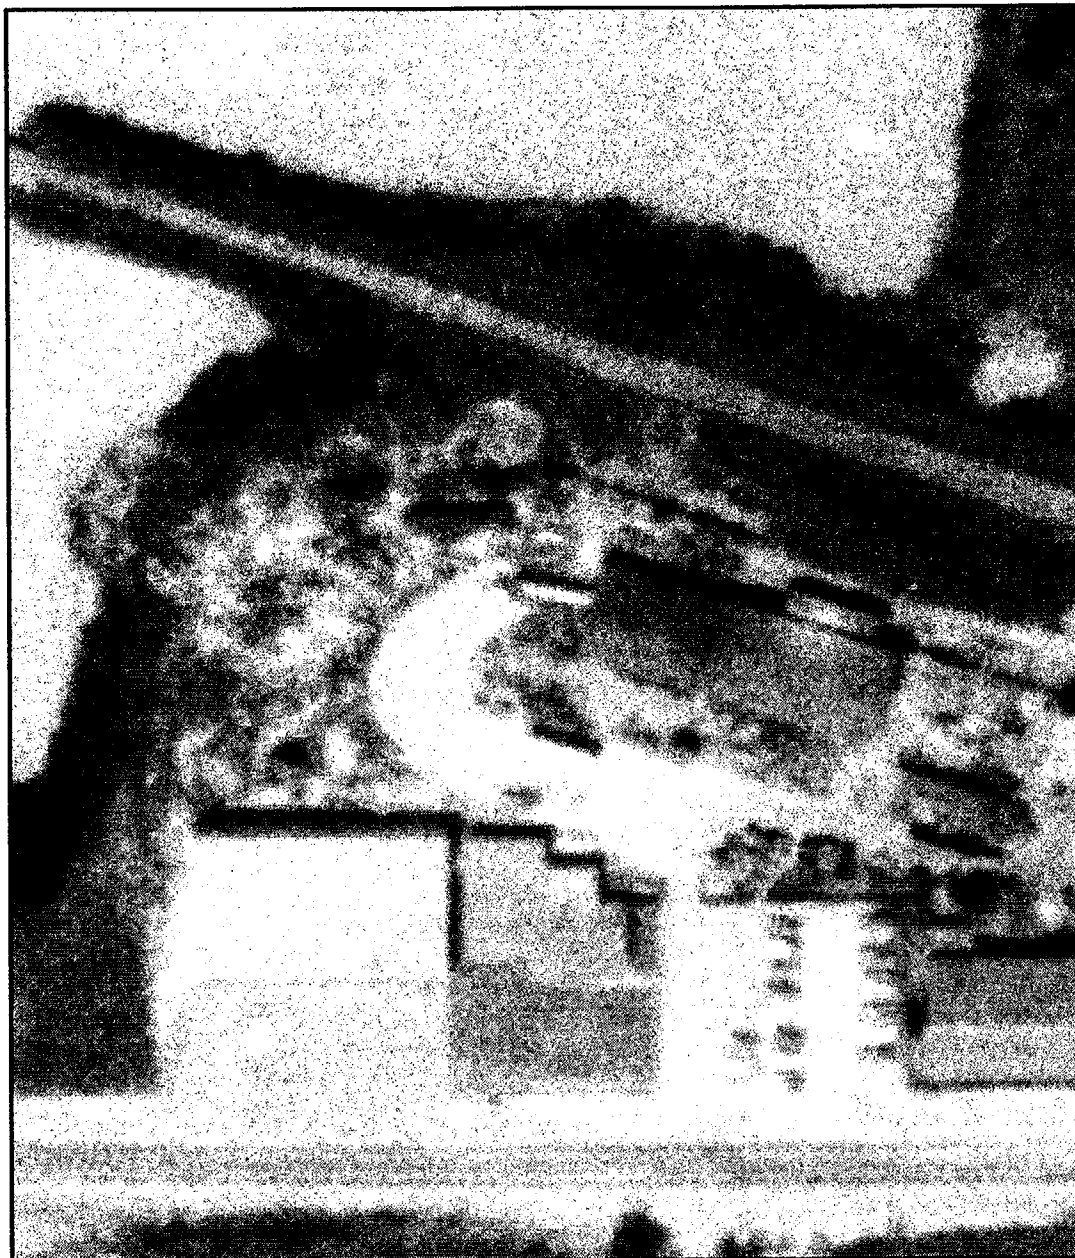
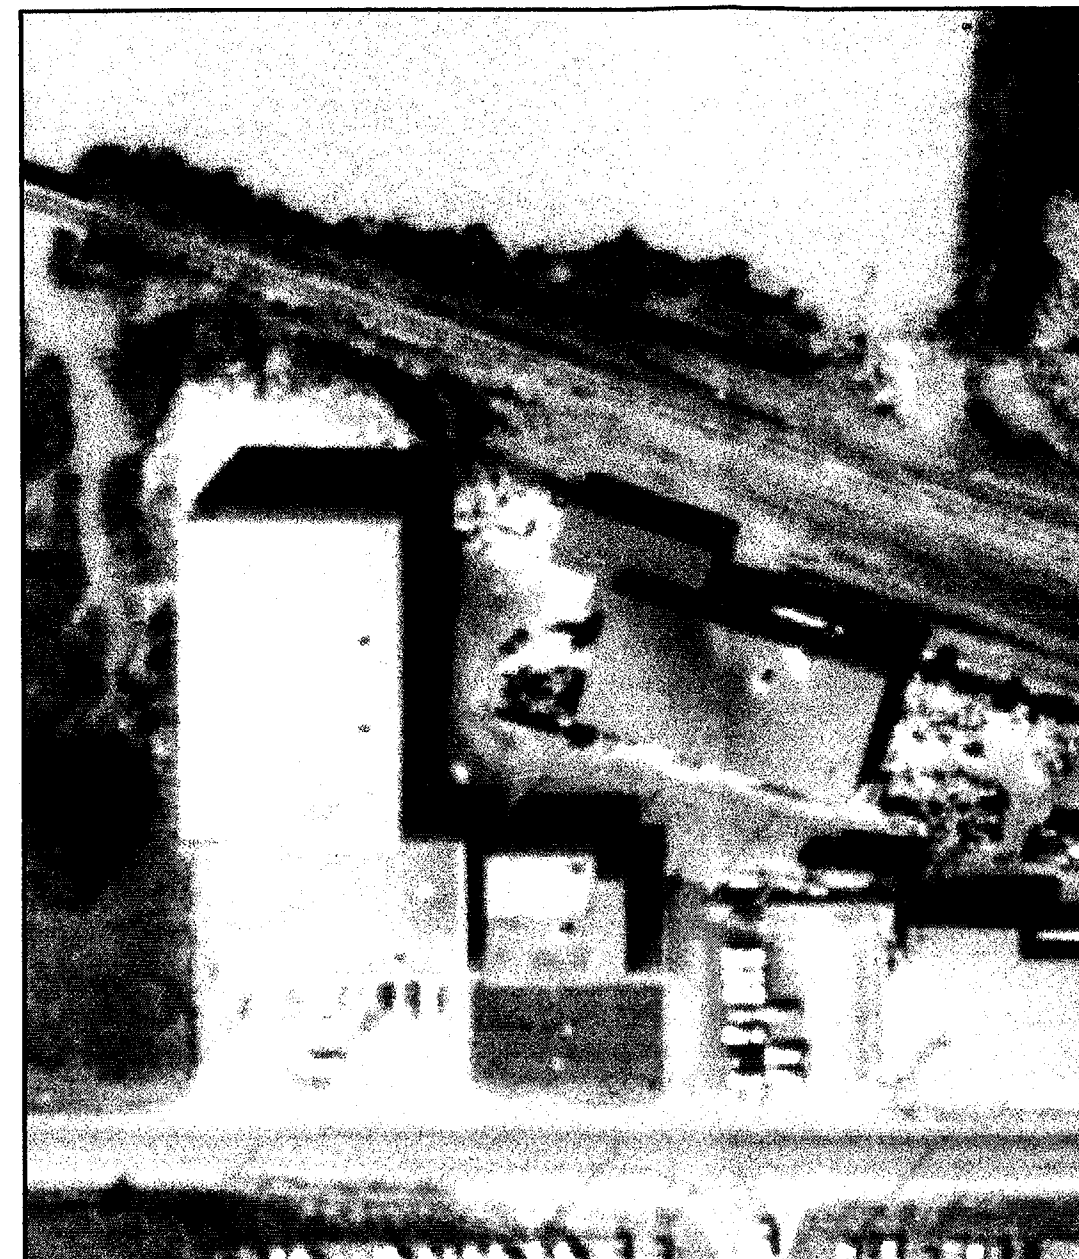
The emergence of this debris pile sometime before 1964 may relate to an explosion and fire at the original magnesium smelter building in 1961. This smelter building was located midway between the current Maintenance Building and the original Crusher Building, and was adjacent to the west wall of a new smelter which was nearing completion in 1961. The scale of the fire is unknown, but one available photograph looking east from the Office Building shows a partially collapsed Warehouse Building, the (slightly damaged) new Smelter Building, and the damaged old Smelter Building. In addition, large sheets of metal siding appear scattered about the yard area between the buildings. As the Crusher Building is not clearly evident in the aerial photograph, it is impossible to evaluate damage from the fire. Similarly, the two smelters block the view toward the Flux Building location.

Significant changes are apparent to most of the structures on site between the 1958 and 1964 aerial photographs. The structures identified as the Maintenance Building, Warehouse Building, and Crusher Building appear significantly different in roof configurations and all have been enlarged. Whether changes are a result of expansion, or of the fire, is unknown. Regardless of the extent of fire damage, debris cleared for building modifications or reconstruction appears to have been transported to the retention pond area for management.
