Monkey tube

Profiles of tube r34c51 of Steam Generator 22

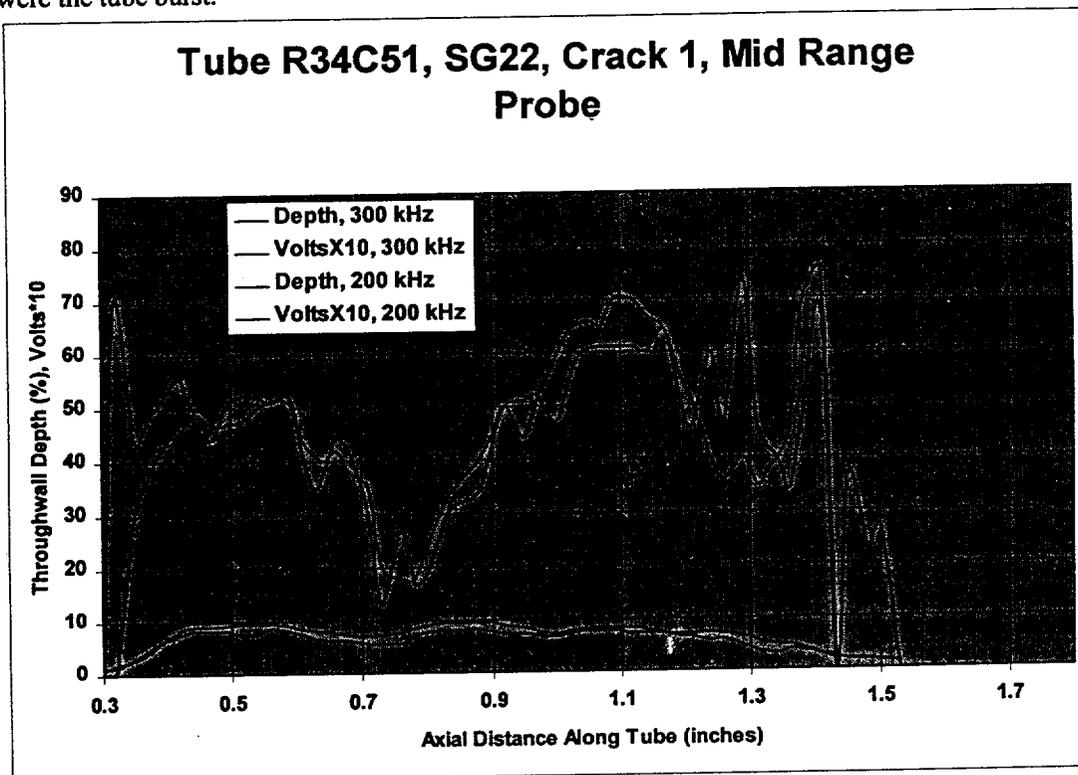
Figure 1 Profile of crack1 in tube R34C51 of steam generator 22.

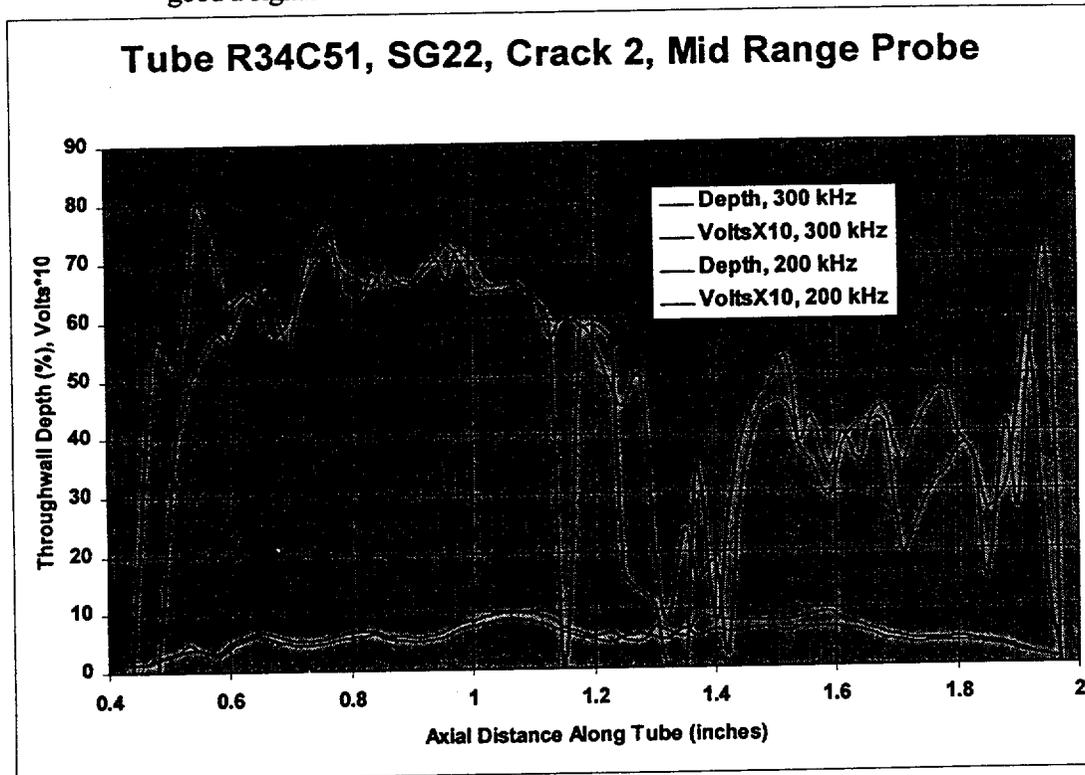
Crack 2, as shown in Figure 2, is slightly longer and slightly deeper. This is the crack that burst. The voltage amplitude of this crack is about the same, and probably averages less than that of crack one. This demonstrates that voltage is not a good measure of crack size, depth or severity. Crack 2 appeared to go through wall, and the voltage amplitude increased by a large factor. This tube also had a large voltage increase of a crevice crack due to the pressurization.

Figure 2 Profile of crack 2 of tube r34c51 in steam generator 22.

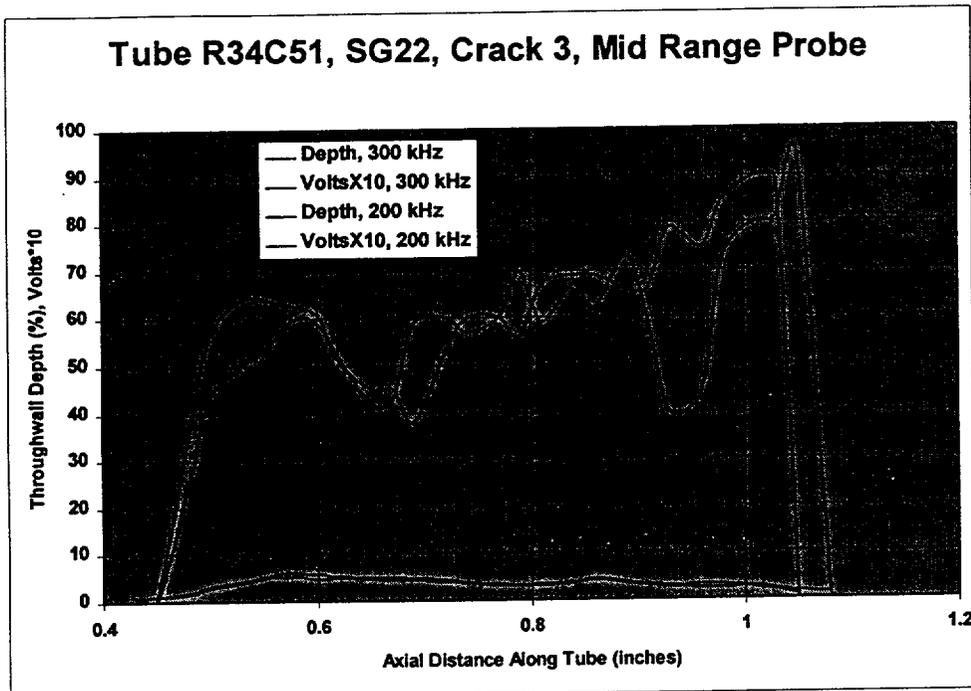
In Figure 3 and Figure 4 we show smaller cracks. In the post pressure-test scan these cracks

were still visible, but could not be profiled due to the large increase in signal from crack 2. Its signal distorted the phase of the smaller cracks, which were adjacent to it.

Figure 3 Profile of crack 3 in tube r34c51 of Steam Generator 22.

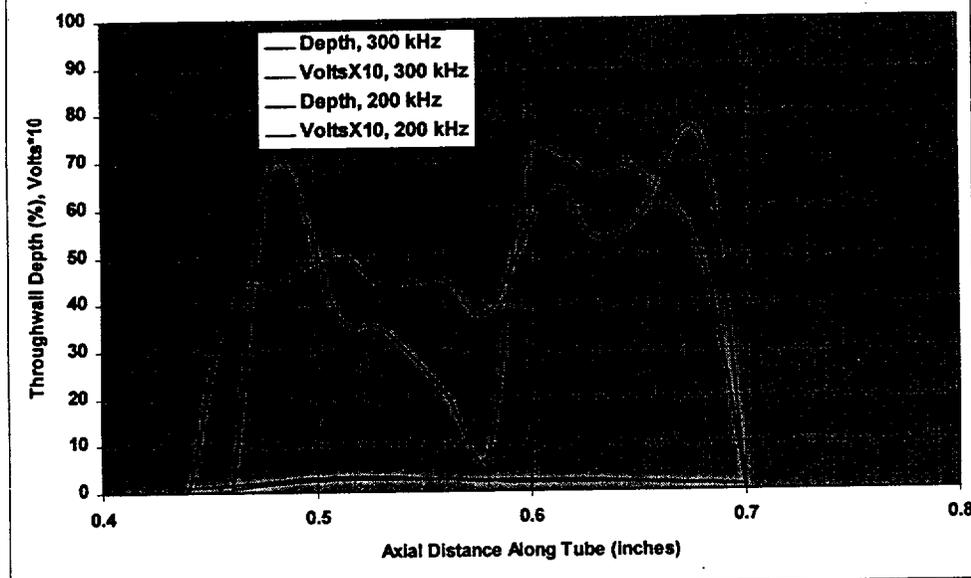
Tube R34C51, SG22, Crack 4, Mid Range Probe

Figure 4 Profile of crack4 in tube r34c51 of Steam Generator 22.

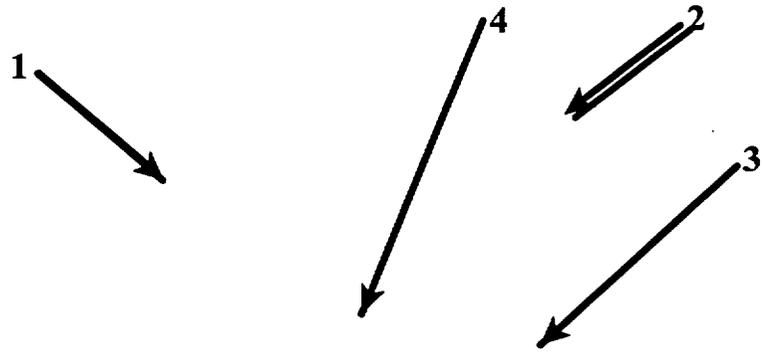
The positions of each of the cracks is labeled in the C-scan that is shown in Figure 5. Note the large voltage signal from the cracks in this tube, and the low noise. Other tubes do not have as good a signal-to-noise ratio and are more difficult to inspect in this region.

Figure 5 C-scan to tube r34c51 of steam generator 22 before pressurization.

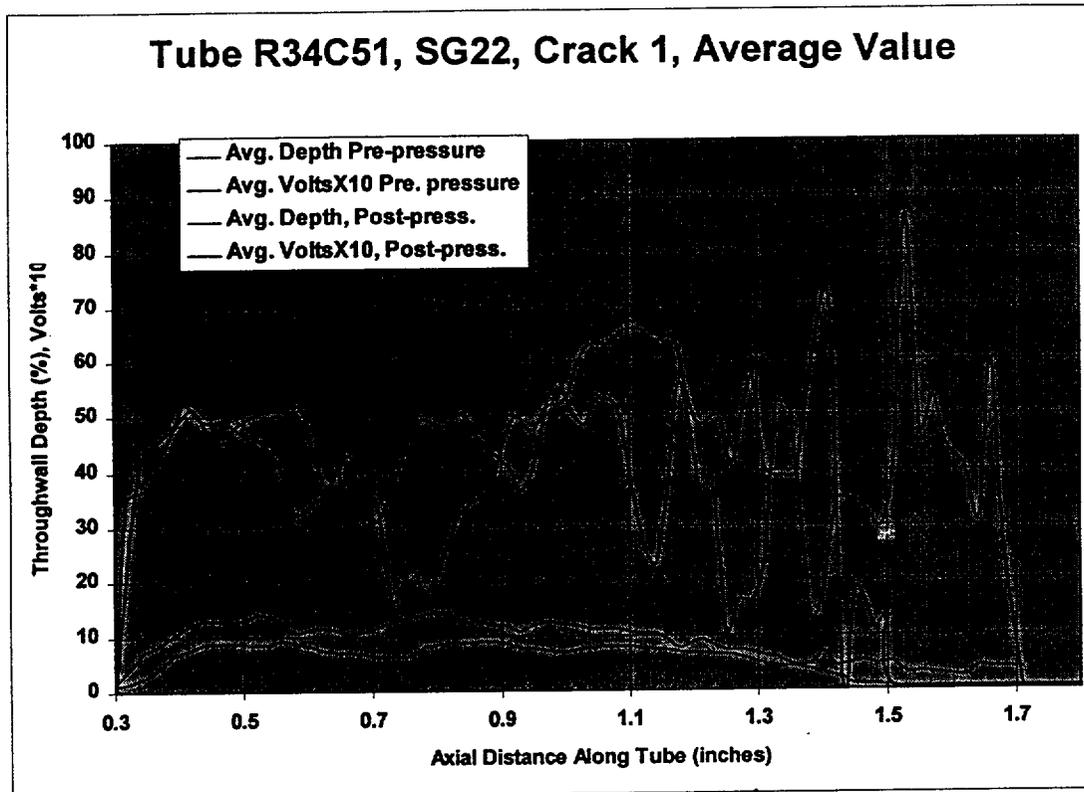
Figure 7 Effect of pressurization on Crack 1 for tube R34C51 of steam generator 22.

In Figure 7 we show the profiles averaged for the plus-point probe for the 300 kHz and the 200 kHz frequencies. The first part of the crack nearer the tube sheet seems to be about the same. For the second part of the crack, the readings seem to have become unreliable. The signals from all the coils were reviewed. The pancake coils showed a deeper crack, but there also was evidence of increased lift-off. The crack may have spread apart somewhat, due to the pressure test, and is no longer strictly crack shaped. The amplitude of the signal increased for all of the coils. This increase was about 25% for most of the crack for the plus-point coils. There probably would have been more increase if Crack 2 had not opened up, relieving the stress.

Measurements made on this crack with the 0.080-inch high frequency probe showed a very sharp spike-like response before pressurization, and a more broad response afterwards, also indicating some spreading of the crack. A comparison of Crack1 in figures 5 and 6 show that the base of the crack is much fatter as the distance from the tube sheet has increased. Another crack parallel to Crack1 may have opened in this region, causing errors in the depth readings.

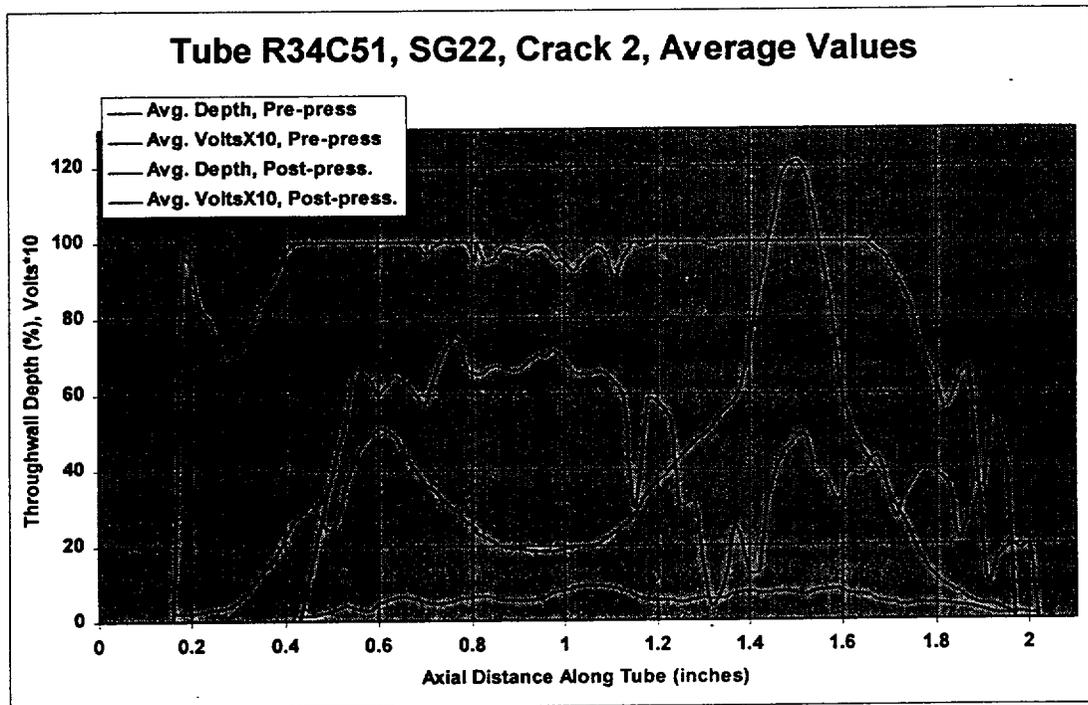
In Figure 8 we show the profiles for Crack 2, for the plus-point probe, averaged over the 300 kHz and the 200 kHz frequencies. These readings appear to be more regular, but they were also

considerably distorted. This crack reading switched from od to id a number of places along the length, and the crack signal was not the classic shape that occurs on the calibration standards. When the signal went to id, the crack was assigned a value of 100%.

The amplitude of this crack signal increased to 12 volts. The amplitude calibration was set for a 100% EDM notch to have a voltage of 20-volts. Even a through wall crack must have some current bridging across the crack face to cause the signal to decrease to this value.

Figure 8 Effects of pressurization on Crack 2 in tube R34C51 of Steam Generator 22.
