From: ~~<Doddcv@ [REDACTED]>~~ C Dodd
 To: KP_DO.kp1_po(WLS) W Schmidt
 Date: Tue, Jul 11, 2000 8:35 AM
 Subject: Three 1997 C-scans

Growth Studies for Indian Point2 Steam Generator U-bend Defects

Tube row 2 col 69 of Steam Generator 24

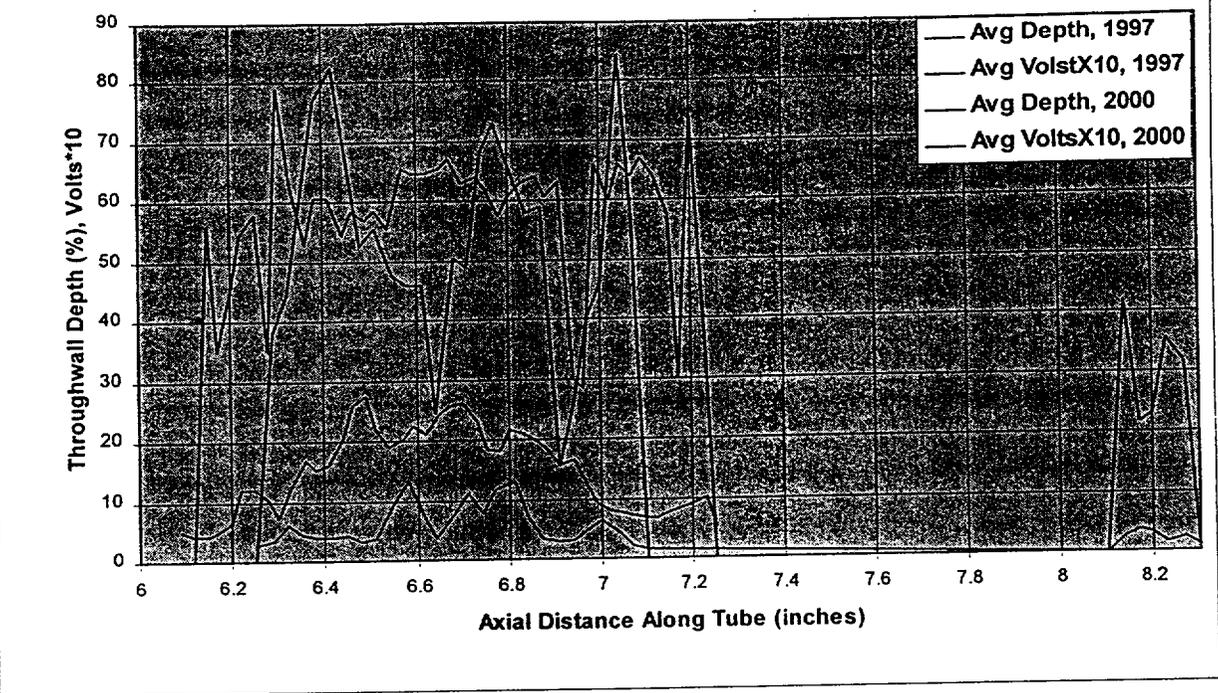
Figure 1 Profile of Growth between 1997 and 2000 for Tube R2C69 of Steam Generator 24

Figure 1 shows the profile of tube Row 2 Col 69 of Steam Generator 24. The profile of the tube taken from the high-frequency data is shown in Figure 2. Although there is considerable noise present in the C scans using the midrange probe, as shown in Figure 3, this is probably the most accurate profile of all the tubes. The noise features between the midrange scans in 1997 and 2000 are similar enough to verify that this is the same defect at the same location. The 1997 scan shows a considerable amount of noise, and much of the depth profiling is guessing. As can be seen in Figure 1, the defect voltage is only about 1 volt, and there is a considerable amount of noise on the tube, relative to the defect signal.

The signal amplitude has increased to about 2.5 volts in 2000 with the same type of probe, calibrated in the same manner. This indicates a growth in the crack, although it may well be in the widening of the crack, rather than the crack getting deeper. The crack also appears longer in 2000 than in 1997. This may be due to the increase in amplitude causing the ends of the crack which were present in 1997 but below the noise, to now become visible. There were other signals in 1997 that may have been part of the defect or part of the noise ridge that the defect was riding on.

The average defect depth was computed from the axial distance of 6.55 to 6.84-inches. The 1997 average depth this was 52.6 %, and the average 2000 depth was 62.7-inches. This results in an average growth of 10% of the wall thickness during the cycle. This crack growth rate is probably more accurate than the next two.

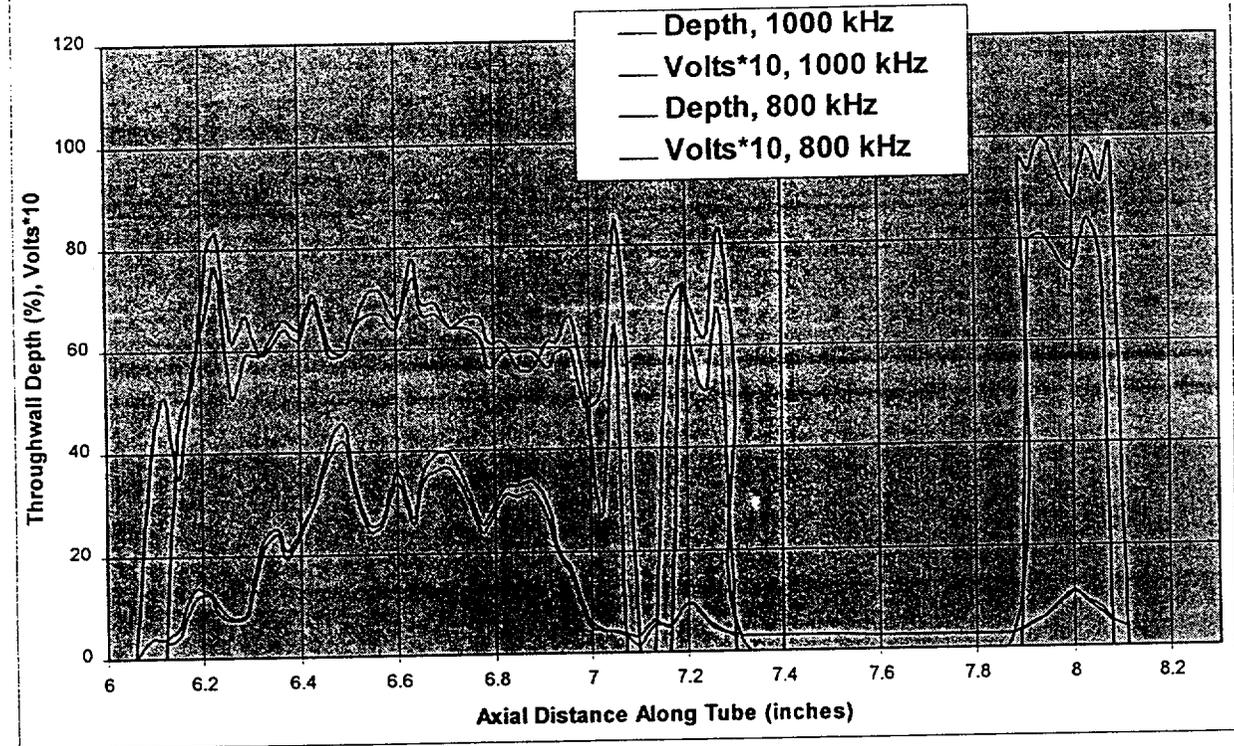
Figure 2 Profile of Tube R2C69 with the High Frequency Probe.

The signal has increased to about 4 volts in the profile shown in Figure 2, using the high frequency data. The noise has also increased, and this signal-to-noise ratio gives a much more accurate profile than either curve in Figure 1.

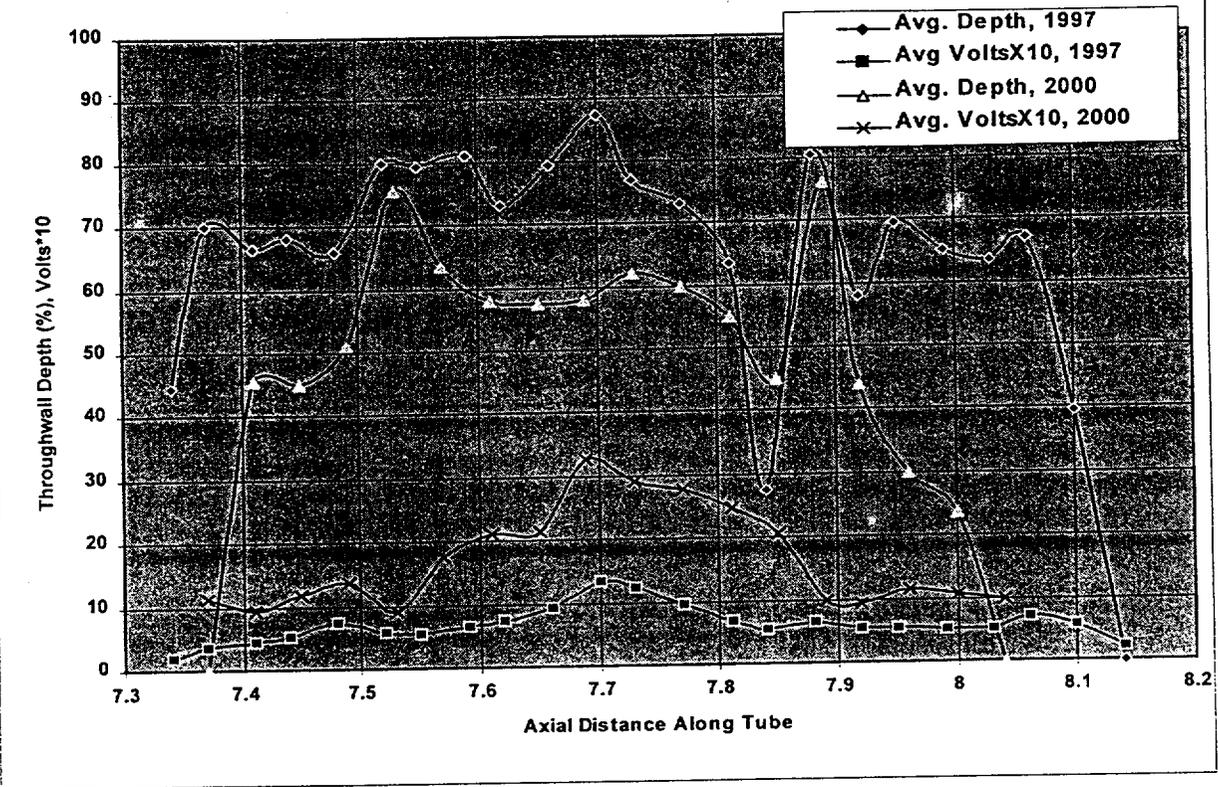
Figure 4 Profile of crack growth of tube R2 C72 of SG24 between 1997 and 2000

Figure 4 shows the profile of the crack growth in tube Row 2, Col 72 in steam generator 24 between 1997 and 2000 using the high frequency probe. The later profile done with the high-frequency probe, as shown in Figure 5 is more accurate.

The average defect depth was computed from the axial distance of 7.66 to 7.77-inches. The 1997 average depth this was 79.2 %, and the average 2000 depth was 59.3%. This results in an average decrease of 19.1% of the wall thickness during the cycle.

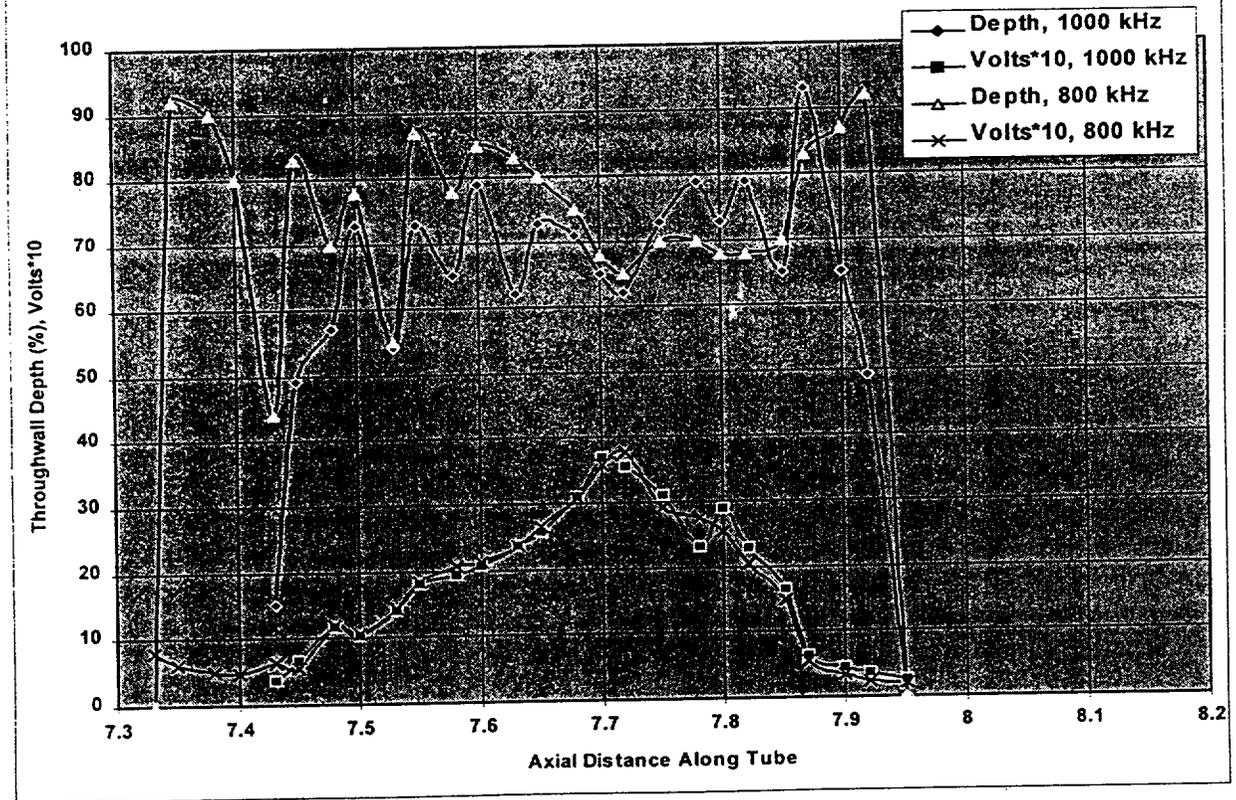
Figure 5 Profile of crack in tube R2 C72 of SG24 with the high frequency probe.

The C-scan for the high-frequency scan of this crack was taken from the opposite direction, so the features will be reversed between it and the two midrange probes. This is the most accurate profile, with the lowest signal-to-noise ratio. The maximum measured voltage is about 3.7-volts for the scan with this probe.

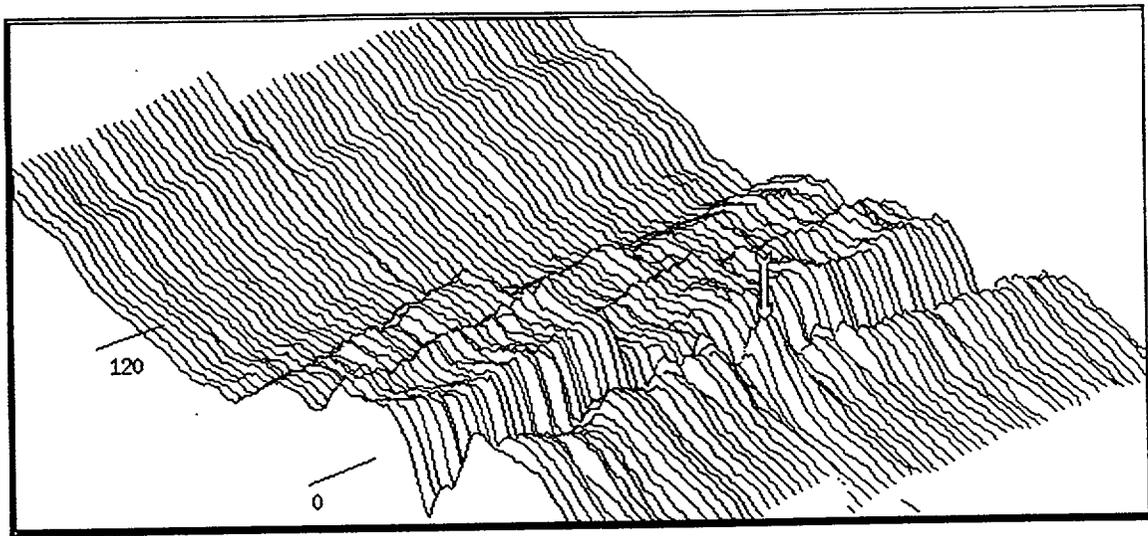
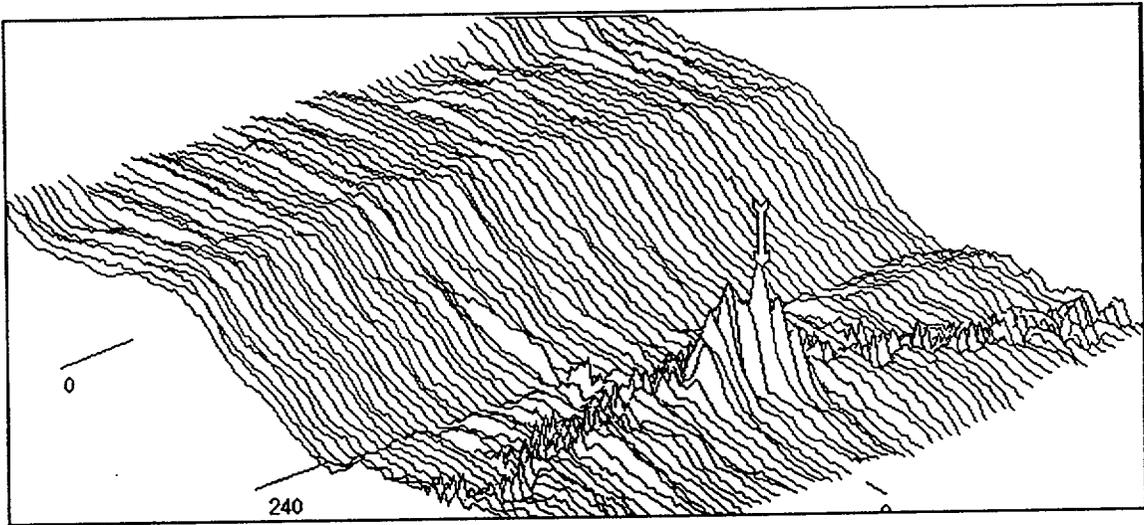
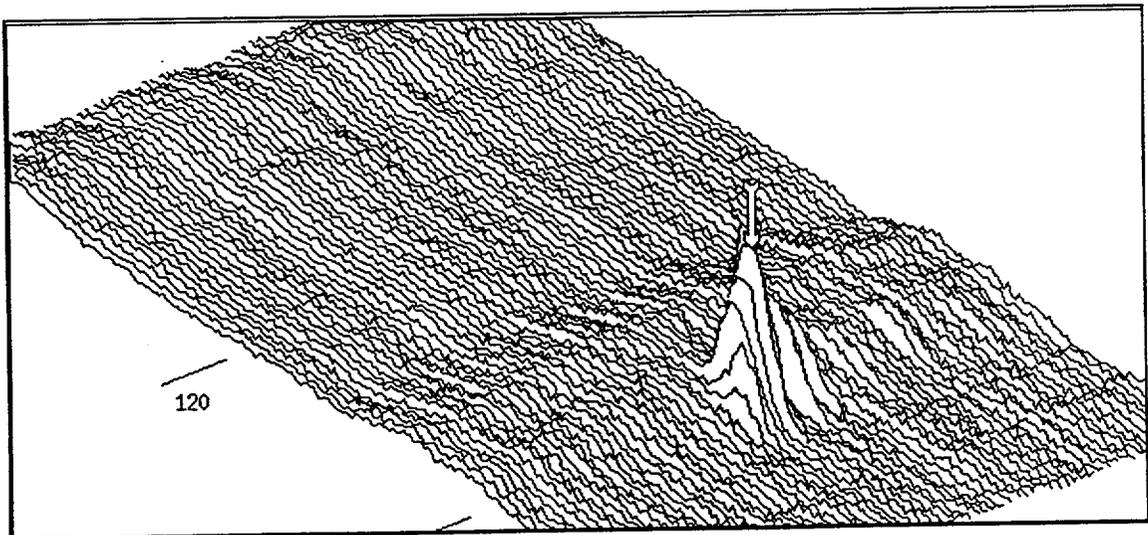
Figure 6 C-scan of tube row 2 col 12 of Steam Generator 24 in with the midrange plus-point probe in 1997 and in 2000 and with the high-frequency plus-point probe in 2000

As we can see in Figure 6, there is considerable noise present in the C- scan in 1997 with the midrange probe. The crack is sitting in a ridge of noise, and barely extends above a ridge of deposits. The crack barely extends above a 1-volt amplitude for a short length, and this is the only part of the crack that we can profile reliably.

The C-scan in 2000 with the midrange probe shows very little of the ridges present in the 1997 scan, but shows a series of spikes. These spikes are believed to be noise pulses associated with the data acquisition, possibly a problem in the slip rings. The ridges that I attributed to od deposits in the 1997 scan have vanished. There is a wave in the 1997 and 2000 scans that is similar. The signal amplitude has increased to a maximum of about 3.2-volts, making the defect easier to detect and more accurate to profile. There is a clear amplitude increase in this crack.

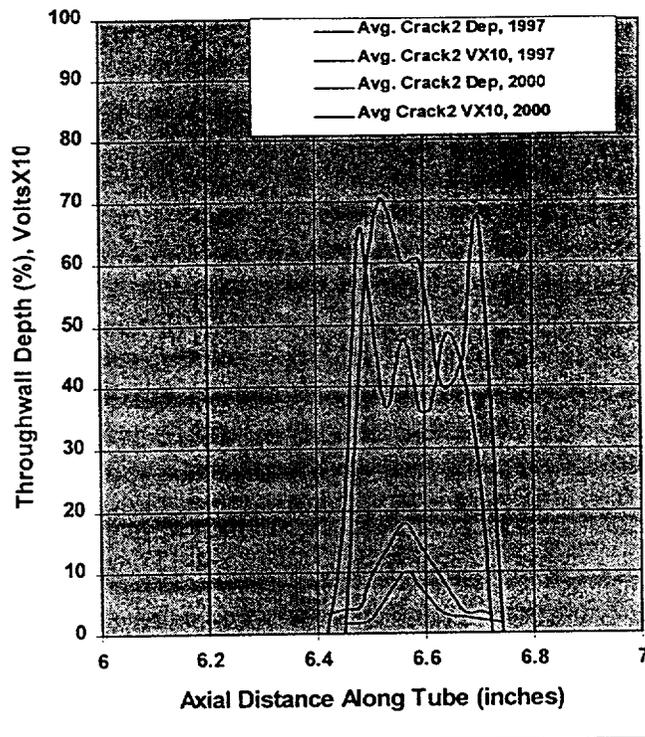
Figure 7 Profile of crack growth of tube R2 C87.

This tube was identified as having several cracks, but only one has been profiled, as shown in Figure 7. This crack was also profiled with the high-frequency probe, as shown in Figure 8.

The average defect depth was computed from the axial distance of 6.53 to 6.59-inches. The 1997 average depth this was 63.7 %, and the average 2000 depth was 40%. This results in an average decrease of 23.7% of the wall thickness during the cycle.

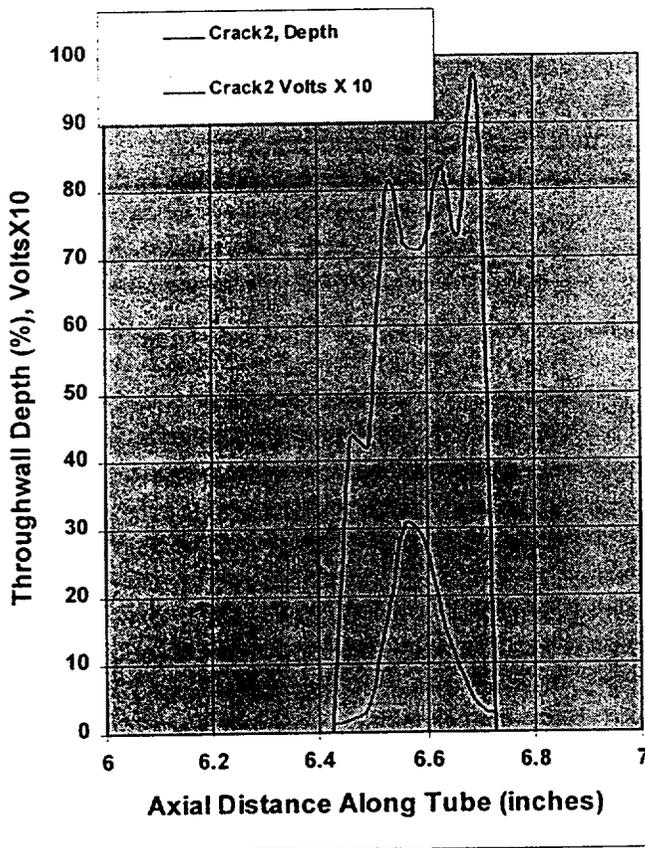
Figure 8 High-frequency profile of tube R2 C87.

In the high-frequency scan, the measured voltage increased to 3-volts, and the measured depth appears to have increased also. This is probably due to the short length of this crack. The smaller, higher frequency probe is not as susceptible to end-effects as the larger midrange probe.

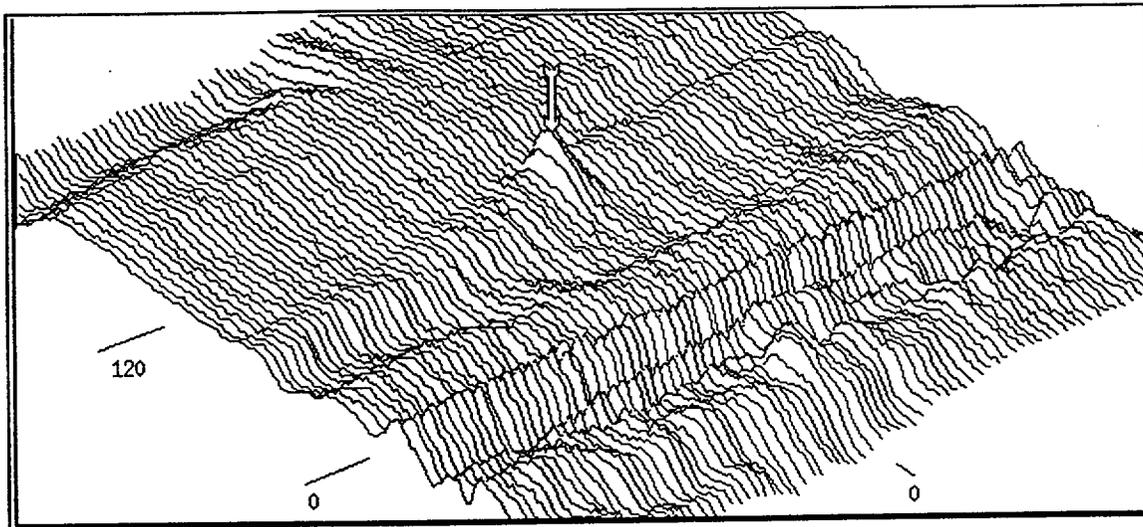
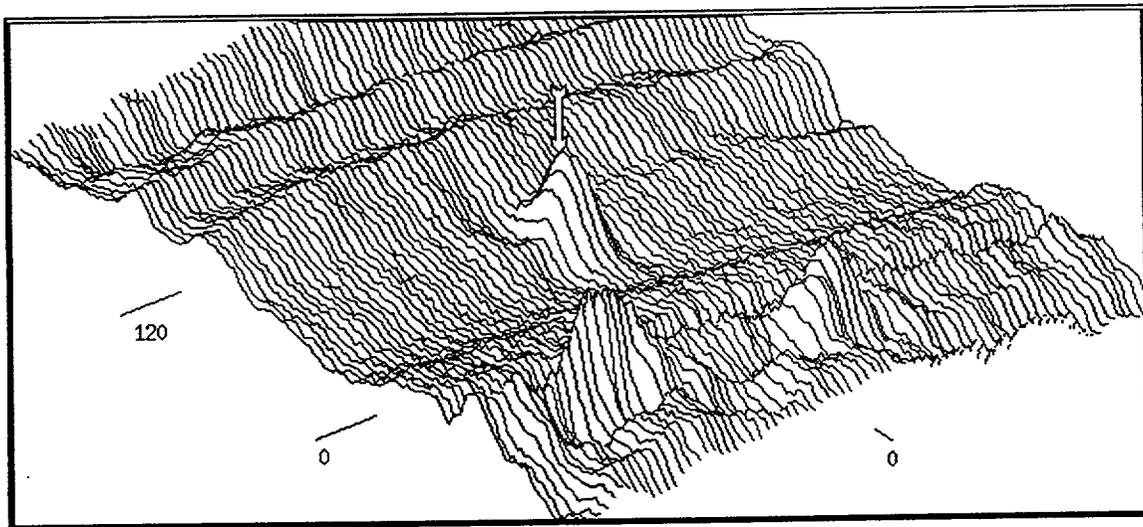
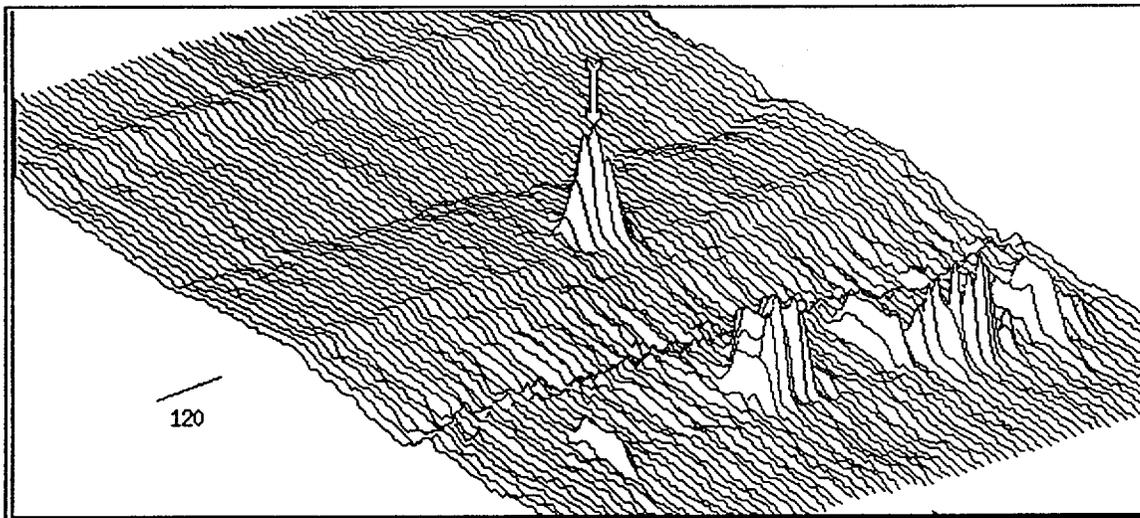
Figure 9 C-scan of tube row 2 col 87 of Steam Generator 21 in with the midrange plus-point

As we can see from the C-scans, in Figure 9, this crack is sitting in a relatively clean area of the tube. It is the crack under the arrow in all three C-scans. A small part of the crack is showing in the ridge in the 1997 scan, but the noise dominated when profiling was attempted using the 1997 data. The small, center portion of the crack is the only part that can be profiled with any accuracy.

The 2000 midrange scan is in the opposite direction as the 1997 midrange scan and the 2000 high frequency scan. The voltage amplitude increased from about 1-volt to 1.8-volts during the operating cycle. The crack depth appeared to have decreased slightly.
