From: ~~<Doddcv@ [REDACTED]>~~ C. Dodd
 To: KP_DO.kp1_po(WLS) W Schmidt
 Date: Tue, Jul 11, 2000 8:35 AM
 Subject: Three 1997 C-scans

Growth Studies for Indian Point2 Steam Generator U-bend Defects

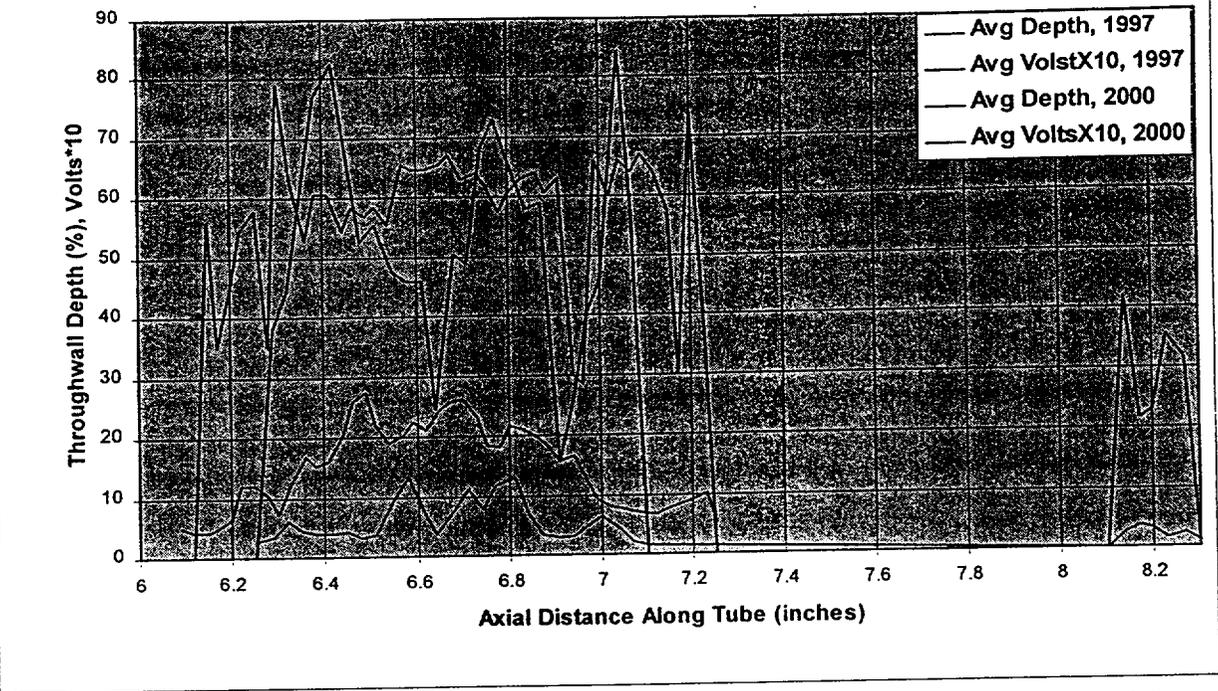
Figure 1 Profile of Growth between 1997 and 2000 for Tube R2C69 of Steam Generator 24

Figure 1 shows the profile of tube Row 2 Col 69 of Steam Generator 24. The profile of the tube taken from the high-frequency data is shown in Figure 2. Although there is considerable noise present in the C scans using the midrange probe, as shown in Figure 3, this is probably the most accurate profile of all the tubes. The noise features between the midrange scans in 1997 and 2000 are similar enough to verify that this is the same defect at the same location. The 1997 scan shows a considerable amount of noise, and much of the depth profiling is guessing. As can be seen in Figure 1, the defect voltage is only about 1 volt, and there is a considerable amount of noise on the tube, relative to the defect signal.

The signal amplitude has increased to about 2.5 volts in 2000 with the same type of probe, calibrated in the same manner. This indicates a growth in the crack, although it may well be in the widening of the crack, rather than the crack getting deeper. The crack also appears longer in 2000 than in 1997. This may be due to the increase in amplitude causing the ends of the crack which were present in 1997 but below the noise, to now become visible. There were other signals in 1997 that may have been part of the defect or part of the noise ridge that the defect was riding on.

The average defect depth was computed from the axial distance of 6.55 to 6.84-inches. The 1997 average depth this was 52.6 %, and the average 2000 depth was 62.7-inches. This results in an average growth of 10% of the wall thickness during the cycle. This crack growth rate is probably more accurate than the next two.

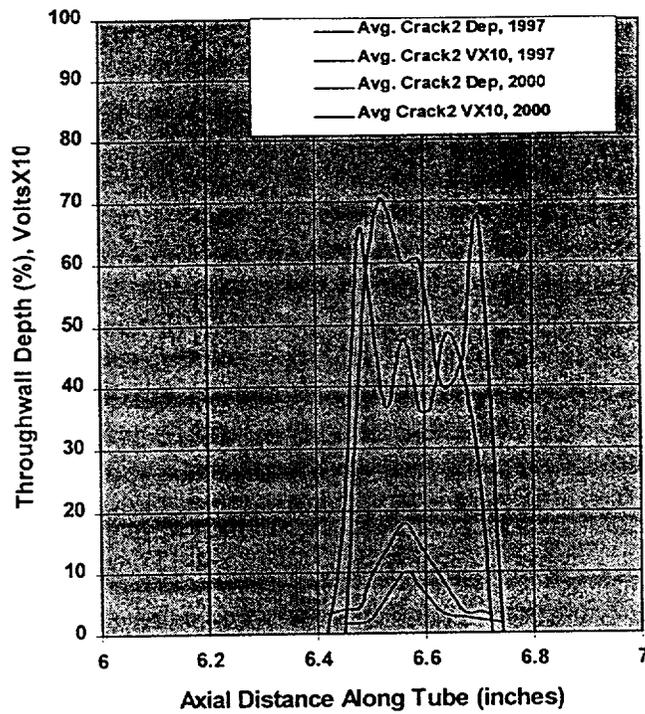
Figure 7 Profile of crack growth of tube R2 C87.

Tube row 2 col 87 of Steam Generator 21
 This tube was identified as having several cracks, but only one has been profiled, as shown in Figure 7. This crack was also profiled with the high-frequency probe, as shown in Figure 8.

The 2000 midrange scan is in the opposite direction as the 1997 midrange scan and the 2000 high frequency scan. The voltage amplitude increased from about 1-volt to 1.8-volts during the operating cycle. The crack depth appeared to have decreased slightly.

The average defect depth was computed from the axial distance of 6.53 to 6.59-inches. The 1997 average depth this was 63.7 %, and the average 2000 depth was 40%. This results in an average decrease of 23.7% of the wall thickness during the cycle.

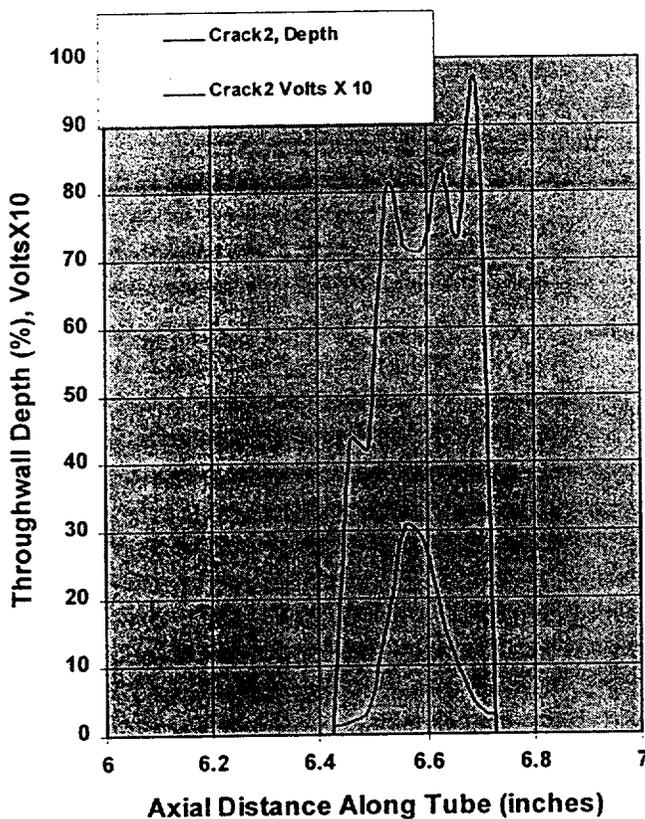
Figure 8 High-frequency profile of tube R2 C87.

In the high-frequency scan, the measured voltage increased to 3-volts, and the measured depth appears to have increased also. This is probably due to the short length of this crack. The smaller, higher frequency probe is not as susceptible to end-effects as the larger midrange probe.

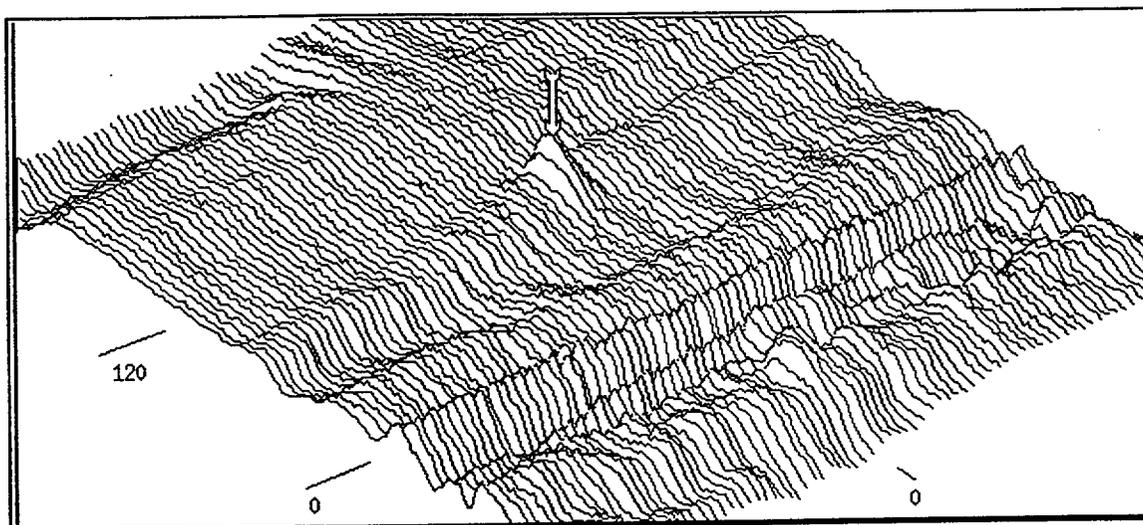
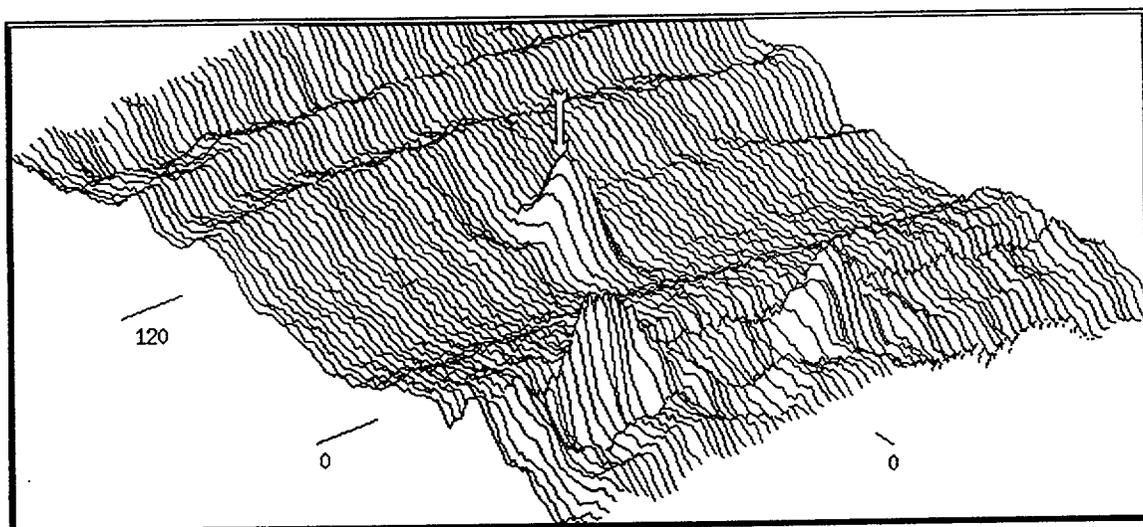
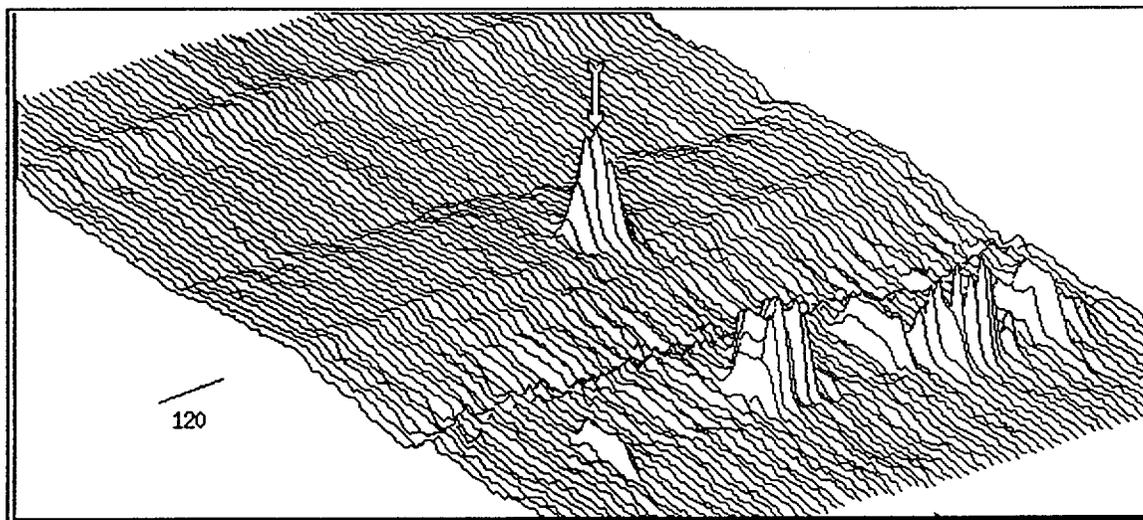
Figure 9 C-scan of tube row 2 col 87 of Steam Generator 21 in with the midrange plus-point

As we can see from the C-scans, in Figure 9, this crack is sitting in a relatively clean area of the tube. It is the crack under the arrow in all three C-scans. A small part of the crack is showing in the ridge in the 1997 scan, but the noise dominated when profiling was attempted using the 1997 data. The small, center portion of the crack is the only part that can be profiled with any accuracy.
