SUBJECT: NRC PORTSMOUTH INSPECTION REPORT 07007002/2001-008(DNMS)

Facility Name: Portsmouth Gaseous Diffusion Plant

Dates: September 11, 2001, through October 22, 2001

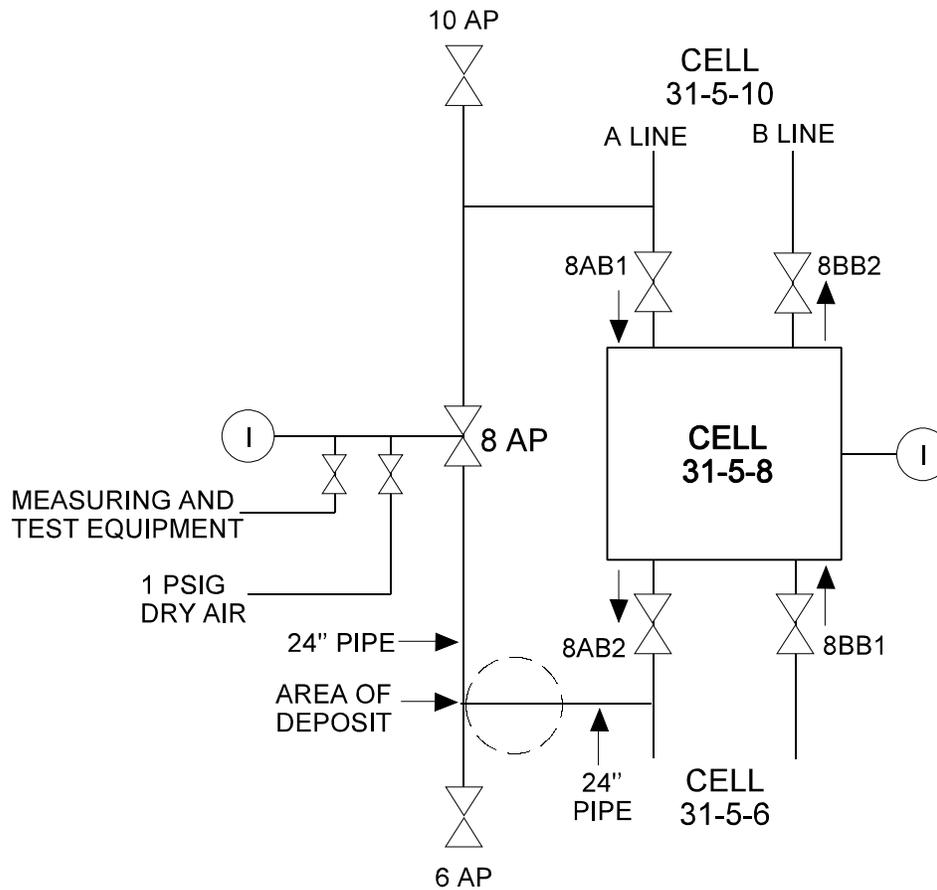
Figure 1 PORTSMOUTH CASCADE DEPOSIT

On September 22, the plant staff identified that the pressure in a portion of the cascade, with a large fissile material deposit, was less than 14 psia [pounds per square inch absolute] and that a previously established dry air buffer had been lost. The deposit in question was in the bypass piping between Cells 31-5-6 and 31-5-8 in an area identified as the Cell 31-5-6/8 A-Drop (See Figure 1 below). The affected cascade piping had previously been isolated in May 2001 along with Cell 31-5-8 in order to establish and maintain the required dry air buffer on the large deposit. Prior to that time, the cell and deposit had been in a fluorinating environment.

Plant staff determined that valves 31-5-8AB1 and 31-5-8AB2, which were required to be maintained open so that the buffer pressure could be monitored from Cell 31-5-8, were closed and that the buffer pressure on the deposit had been reduced to 5.8 psia due to leakage through another nearby valve. As immediate corrective action, plant staff took the following steps:

The inspectors noted that, at the time of the event discovery, the breakers for the block valves were in the closed position. However, the plant staff could not provide an explanation for this change in configuration. According to the plant staff, at the time of discovery the First Line Manager (FLM) was performing routine checks prior to start up of the cell for chemical treatment of the deposit. These checks included valving in a pressure gauge located on the bypass block valve 31-5-8AP (See Figure 1 above). Upon valving in, the FLM recognized the loss of dry air buffer on the deposit and then discovered the closed status of block valves 31-5-8AB1 and 31-5-8AB2. Because the pressure of the deposit was monitored by surveillance of pressure indication from the

cell, the pressure change was never noticed during the surveillance because the closure of the valves isolated the pressure transmitter from the deposit that was to be monitored by the surveillance. Since plant staff could not determine when the valves were isolated, this condition could have existed for up to four months.

Nuclear Criticality Safety (NCS) staff initiated an analysis to establish the risk significance of the as-found condition. The analysis determined that the maximum size of the deposit was approximately 930 pounds, and the maximum enrichment was determined to be 3.1 weight percent (wt%). This was larger than a critical mass for this configuration which was about 690 pounds. A certificatee calculation of a fully reflected sphere of 3.1 wt% enriched material with a limiting H/U [hydrogen to uranium] ratio of 4 resulted in a  $k_{\text{eff}}$  of greater than one. This calculation leads to the conclusion that a criticality was possible under conditions involving significant reflection. The certificatee also performed calculations under nominal reflection conditions resulting in a  $k_{\text{eff}}$  of .932. The inspectors noted that the affected portion of the cascade equipment was protected by the single contingency of covering large deposits with a blanket of dry air. Although piping integrity was maintained based on the pressure in the pipe being less than atmospheric, the cover gas control was lost over time so that no controls were available for the contingency of wet air in-leakage. Approximately five months are required for a  $\text{UO}_2\text{F}_2$  deposit to absorb enough wet air to effectively moderate the deposit and cause a significant criticality safety concern.

- opened valves 31-5-8AB1 and 31-5-8AB2 and reestablished the required buffer pressure;
- placed caution tags on the affected valves to further control the valve line-up;
- checked other large cascade deposits to assure adequate dry air buffer;
- placed caution tags on affected valves in unusual line-ups associated with other deposits as needed to further control the line-ups; and
- reported the 4-hour event to the NRC Operations Center in accordance with NRC Bulletin 91-01 due to the loss of the single control (moderation) for a cascade cell containing a greater than safe mass deposit.
