UNITED STATES  
NUCLEAR REGULATORY COMMISSION

SUBJECT: RESOLUTION OF DEGRADED CEQ FAN ROOM WALL

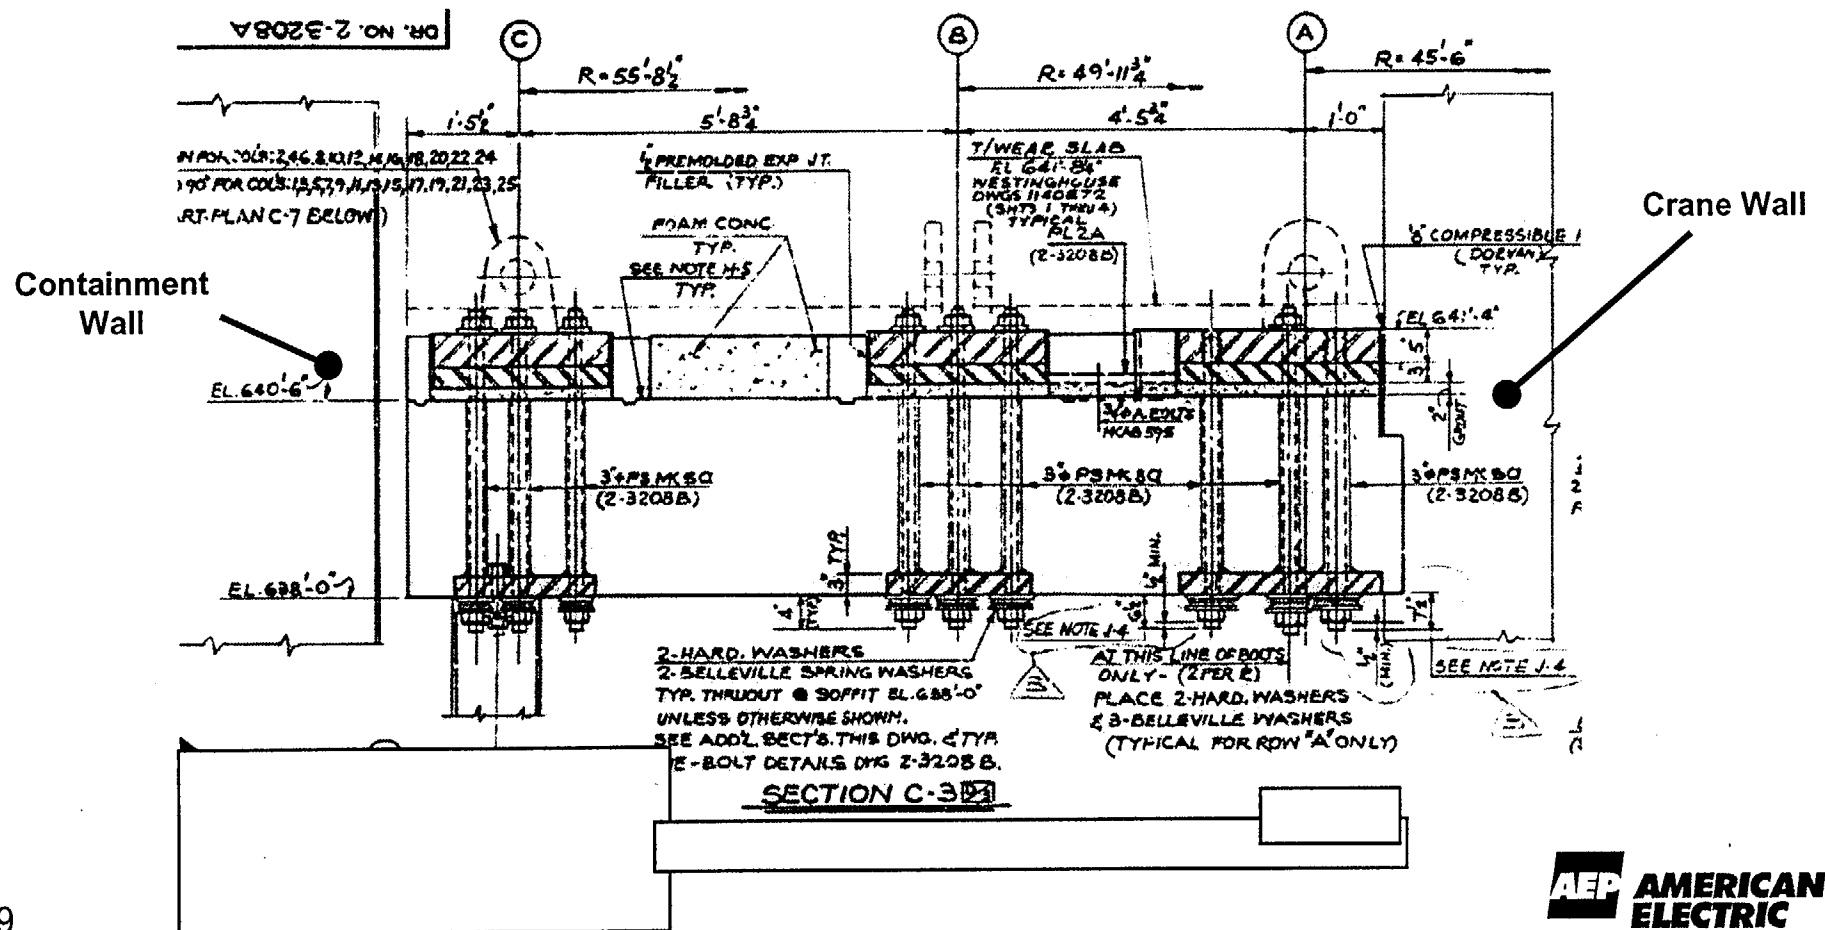
## ■ Typical Slab/Column Connection (Unit 2 Only)

# Description of the Issues: Open Pockets - Configuration of Unit 2 Ice Condenser Column Anchorage
