FAILURE ANALYSIS OF A SLIP-ON FLANGE

The following is a report by Columbus Metallurgical Services, Inc. on the failure analysis of a slip-on flange.

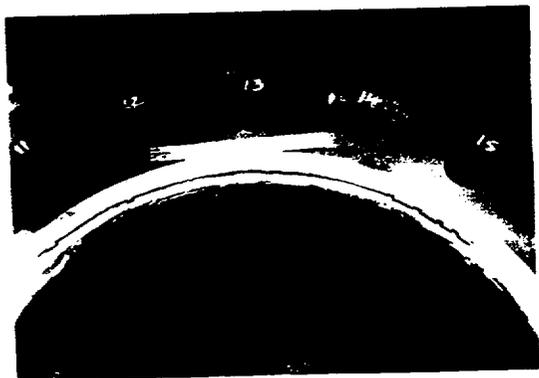
First, the flange was UT tested from the OD. The indications were rather puzzling because the reflections were consistently from a cylindrical surface about 3.75" from the OD. A dry magnetic particle examination confirmed that the cracks extended more or less continuously in a circular path. The NDT examination was concluded with dye penetrant tests as shown in the photographs in Figures 1 through 4. It was quite evident that the flange was not a single piece component. A large inside diameter (ID) flange was reduced to a 14" ID unit by welding a 0.75" thick ring. The welding faces had been machined.

Figure 4: A close-up of the pipe side showing the "crack".
