LICENSEE: Entergy Operations, Inc.
FACILITY: River Bend Station, Unit 1
SUBJECT: SUMMARY OF MEETING BETWEEN THE NUCLEAR REGULATORY COMMISSION (NRC) STAFF AND ENTERGY OPERATIONS, INC. (EOI), RIVER BEND STATION MANAGEMENT, JUNE 22, 1999

LIST OF ATTENDEES
NRC - EOI MEETING ON FUEL INTEGRITY ISSUES
JUNE 22, 1999

River Bend Station Fuel Recovery

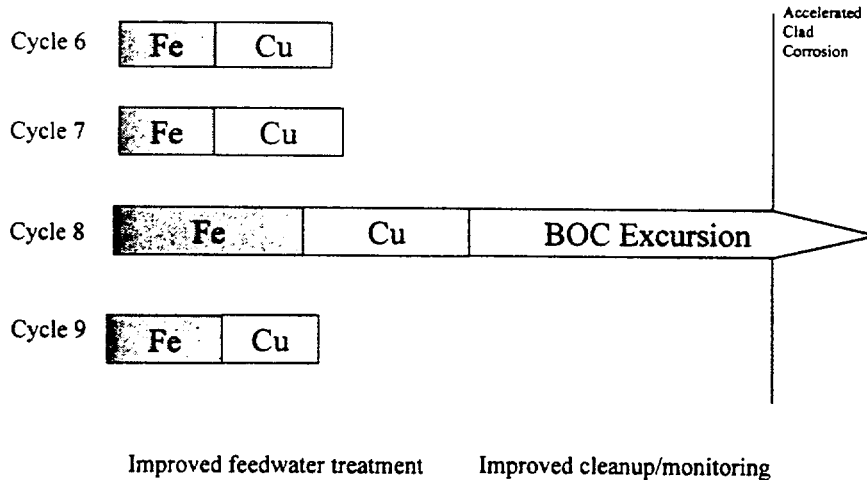
Cause of Fuel Clad Perforations

Thermally-induced accelerated corrosion, due to the combined effects of elevated iron and copper deposits with a chemistry excursion early in the operating cycle

- Conservatively discharged all once burned fuel assemblies (HGE)
- Additional conservatism in core design
- Short operating cycle for Cycle 9
- Reducing metals transport to reactor
- Improving chemistry monitoring capability
- Increasing chemistry monitoring
- Performing confirmatory inspections during the ninth refueling outage
