**UNITED STATES
NUCLEAR REGULATORY COMMISSION**
WASHINGTON, D.C. 20555-0001

FACILITY: River Bend Station, Unit 1

SUBJECT: SUMMARY OF MEETING BETWEEN THE NUCLEAR REGULATORY COMMISSION (NRC) STAFF AND ENTERGY OPERATIONS, INC. (EOI), RIVER BEND STATION MANAGEMENT, JUNE 22, 1999

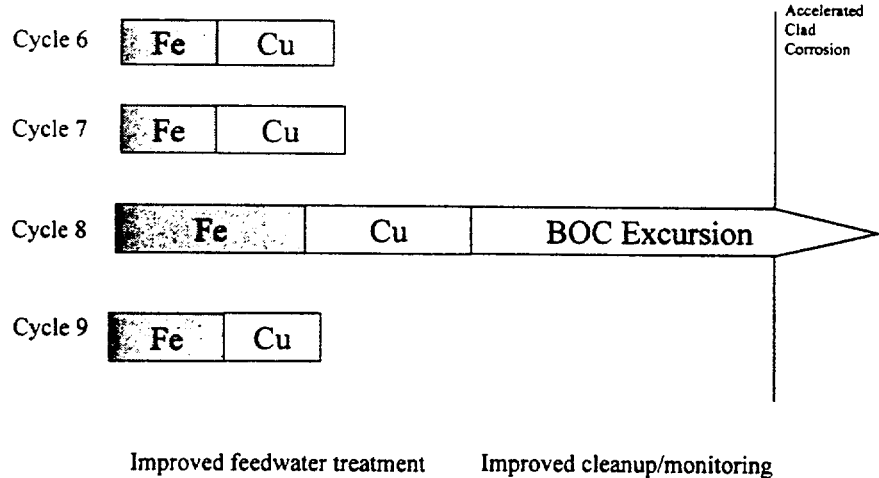
Cause of Fuel Clad Perforations

Thermally-induced accelerated corrosion,
due to the combined effects of elevated iron
and copper deposits with a chemistry
excursion early in the operating cycle

- Conservatively discharged all once burned fuel assemblies (HGE)
- Additional conservatism in core design
- Short operating cycle for Cycle 9
- Reducing metals transport to reactor
- Improving chemistry monitoring capability
- Increasing chemistry monitoring
- Performing confirmatory inspections during the ninth refueling outage

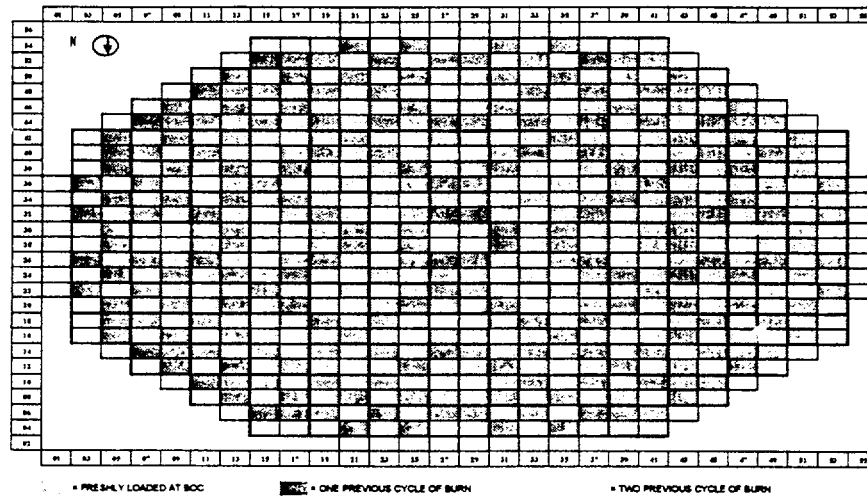
River Bend Core Map

- 624 bundles in the core
 - 212 total HGEs - Once burned bundles (GE-11)
 - Fresh fuel beginning of Cycle 8
 - 232 total GGEs - Twice burned bundles (GE-11)
 - 180 total YJ8s - Thrice burned bundles (GE-8)
- Scatter bundle loading to levelize the power
- Approximately one third of the core is replaced each refueling
