UNITED STATES
NUCLEAR REGULATORY COMMISSION
OFFICE OF NUCLEAR REACTOR REGULATION
WASHINGTON, D.C. 20555-0001

January 18, 2002

NRC INFORMATION NOTICE 2002-06: DESIGN VULNERABILITY IN BWR REACTOR
VESSEL LEVEL INSTRUMENTATION BACKFILL
MODIFICATION

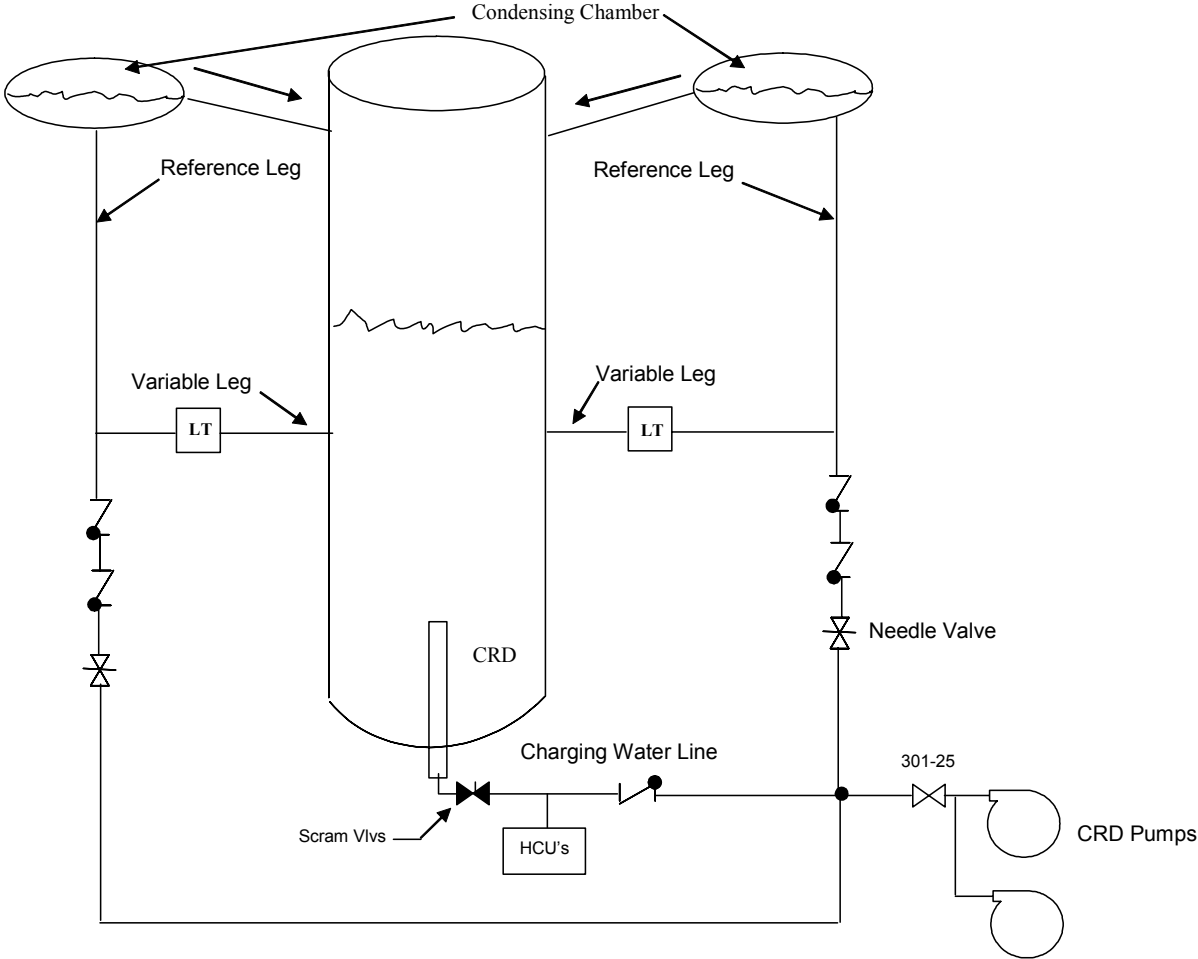
RWL Reference Leg Backfill

It was discovered that, under certain conditions, the safety-related reactor vessel water level indicators that provide certain safety-related initiation signals could give nonconservative water level readings. During a reactor trip at Pilgrim, both trains of the emergency core cooling system (ECCS) reactor water level instruments indicated higher than actual levels. These instrument inaccuracies were noted after operator actions were taken to isolate the CRD system charging water header supply valve, CRD 301-25, to insert a control rod that had not settled at position 00. Closure of the charging water header isolates the ECCS level indicator reference-leg backfill system (see Attachment 1). The erroneous readings were attributed to

the reference legs draining back through the reference-leg keepfill system to the CRD hydraulic control units (HCUs). With the CRD charging header valve shut, the reactor scram reset, and reactor pressure rising, the reference legs drained back to the HCUs. This occurs when the CRD system pump is secured or the charging header isolation valve is closed, the source of the reference-leg keepfill system, is at a slightly lower pressure than the reactor so that the differential pressure across the keepfill system check valve is not sufficient to fully seat the check valves. The draining of the reference legs results in a transient false reference-leg indication until the check valves seat and the reference legs refill via the condensate pots or flow is reestablished through the CRD reference leg backfill system. Pilgrim concluded that this phenomenon can occur with either the isolation of the reference leg backfill system or possibly with the loss of the running CRD pump.

During the reactor scram at Pilgrim, this event resulted in both the wide-range vessel level instruments indicating higher than actual water level with the A train reaching a maximum deviation of 26 inches and the B train reaching a maximum of 11 inches. These erroneous high readings occurred for approximately 30 minutes. During this time, the automatic emergency core cooling system initiation function would not have occurred on low-low water level as designed. This false reading is due to the relative locations of the reactor vessel instrument nozzles and the differential pressure corresponding to the ECCS initiation setpoint.
