UNITED STATES
NUCLEAR REGULATORY COMMISSION
OFFICE OF NUCLEAR REACTOR REGULATION
WASHINGTON, D.C. 20555-0001

NRC INFORMATION NOTICE 2002-04: WIRE DEGRADATION AT BREAKER CUBICLE
DOOR HINGES

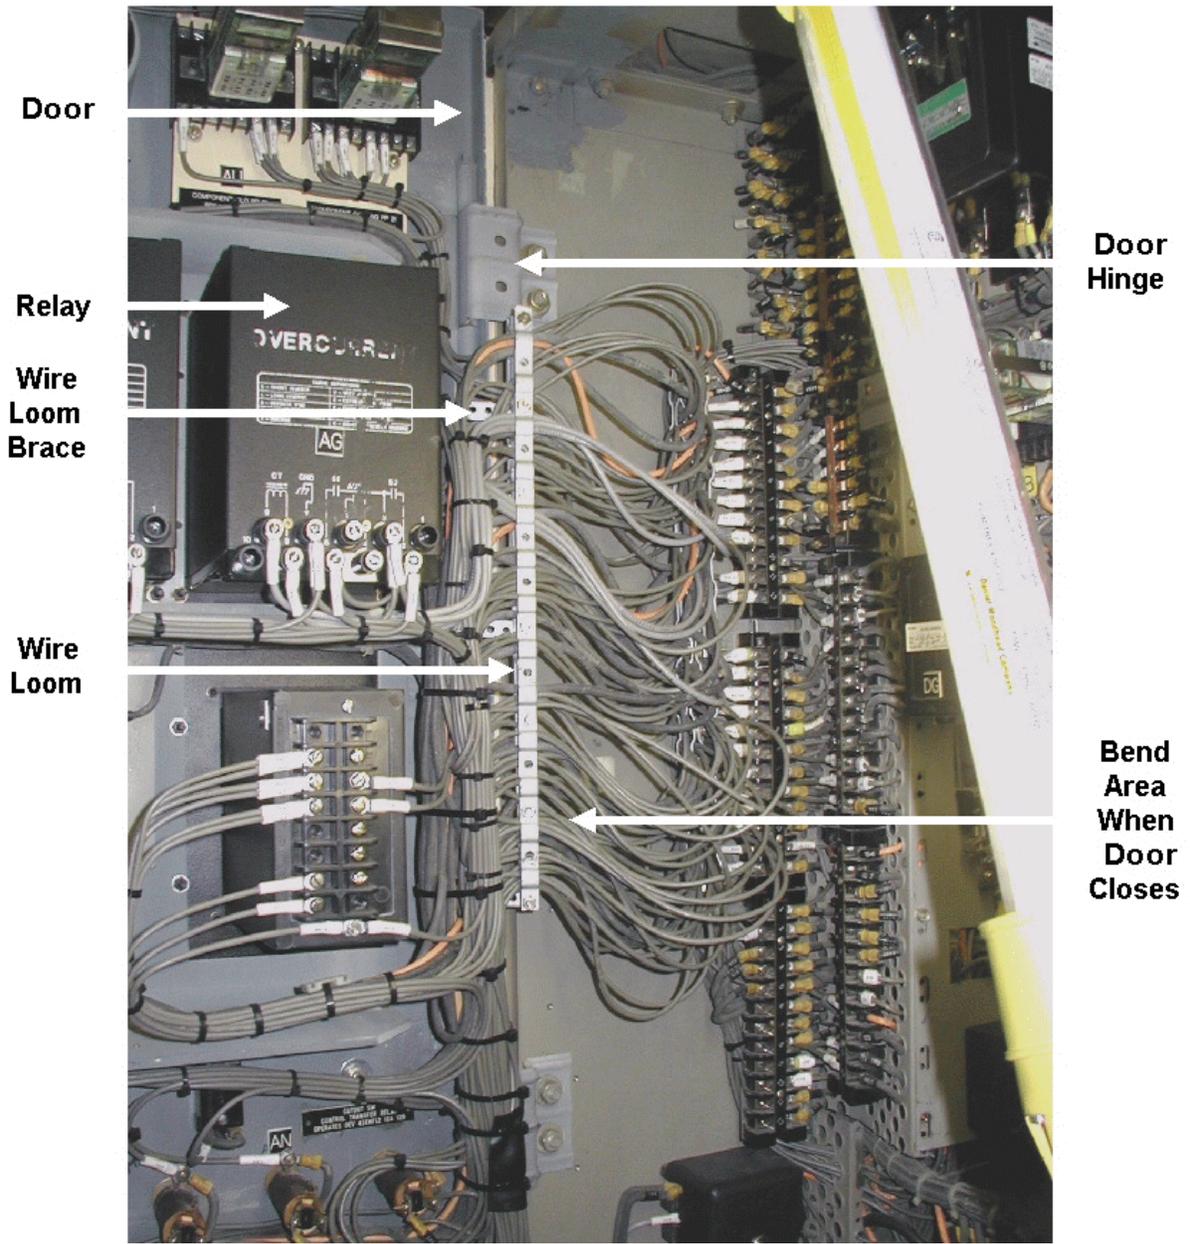
Breaker Cubicle Interior

The wires connecting the door-mounted equipment with terminals inside the cubicle are supported by two vertical wire braces (also called wire looms) as shown in Attachment 1. The purpose of the wire looms is to prevent the wires from becoming pinched in the door hinge when the breaker is opened and closed. One wire loom is mounted on the swingout door approximately 6 inches off the door surface and 2 inches from the door hinge. The other wire loom is mounted inside the cubicle approximately 10 inches from the door hinge and approximately 2 inches off the inner cubicle wall. The figure shows the construction and the location of the wire loom in relation to the door, door hinge, and other breaker components. When the door is fully opened, there is approximately 2 to 10 inches of wire slack between the two wire braces.

- (1) Cold Working
In a wire loom layout, in certain cases the wires are forced into the side of the breaker cubicle when the cubicle door is closed. This can force the wire on the inside of the bend to exceed the minimum bend radius for a dynamic bend, resulting in cold-working of the strands. Subsequent cycling of the door eventually results in wire failure.
- (2) Age-related degradation of the wires
Over time, the plasticizer leaches out of the PVC insulation, resulting in embrittlement. Flexing of the wire causes the insulation to break. The loss of the mechanical support provided by the insulation focuses the bending at the break, speeding the cold working of the wire strands and causing eventual failure.

- (1) Redesign the breaker cubicle wire looms and/or wire loom supports to eliminate excessive bending at the door hinge area.
- (2) Replace the wires that span the breaker cubicle hinge areas with standing class K or S wire that uses contemporary insulation (non-PVC).
