SUBJECT: NRC INSPECTION REPORT 040-07580/01-03

Docket No.: 040-07580
License No.: SMB-911
Report No.: 040-07580/01-03
Licensee: Fansteel, Inc.
Facility: Muskogee Plant
Location: Muskogee, Oklahoma
Inspection Dates: December 4-6, 2001
Inspector: Robert J. Evans, PE, CHP, Health Physicist
Fuel Cycle & Decommissioning Branch
Approved By: D. Blair Spitzberg, Ph.D., Chief
Fuel Cycle & Decommissioning Branch
Attachments: Supplemental Inspection Information
Photographs Taken at the Fansteel Facility

Fansteel, Inc. Muskogee Plant
NRC Inspection Report 040-07580/01-03

ATTACHMENT 2
FANSTEEL FACILITY IN MUSKOGEE, OKLAHOMA

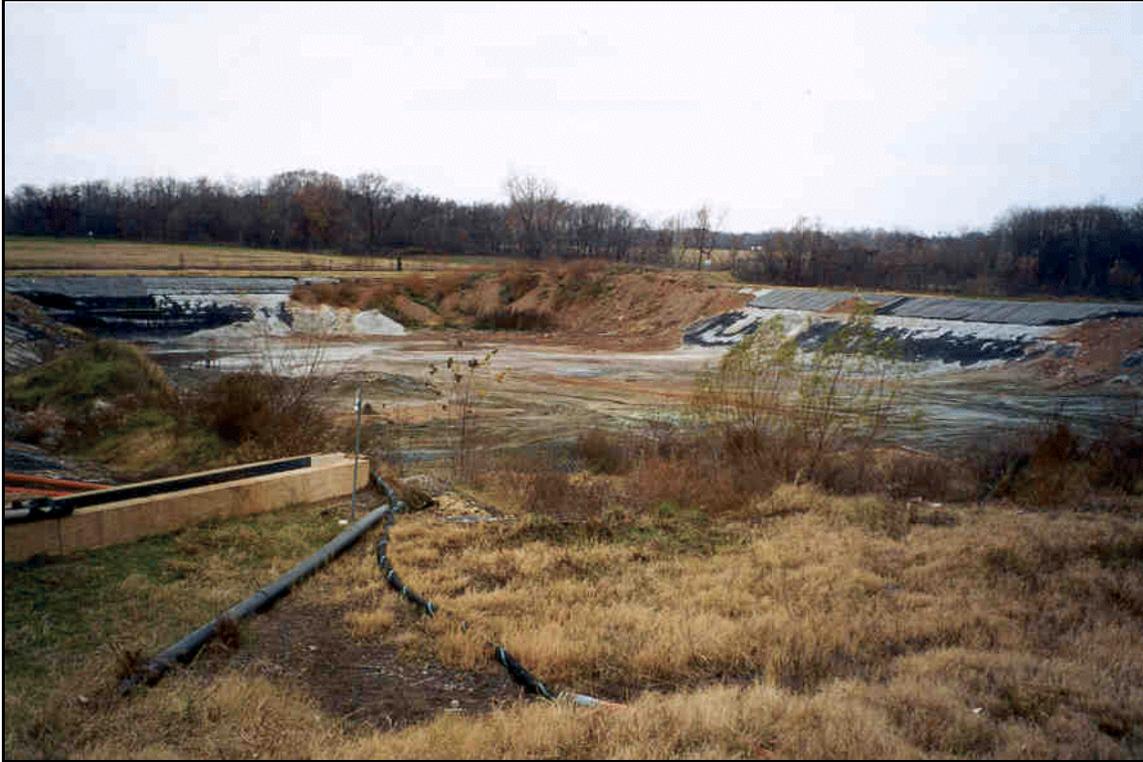
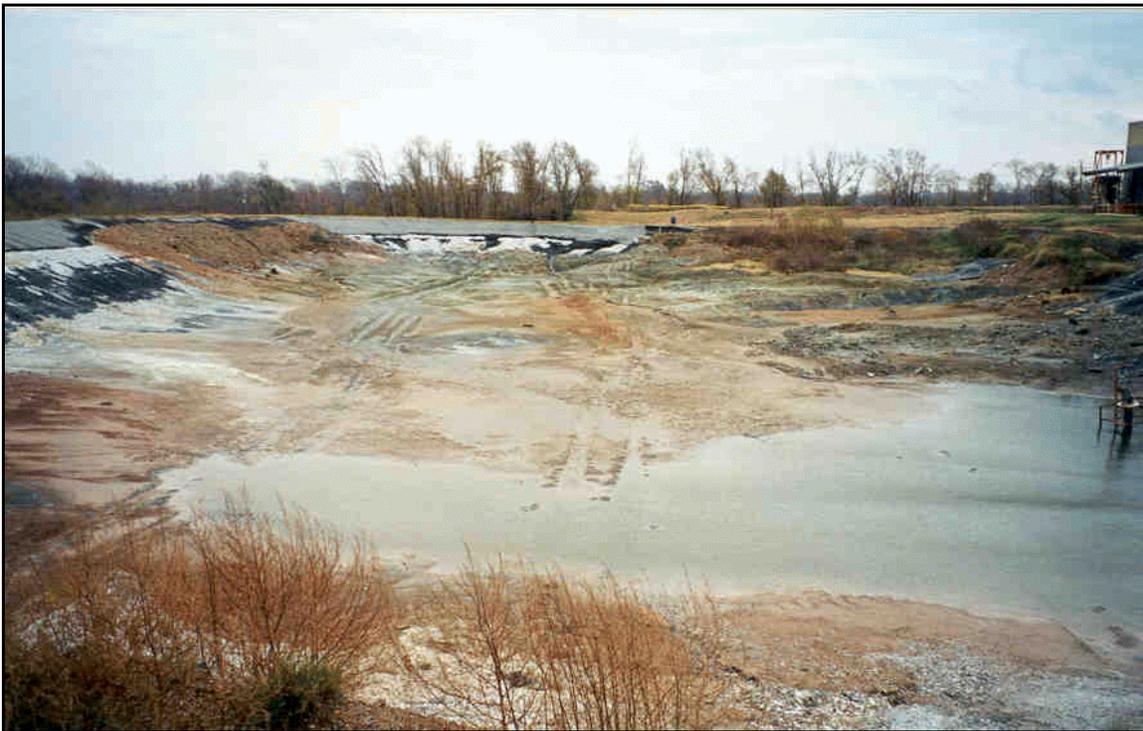
Pond 3 - contains previously processed ores and slag material.

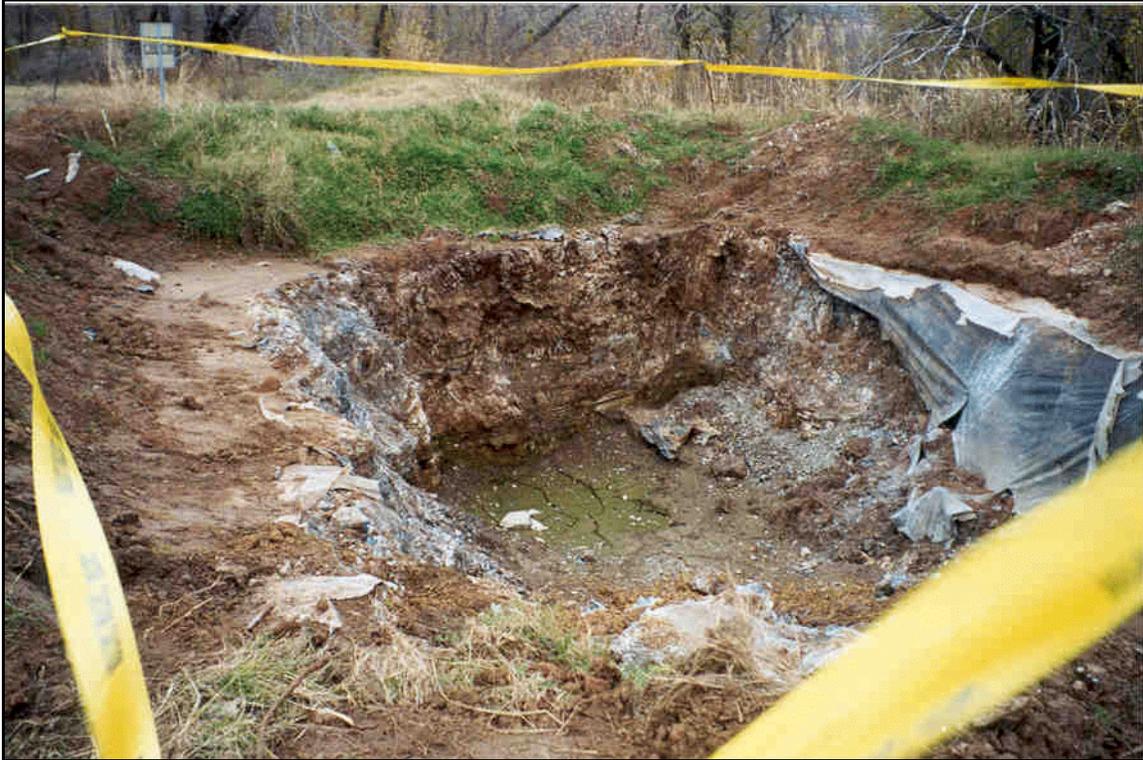
Excavated pit in Pond 2; location where WIP material was obtained.

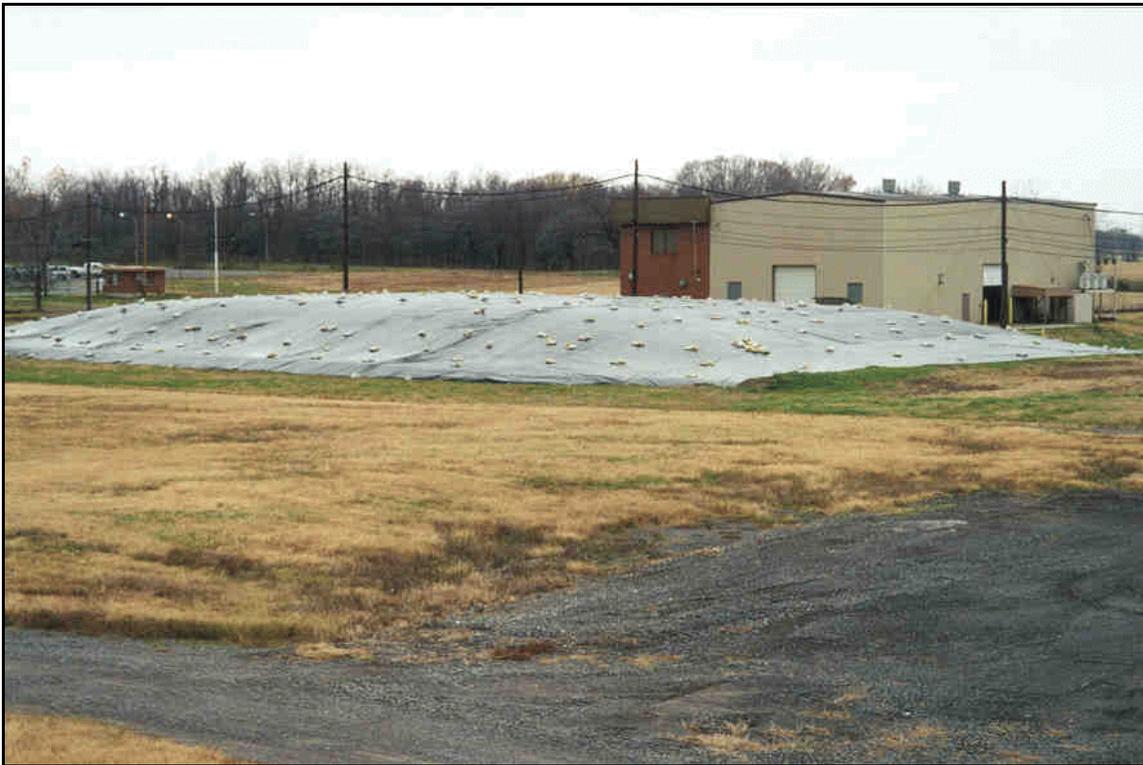
Contaminated soil being stored in restricted area (covered for protection).

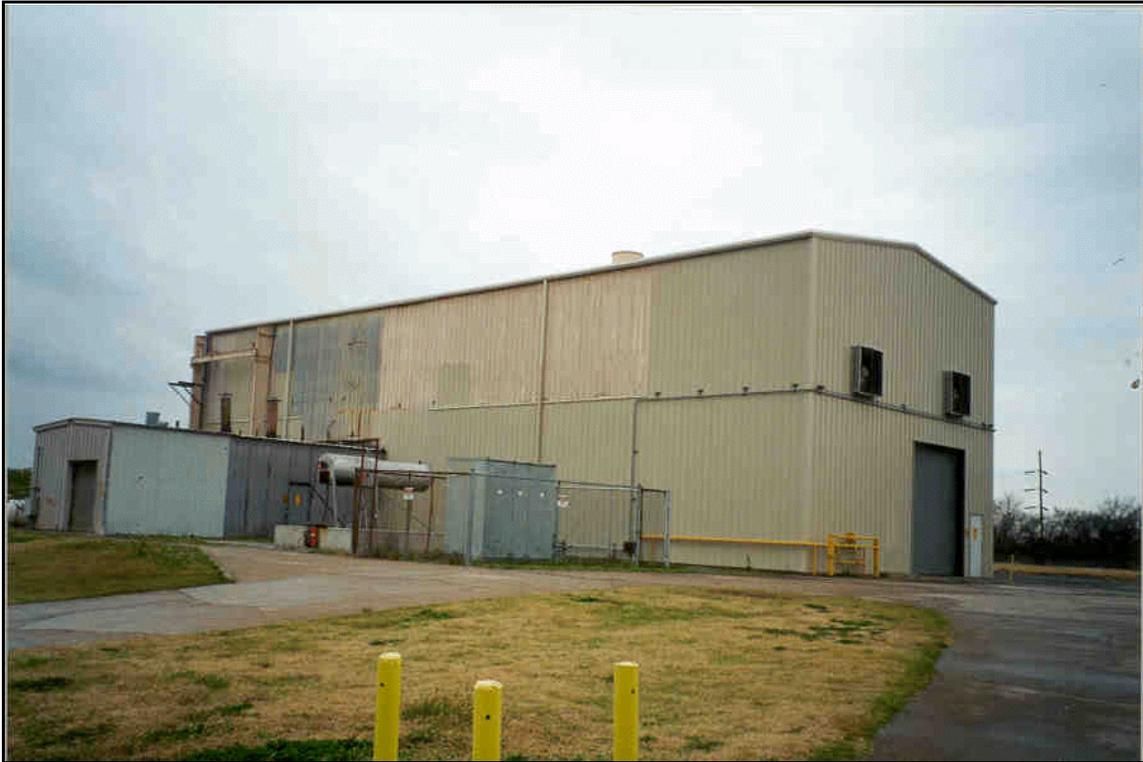
During the previous inspection, the NRC identified that the licensee had failed to post the Sodium Reduction Building as an airborne radioactivity area because of elevated radon-222 levels, a violation of 10 CFR 20.1902(d). In response to the NRC's findings, the licensee posted the building and implemented access control measures. The licensee's long-term plan was to remove the source of the radon-222, the radioactive material in storage in the building.

Sodium Reduction Building; Pond 5 material was stored in this building.

Since the previous inspection, the licensee relocated the radon monitor to an area in the Sodium Reduction Building that was more representative of actual conditions for individuals who enter the building. Depending on the results from the new location, the licensee may or may not have to post the building as an airborne radioactivity area in the future. The sample result for the second quarter of 2001 (26.4 picocuries per liter) was below the derived air concentration limit specified in 10 CFR Part 20, Appendix B, for radon-222 (30 picocuries per liter). Until several quarters of data are available, the licensee will continue to post the building as an airborne radioactivity area and will continue to control access to the building.

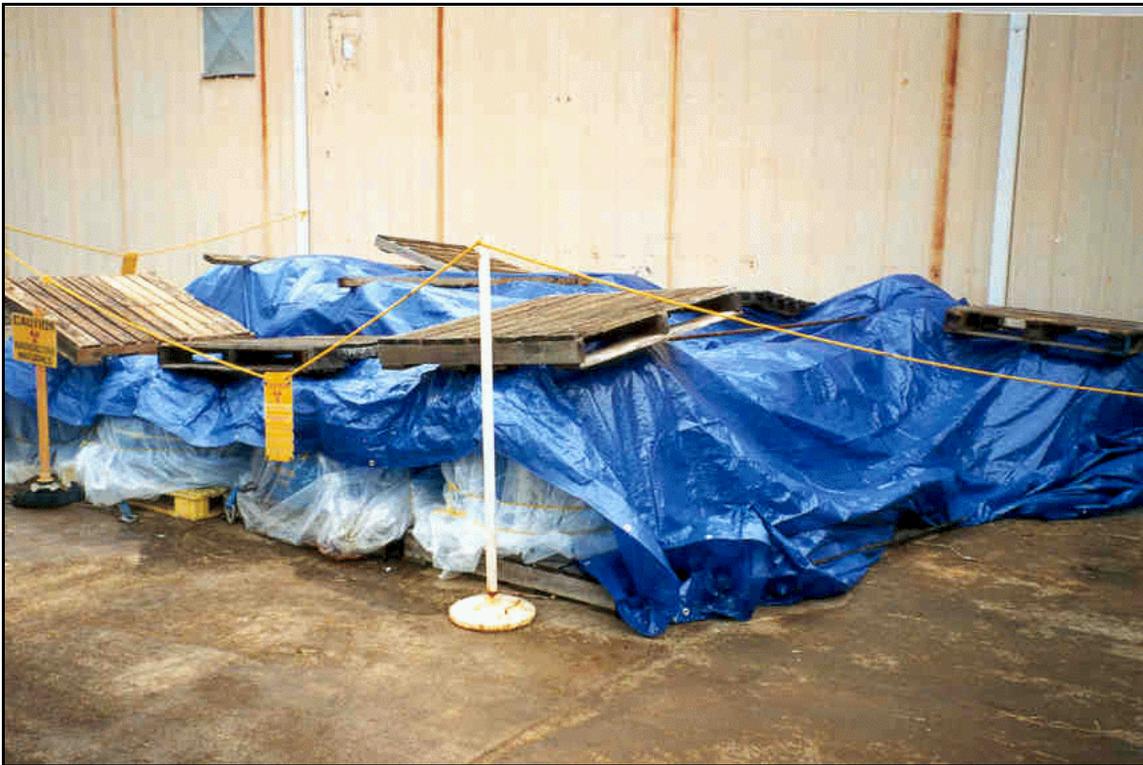
Temporary storage of about 14 tons of recovery product.

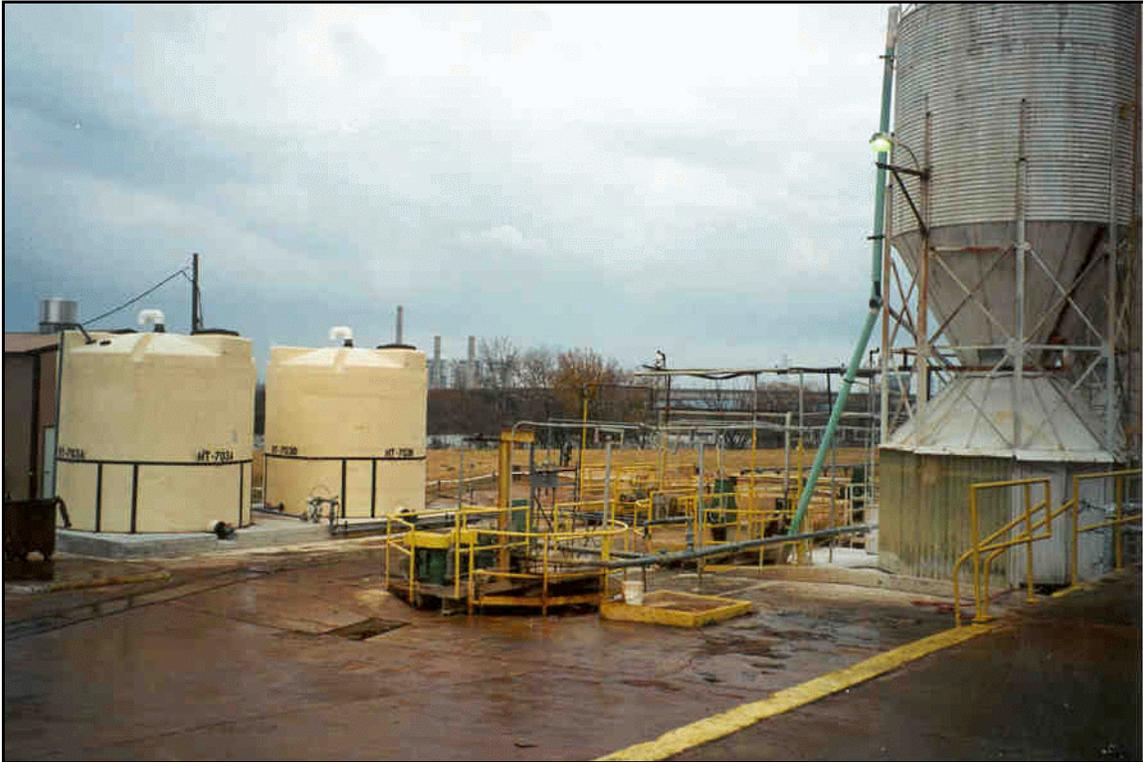
Portions of waste water treatment system located behind Chem C Bldg.

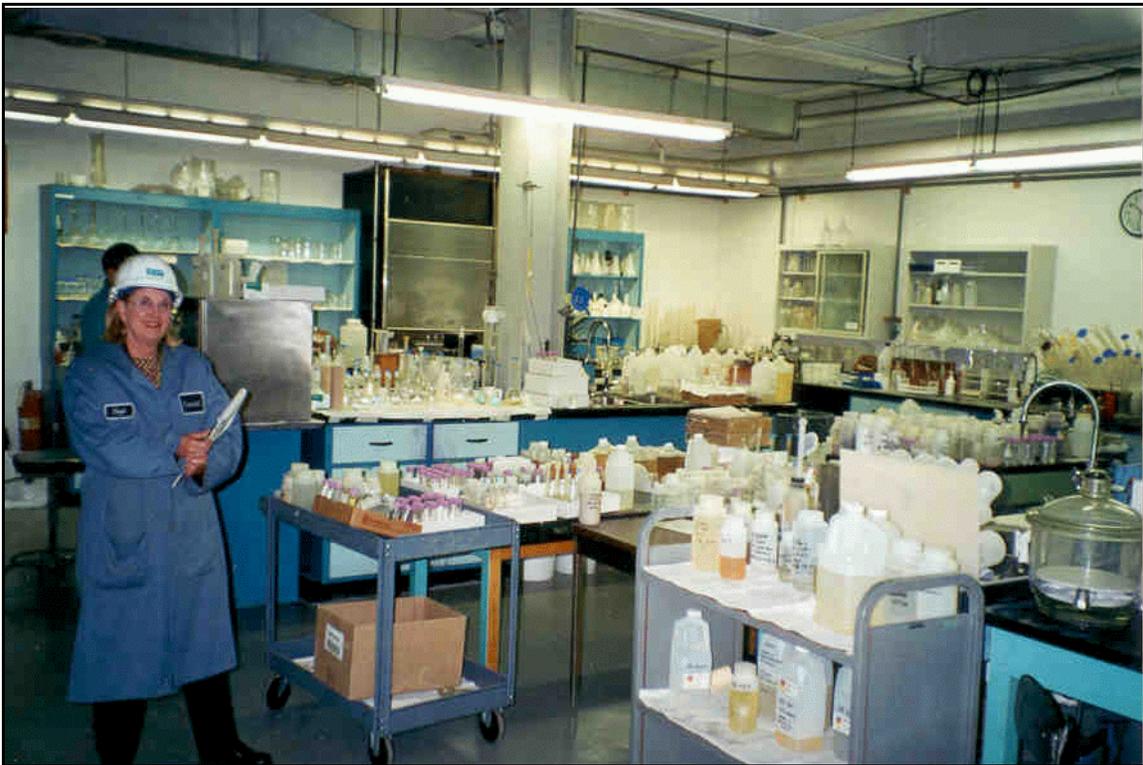
The inspector toured the plant chemistry laboratory. Work-in-progress included discarding unnecessary samples, laboratory cleanup, and analyses of remaining samples obtained from the last production run. Since the last inspection, the only material shipped offsite were laboratory samples but no shipments of completed product.

Laboratory located within Chem C Building.
