UNITED STATES  
NUCLEAR REGULATORY COMMISSION  
OFFICE OF NUCLEAR REACTOR REGULATION  
WASHINGTON, D. C. 20555-0001

January 8, 2002

NRC INFORMATION NOTICE 2002-01: METALCLAD SWITCHGEAR FAILURES AND  
CONSEQUENT LOSSES OF OFFSITE POWER

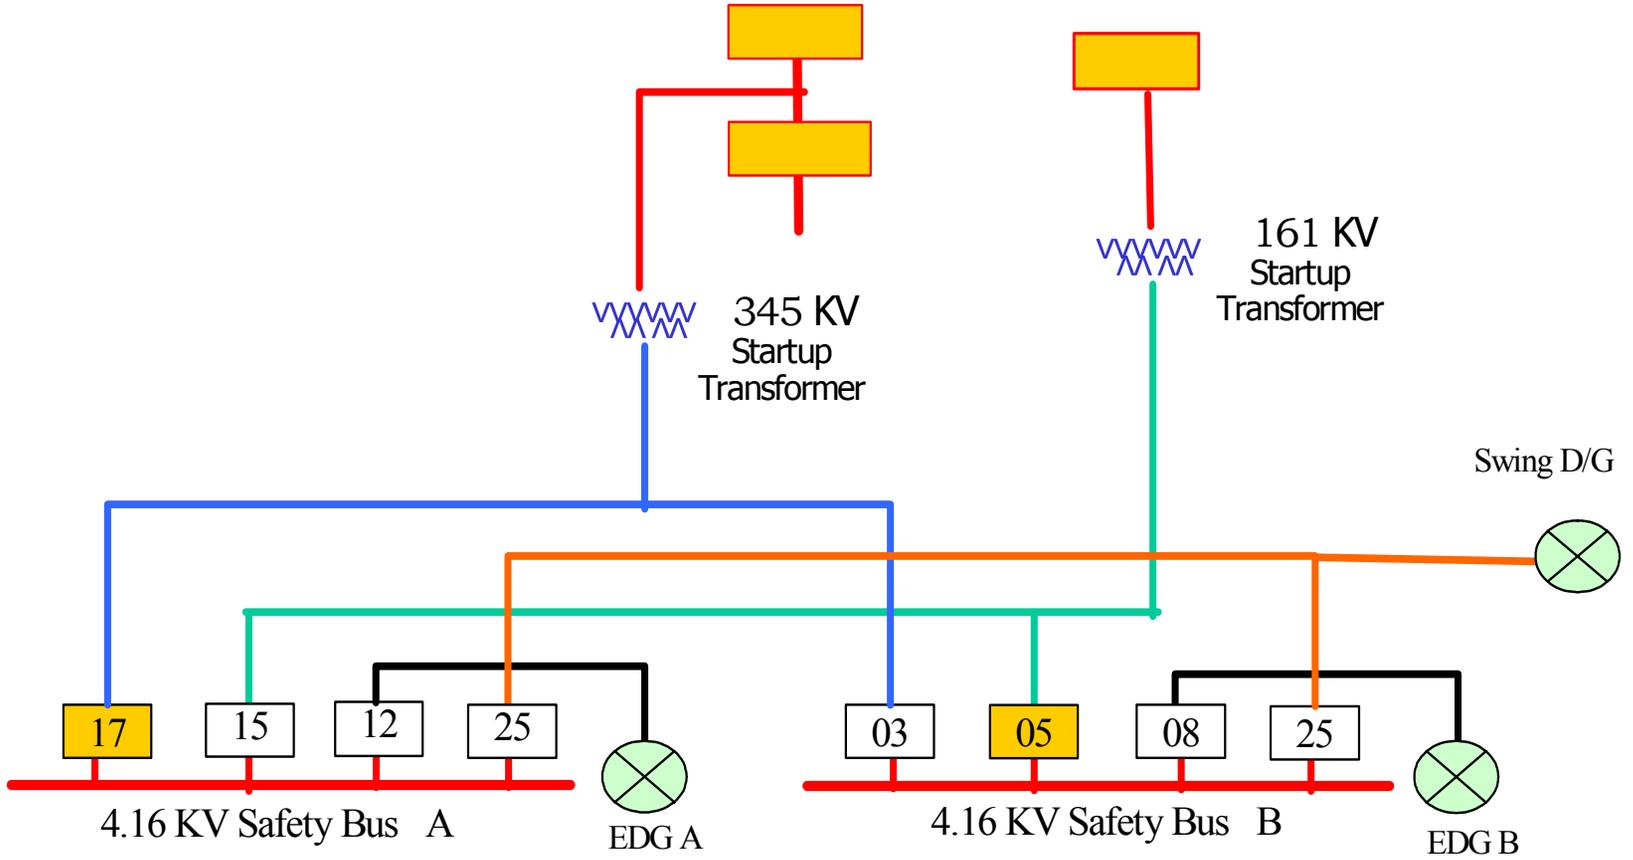
**AC Power  
Distribution System  
with Y Connection  
to Safety Buses**

This foreign plant is a PWR in commercial operation since the mid 1980s. Offsite power is provided by two independent circuits from the transmission network (see Attachment 1). The circuit from the 345 kV transmission network is the normal source of offsite power to each of the two redundant 4.16 kV safety-related trains. The circuit from 161 kV transmission network provides a backup offsite source to each train.

An electrical fault occurring in medium voltage switchgear enclosure can cascade, causing collateral damage within the switchgear and consequent loss of multiple circuits. When both safety trains are supplied from the same offsite supply with a common upstream circuit breaker (see Attachment 1), one fault in the supply circuit can disable offsite power to both redundant trains. Operators ought to be aware of such a vulnerability and to have considered means to isolate the faulted feeder if both offsite power sources could be affected by a fault in the feeder circuit.
